MINERALS PROGRAM INSPECTION REPORT PHONE: (303) 866-3567

MINE NAME:		MINE/PROSPECTING ID#:	MINERAL:	COUNTY:
Benson Pit		M-1977-256	Sand and gravel	Grand
INSPECTION TYPE:		INSPECTOR(S):	INSP. DATE:	INSP. TIME:
Monitoring		Peter S. Hays	June 15, 2016	12:30
OPERATOR:		OPERATOR REPRESENTATIVE:	TYPE OF OPERATION:	
Grand County		Bill Clark	112c - Construction Regular Operation	
REASON FOR INSPECTION:		BOND CALCULATION TYPE:	BOND AMOUNT:	
Normal I&E Program		None	No Bond Held	
DATE OF COMPLAINT:		POST INSP. CONTACTS:	JOINT INSP. AGENCY:	
NA		None	None	
WEATHER:	INSPECTOR'S SIGNATURE:		SIGNATURE DATE:	
Clear	fitting		July 20, 2016

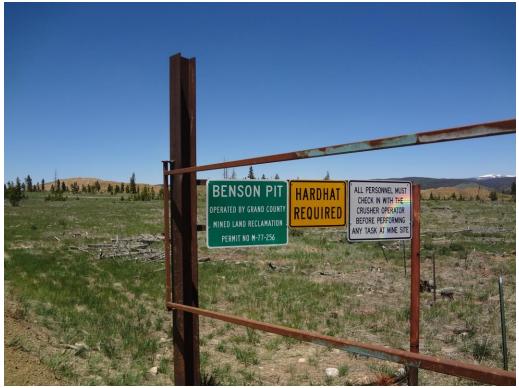
The Benson Pit is located 2 miles northwest of Frasier, Colorado in Grand County. The site is permitted for a total of 104.28 acres. The entrance road has been relocate along the west side of the site from CR5 on CR5103. The required mine sign was posted at the entrance from CR 5103 and the permit boundaries were well defined as required by Rule 3.1.12.

Benson Pit mine sign

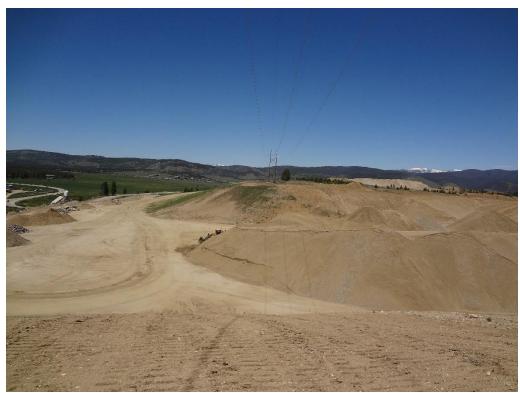
Looking north from south powerline peninsula

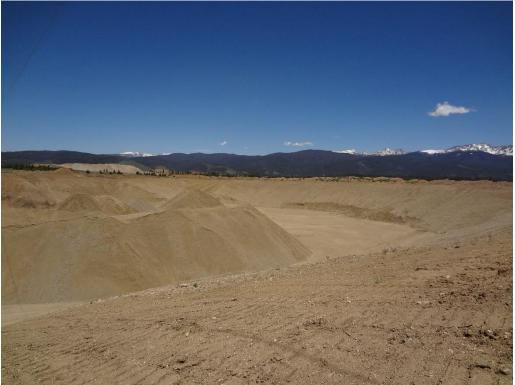
Looking NE from south powerline peninsula

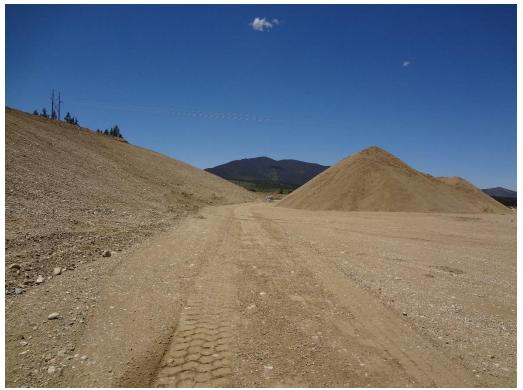
Looking west from SE corner of pit floor

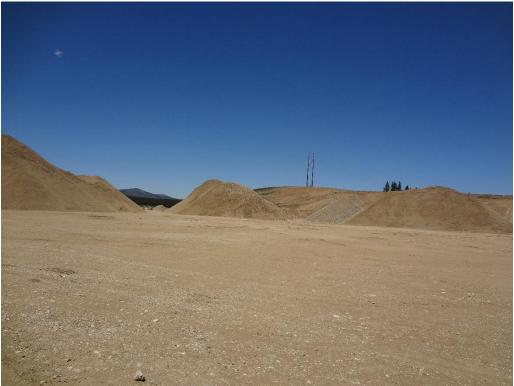
Looking NW from SE corner of pit floor

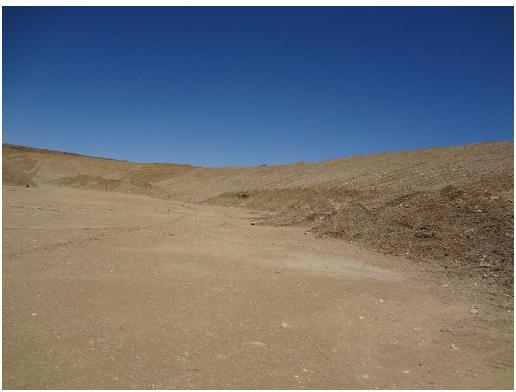
Looking north from SE corner of pit floor

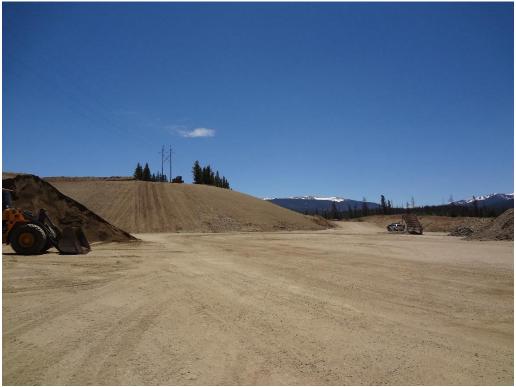
Looking south at south powerline peninsula

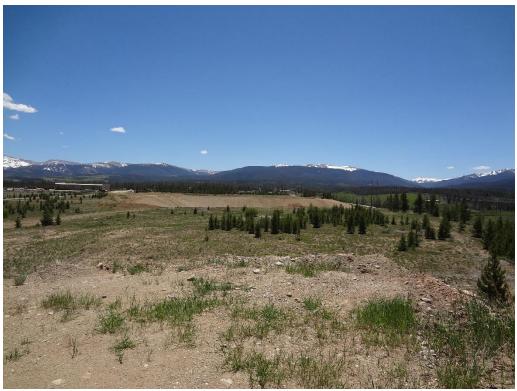
Looking south from topsoil stockpile at current pit
