MINERALS PROGRAM INSPECTION REPORT PHONE: (303) 866-3567

MINE NAME:		MINE/PROSPECTING ID#:	MINERAL:	COUNTY:	
Benson Pit		M-1977-256	Sand and gravel	Grand	
INSPECTION TYPE:		INSPECTOR(S):	INSP. DATE:	INSP. TIME:	
Monitoring		Peter S. Hays	June 15, 2016	12:30	
OPERATOR:		OPERATOR REPRESENTATIVE:	TYPE OF OPERATION:		
Grand County		Bill Clark	112c - Construction Regular Operation		
REASON FOR INSPECTION:		BOND CALCULATION TYPE:	BOND AMOUNT:		
Normal I&E Program		None	No Bond Held		
DATE OF COMPLAINT:		POST INSP. CONTACTS:	JOINT INSP. AGENCY:		
NA		None	None		
WEATHER:	INSPECTOR'S SIGNATURE:		SIGNATURE DAT	E:	
Clear		74-1	July 20, 2016		
	1	Thy

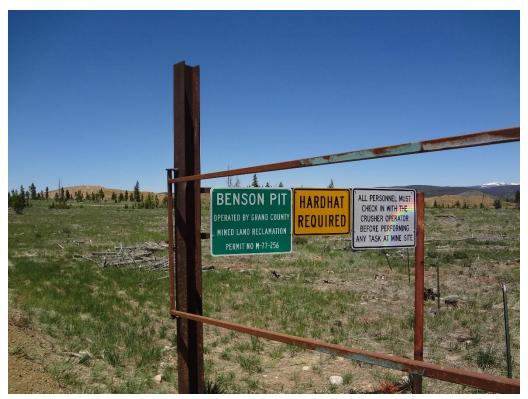
The Benson Pit is located 2 miles northwest of Frasier, Colorado in Grand County. The site is permitted for a total of 104.28 acres. The entrance road has been relocate along the west side of the site from CR5 on CR5103. The required mine sign was posted at the entrance from CR 5103 and the permit boundaries were well defined as required by Rule 3.1.12.

Benson Pit mine sign

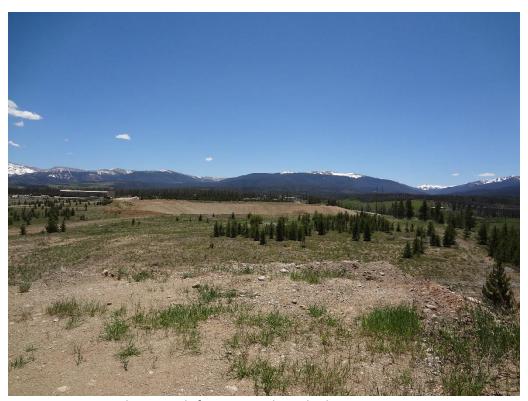
Looking south from topsoil stockpile at current pit

The large area of imported, end dumped topsoil stockpiles located in the north end of the site has been consolidated into a single larger pile. Imported material from the Grand County Water and Sanitation District mining operation was stockpiled on the north end of the site. The stockpile will be processed by the Operator to determine to usability of the material soon. No disturbance in the amendment area was observed.
