MINERALS PROGRAM INSPECTION REPORT
PHONE: (303) 866-3567

MINE NAME: Cedarwood Clay Mine	MINE/PROSPECTING ID#: M-1977-317	MINERAL: Clay (general)	COUNTY: Pueblo
INSPECTION TYPE: Monitoring	INSPECTOR(S): Tyler V. O'Donnell	INSP. DATE: March 16, 2016	INSP. TIME: 09:00
OPERATOR: Summit Brick & Tile Co.	OPERATOR REPRESENTATIVE: Mat Welte	TYPE OF OPERATION: 112c - Construction Regular Operation	
REASON FOR INSPECTION: Normal I&E Program	BOND CALCULATION TYPE: Complete Bond	BOND AMOUNT: \$77,743.00	
DATE OF COMPLAINT: NA	POST INSP. CONTACTS: None	JOINT INSP. AGENCY: None	
WEATHER: Clear	INSPECTOR'S SIGNATURE:

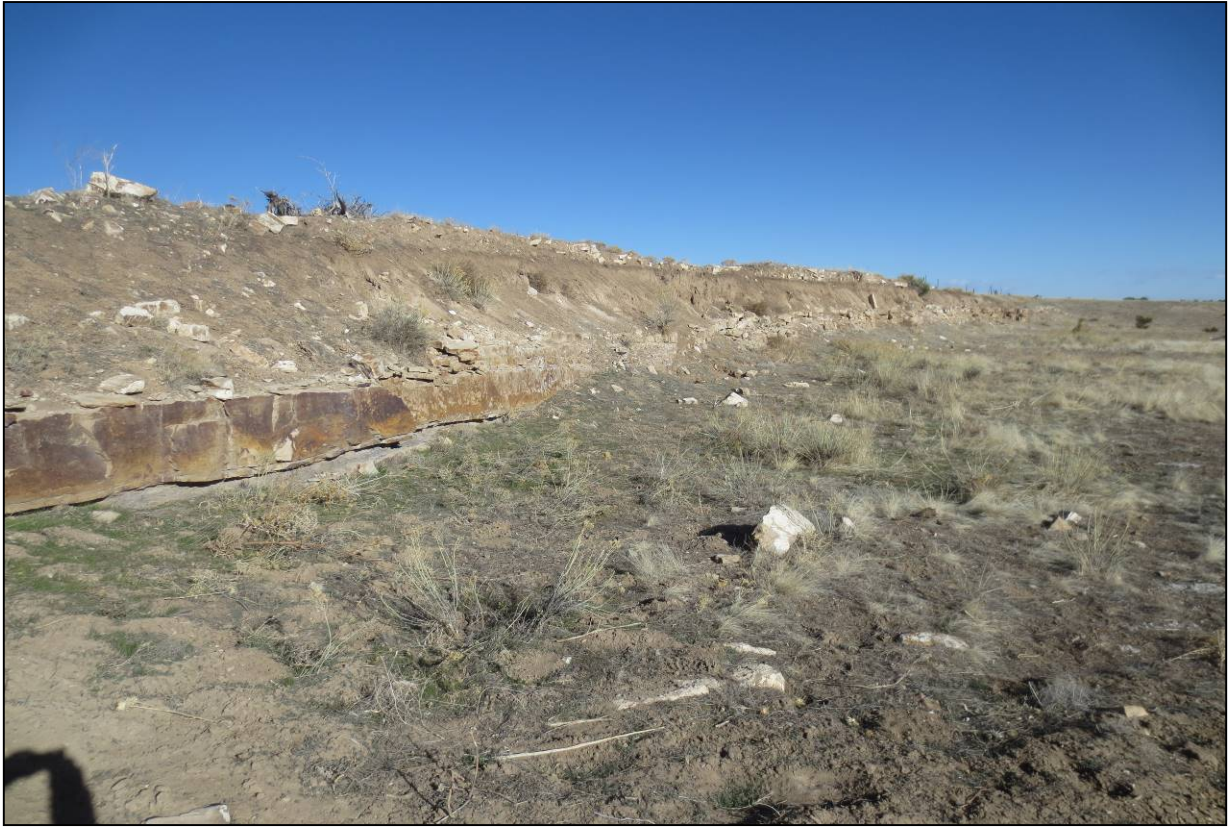
Photo 1: Highwall on top of the river bench/terrace.

The mining operation was expanding to the east, down off of the creek bench/terrace. There were several stockpiles of clay, crushed sandstone, and sandstone for decorative rock scattered throughout the affected lands. There were several small active mining faces scattered around the site. Many of the active mining faces have created shallow vertical highwalls. The highwalls ranged in height from about 5 to 15 feet high. In general the site currently daylight to the east/northeast. When completing final reclamation, the Operator will need to grade all slopes to 3H:1V or flatter to comply with the approved reclamation plan.

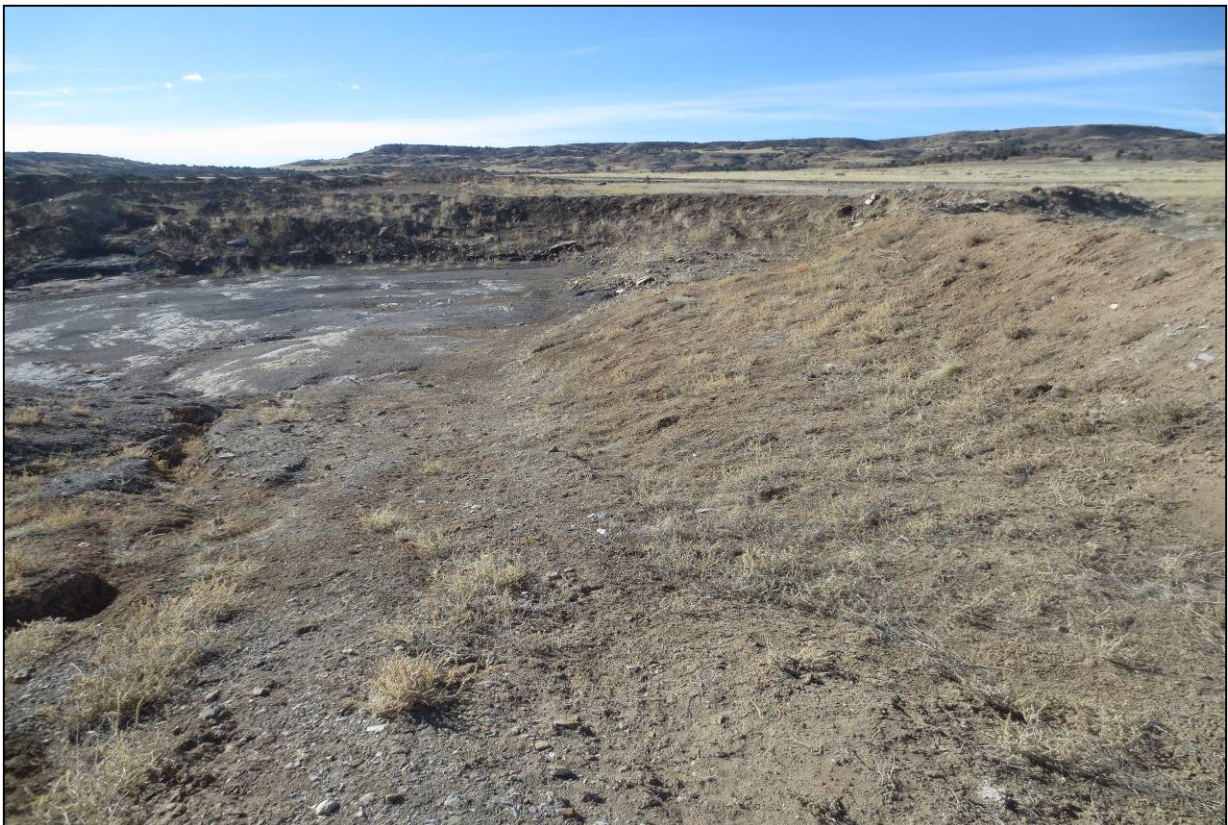
Photo 2: Shallow excavation on top of the river bench/terrace.

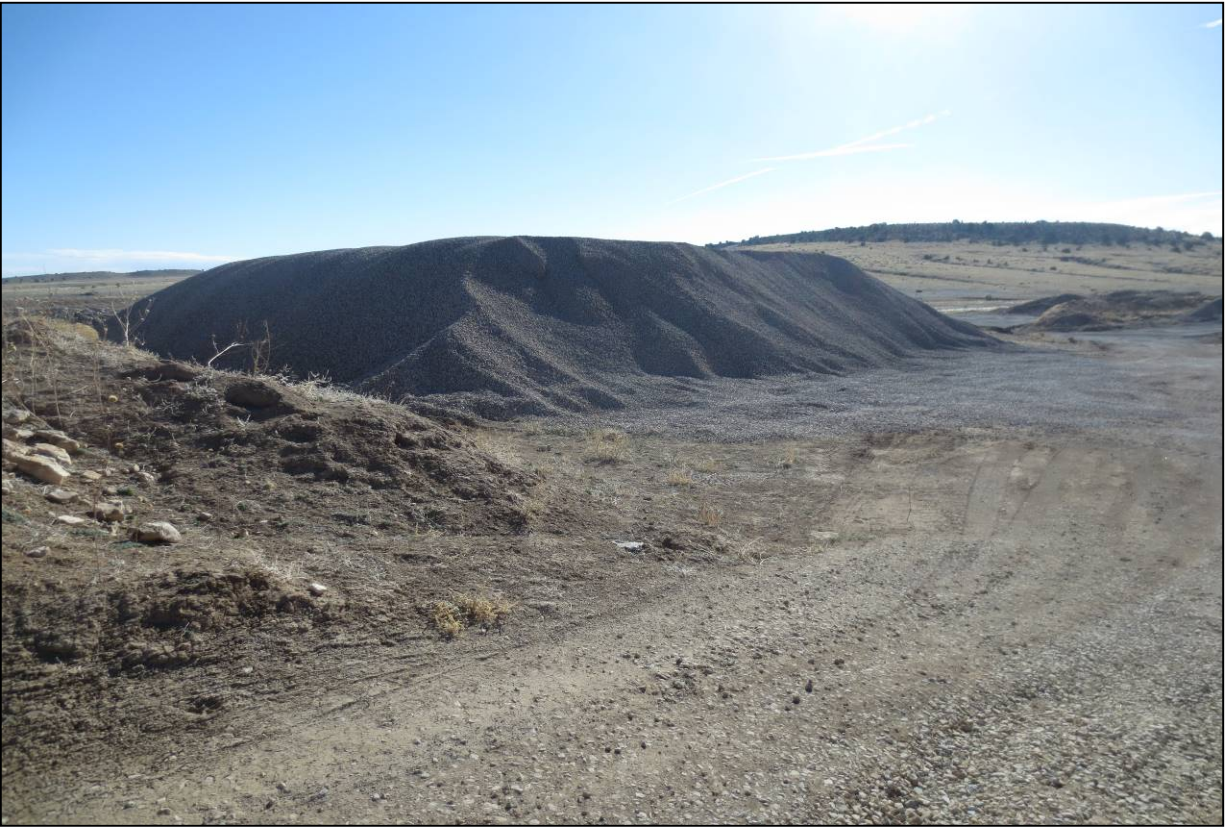
Photo 3: Stockpile of crushed sandstone for road base. The sandstone is being processed and stockpiled by a third party.

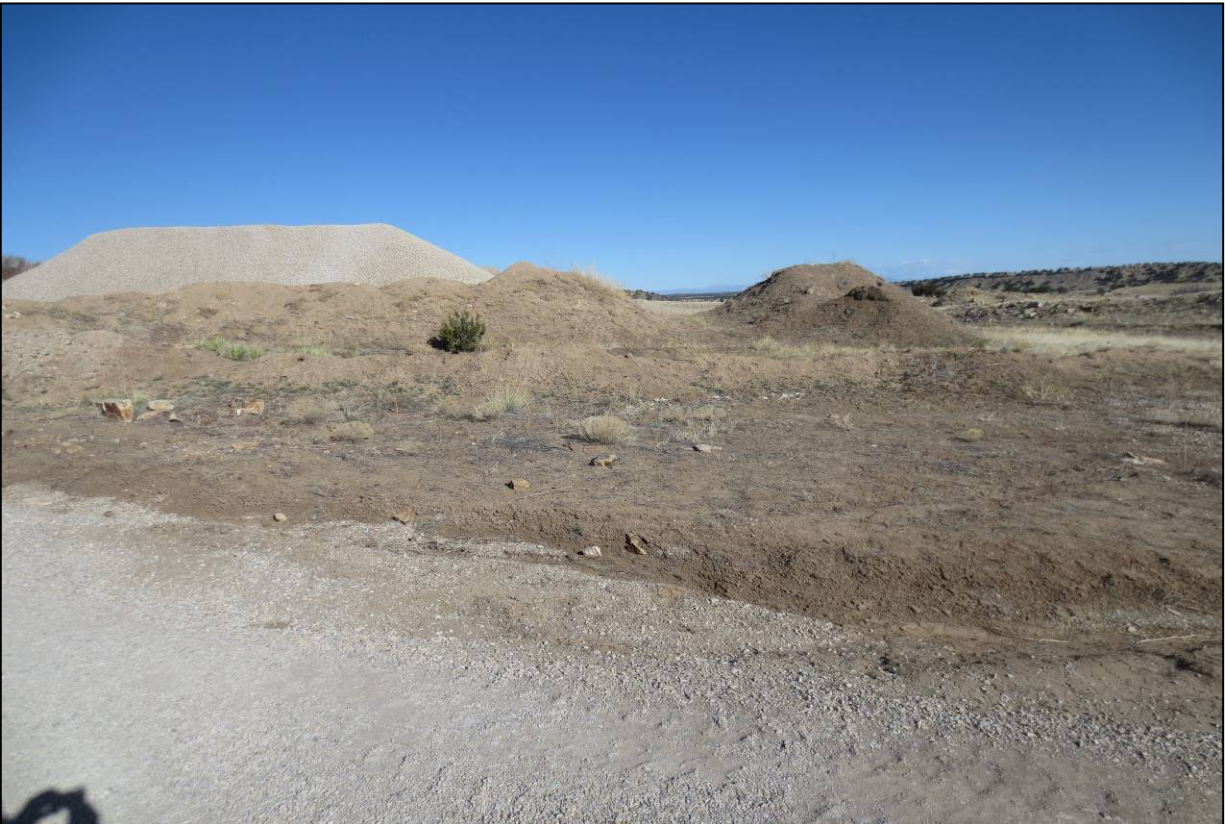
There was adequate topsoil stockpiled on site to conduct the approved reclamation plan. There were several partially vegetated topsoil stockpiles and topsoil berms within the affected lands. It appears that the Operator had been salvaging topsoil in advance of mining and the mining related disturbance. The topsoil stockpiles and berms had adequate vegetative cover to protect topsoil from erosion.

Photo 4: Topsoil bermed up around the stockpiling area.
