MINERALS PROGRAM INSPECTION REPORT

MINE NAME: Incas Mine	MINE/PROSPECTING ID#: M-1986-076	MINERAL: Gold and silver	COUNTY: La Plata
INSPECTION TYPE: Monitoring	INSPECTOR(S): Lucas J. West	INSP. DATE: June 30, 2016	INSP. TIME: 08:42
OPERATOR: Michael McClure	OPERATOR REPRESENTATIVE: None	TYPE OF OPERATION: 110d - Designated Limited Impact

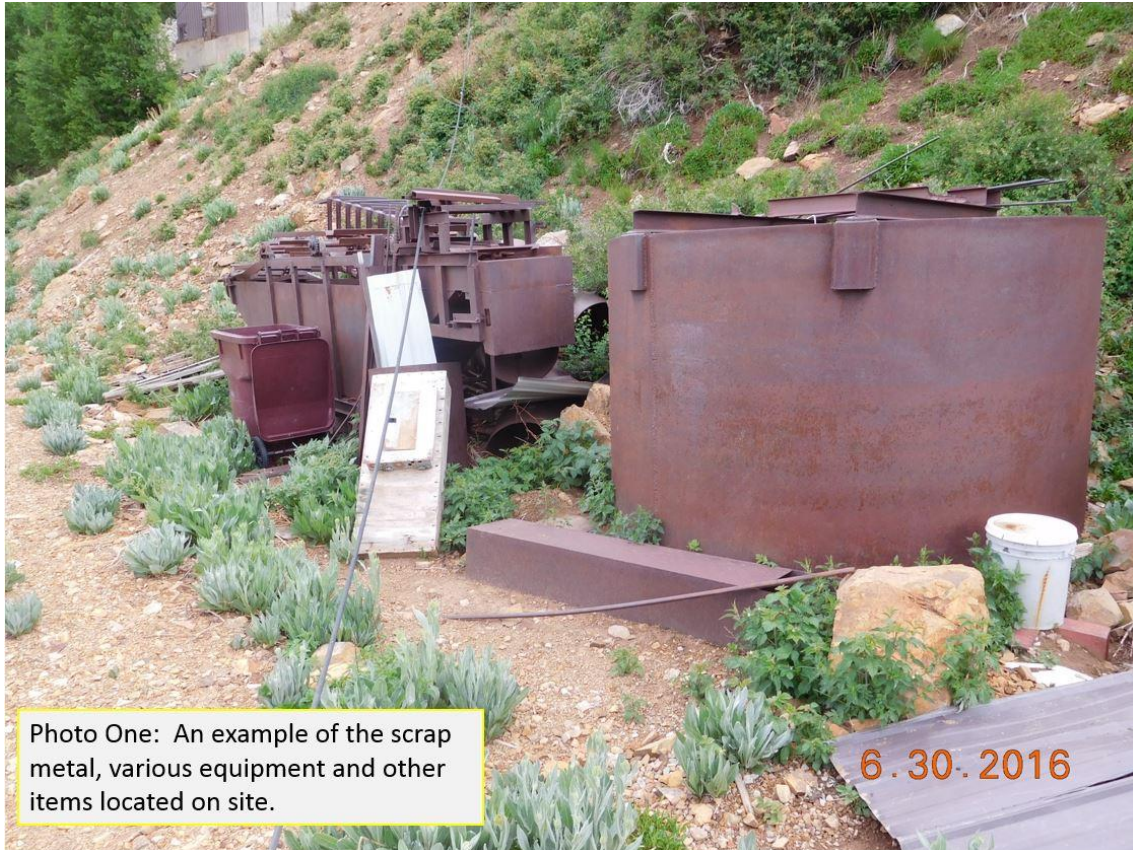
The site was not active during this inspection and has not been in recent years. The site has been in Temporary Cessation effective April 15, 2014. The First 5 year period of Temporary Cessation will expire on April 15, 2019. The proper mine identification sign was not posted at the entrance to the site. Given the recent Succession of Operator, the new operator should post a new sign, complete with permit number, site number and operator contact information at the entrance to the site. All buildings and storage sheds located on site were in good condition and showed no signs of vandalism. Various pieces of equipment, scrap metal and other items were noted throughout the site. Photos One shows examples of the various items located on site. Items that are being stored on site for future use should be stored in a neat and orderly fashion. All other items should be removed from the site.

Photo One: An example of the scrap metal, various equipment and other items located on site.

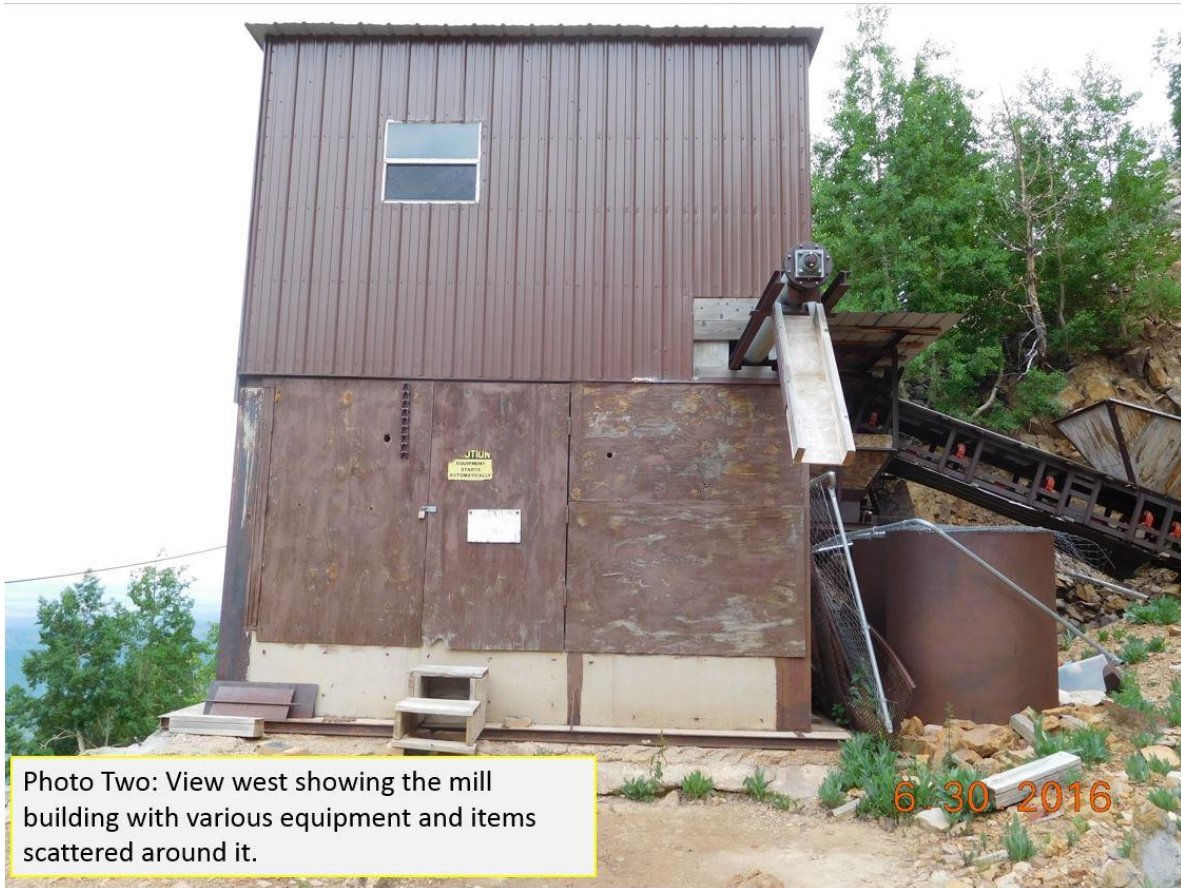
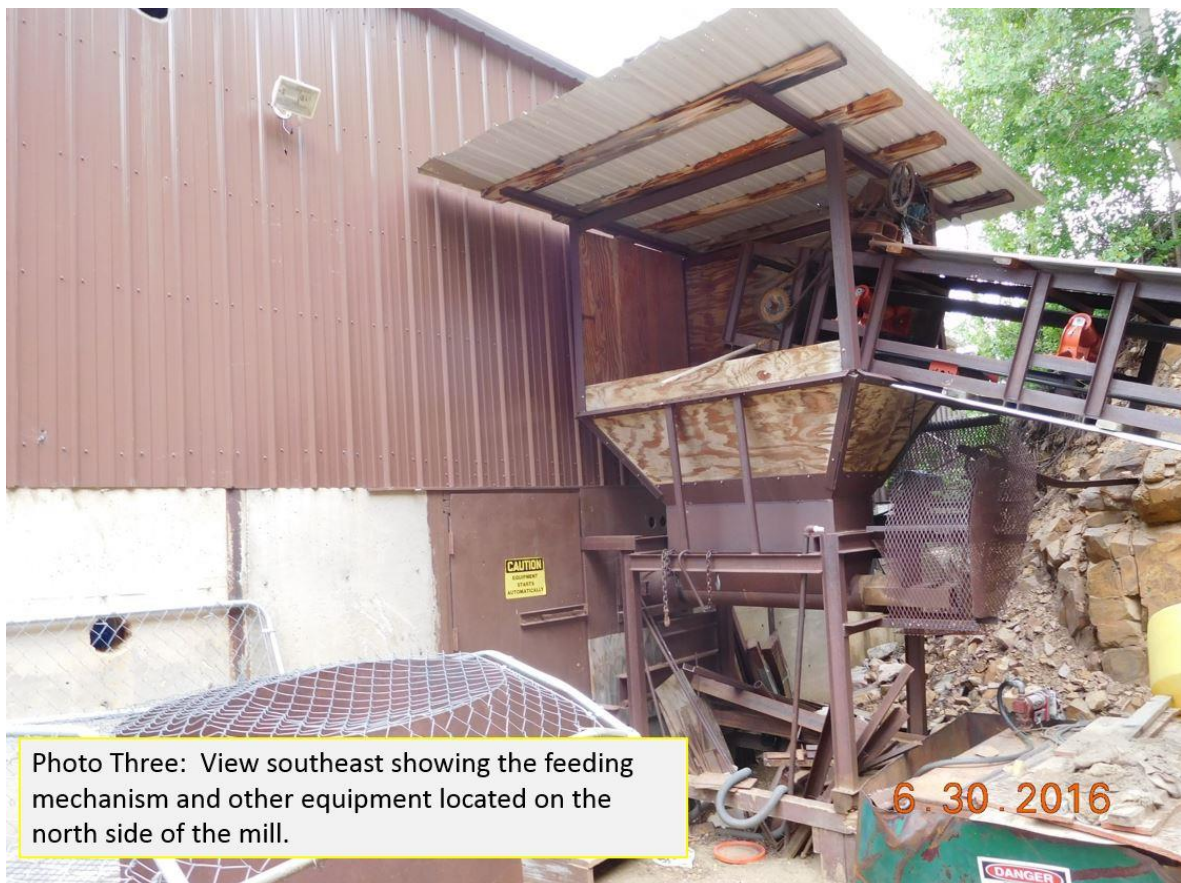
PROBLEM/POSSIBLE VIOLATION: Problem: Several containers of unknown materials are located within the mill building. Due to the fact that the mill used to operate with cyanide, the material is presumed hazardous and should be either neutralized and or removed from the site, or stored in proper hazardous materials containment structures.

Access to the mill building was gained through an unlocked back door. Photos Two and Three show the mill building. The mill equipment, processing and testing equipment were observed throughout the building. Much of the equipment and the mill building itself is in serious disrepair and requires immediate attention. Several containers, including three plastic 55 gallon drums of an unknown substance, as well as two stainless steel drums were observed within the mill. The 55 gallon drums are shown in Photo Four, and the Stainless Steel containers are shown in Photo Five. The containers are filled with an unknown substance, which at this time is being presumed hazardous. The operator shall submit in writing, a report characterizing the materials to the Division. If determined to be hazardous the operator shall take immediate action to neutralize or remove the materials from the site. The report must be received within **90 days** of the date of this letter. All documentation demonstrating compliance must be received by the Division no later than **Friday October 28, 2016**. If compliance is not reached by the date specified above, a reclamation cost estimate will be performed with the inclusion of a hazardous materials characterization and removal task.

CORRECTIVE ACTIONS: The operator shall submit in writing, a report characterizing the materials to the Division. If determined to be hazardous the operator shall take immediate action to neutralize or remove the materials from the site. The report must be received within 90 days of the date of this letter.

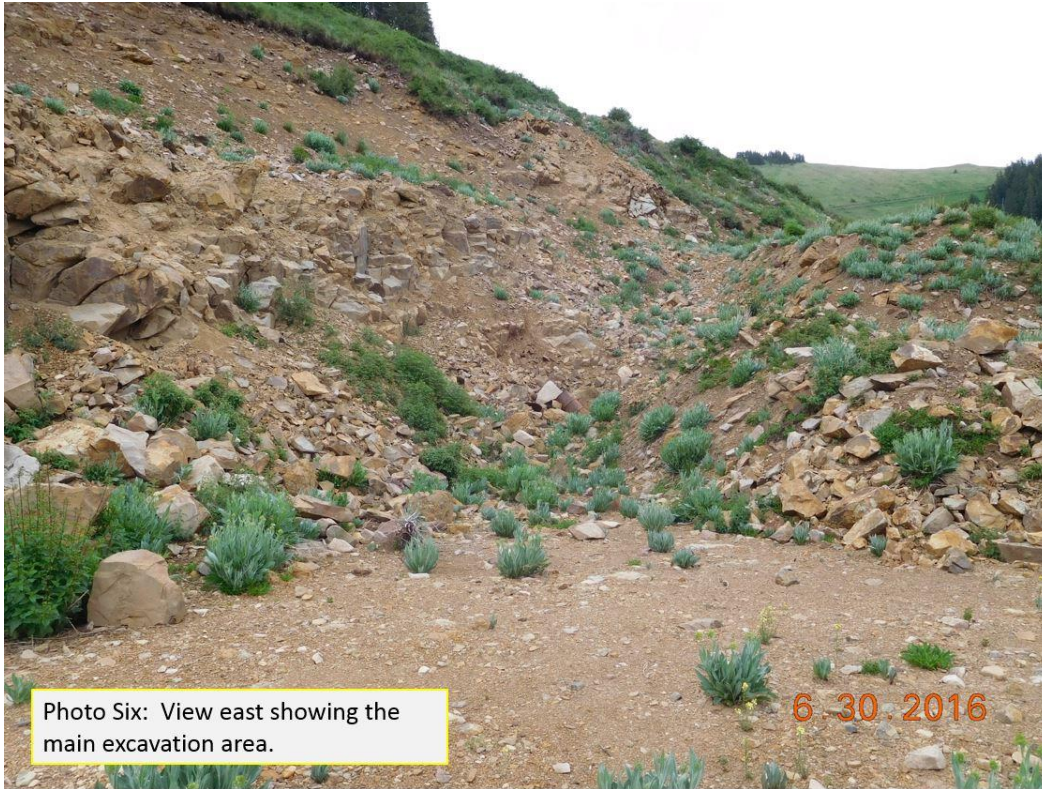
The rest of the site is in poor condition and requires attention. The portals appear to have been backfilled by the previous operator, and a majority of the site is revegetated with volunteer species. There are two areas that have not been re graded. The main excavation area is shown in Photo Six. The areas of the site that require further reclamation activities include the main excavation area, and the mill building.
