**COLORADO DIVISION OF RECLAMATION, MINING AND SAFETY**  
**MINERALS PROGRAM INSPECTION REPORT**  
**PHONE: (303) 866-3567**

<b>MINE NAME:</b> Elrick Pit	<b>MINE/PROSPECTING ID#:</b> M-1997-015	<b>MINERAL:</b> Sand and gravel	<b>COUNTY:</b> Washington
<b>INSPECTION TYPE:</b> Monitoring	<b>INSPECTOR(S):</b> Elliott R. Russell	<b>INSP. DATE:</b> June 1, 2016	<b>INSP. TIME:</b> 11:50
<b>OPERATOR:</b> Washington County	<b>OPERATOR REPRESENTATIVE:</b> Jason Lockard	<b>TYPE OF OPERATION:</b> 112c - Construction Regular Operation	
<b>REASON FOR INSPECTION:</b> Normal I&E Program	<b>BOND CALCULATION TYPE:</b> None	<b>BOND AMOUNT:</b> NA	
<b>DATE OF COMPLAINT:</b> NA	<b>POST INSP. CONTACTS:</b> None	<b>JOINT INSP. AGENCY:</b> None	
<b>WEATHER:</b> Clear	<b>INSPECTOR'S SIGNATURE:</b>

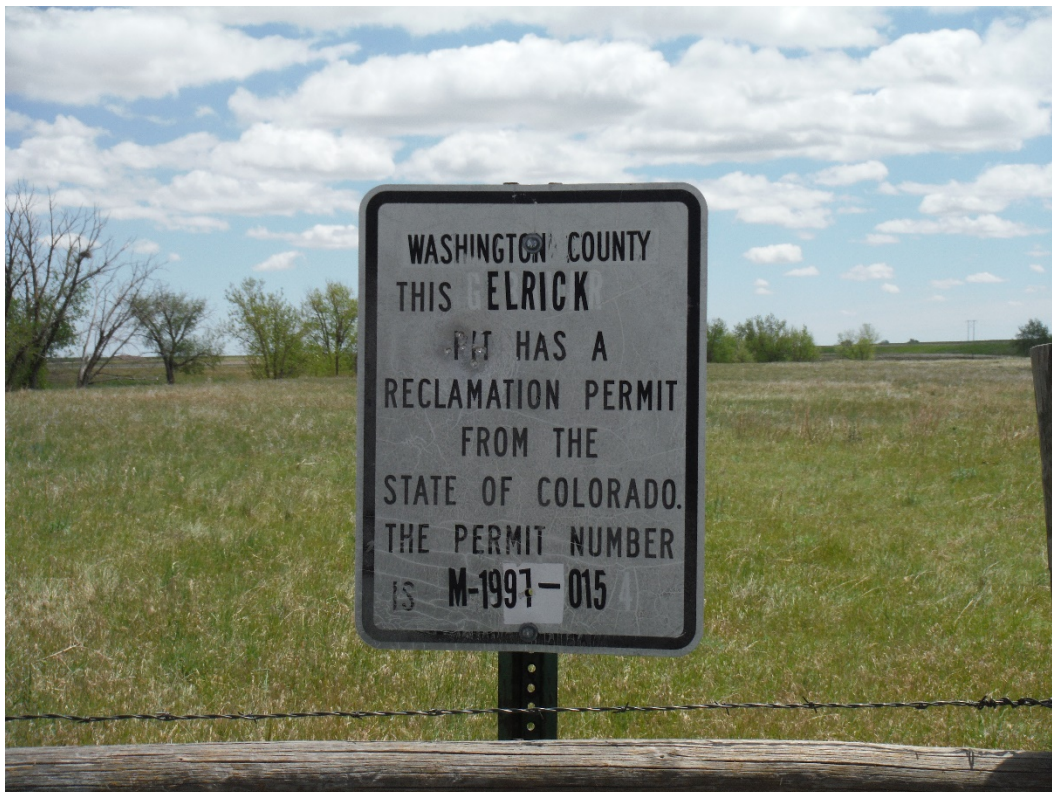
Mine identification sign posted western boundary; looking east.

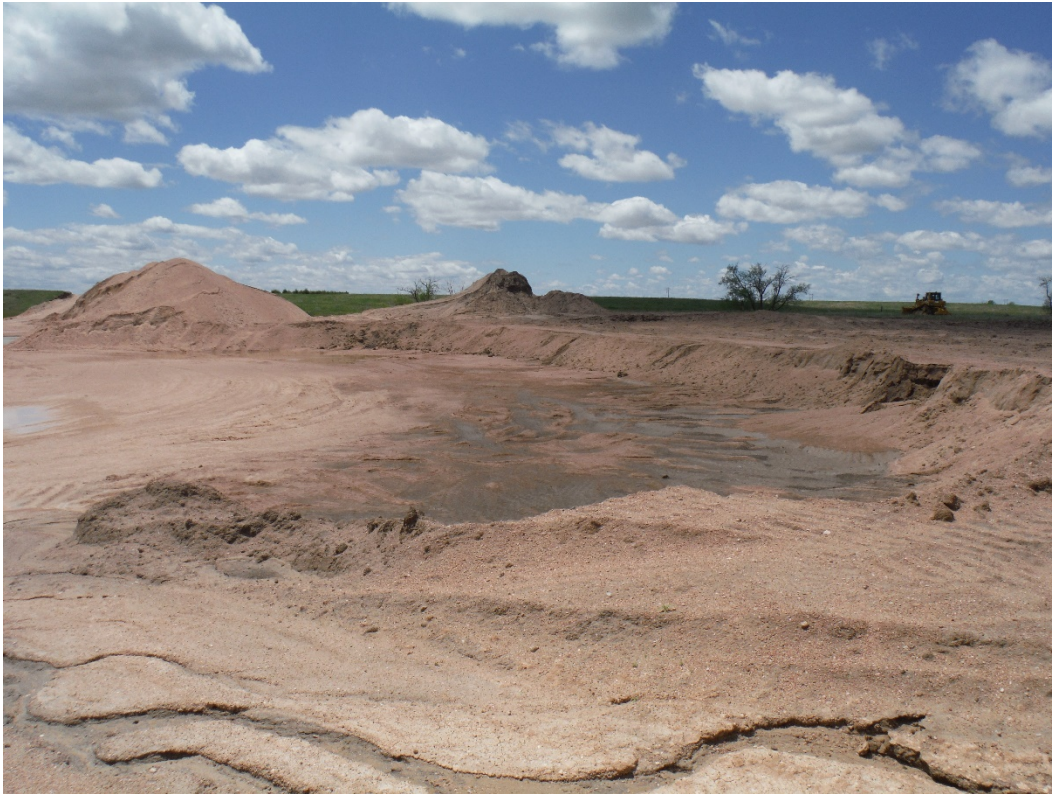
Active mining face in the pit area; looking southwest.

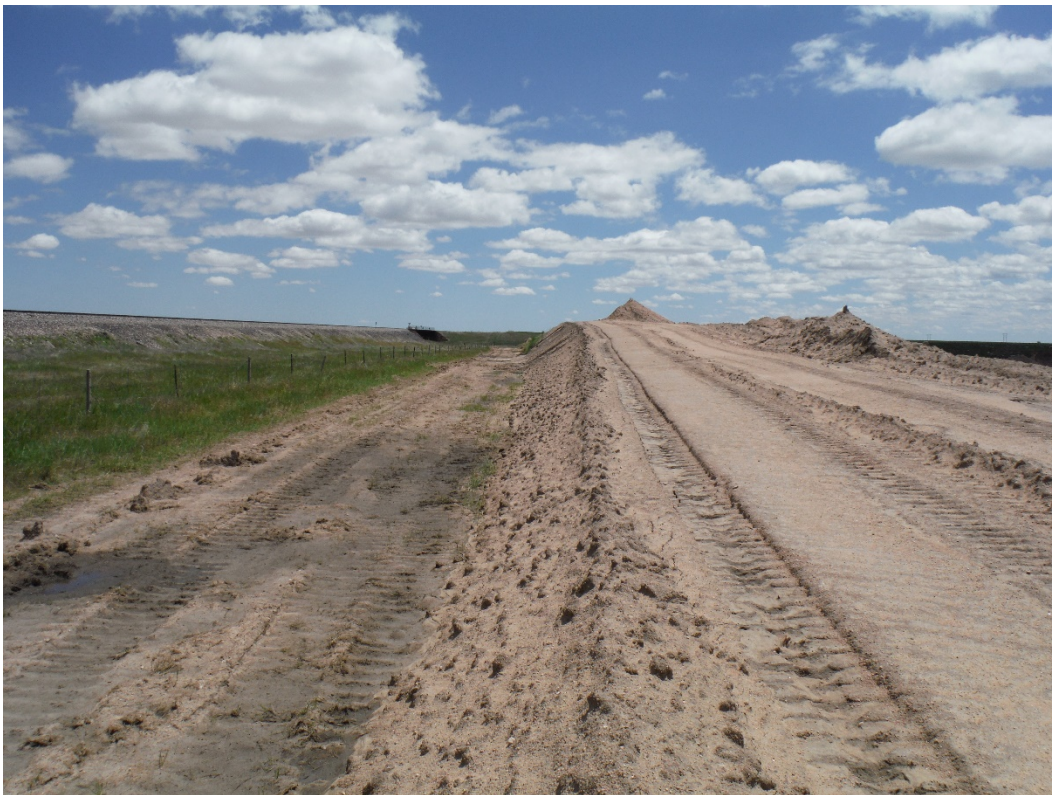
Topsoil stockpile located along northern portion of the pit area; looking east.

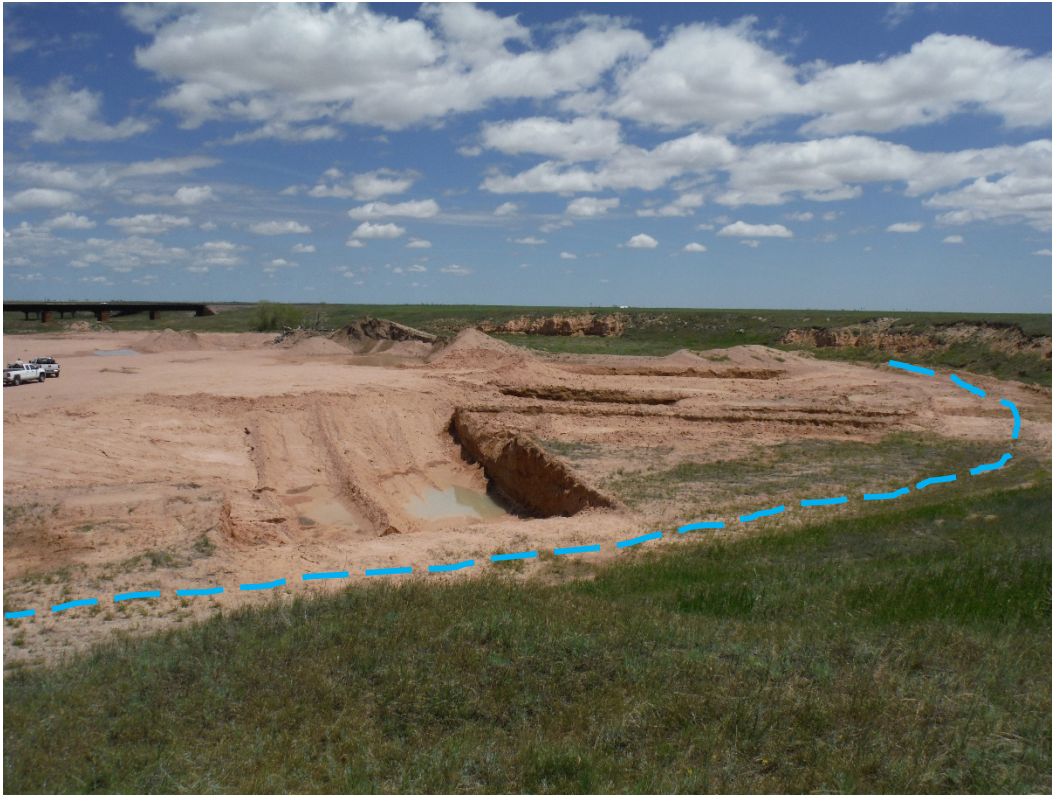
**COMPLIANCE PROBLEM #1:** The current mine plan needs to be updated and clarified pursuant to C.R.S. 34-32.5-112 (1)(c)(VI). The operator must provide sufficient information to describe or identify how the operator intends to conduct the operation.

creek channel and that there was no longer a northern creek bank along the inside of the meander. In one area, the creek channel has been mined approximately 10-15 feet deep and has near vertical walls it what appears to be a dozer slot-style of excavation. The Division believes that mining the northern creek bank and not leaving a 100-foot buffer, as well as excavating into the creek channel, is a substantial deviation of the approved mining plan and the Operator will need to address the current modifications to the mine plan through the Amendment process. This is cited as Compliance Problem #1 on page two of this report.

Excavation into the creek channel (original flow line delineated by the dashed line); looking northeast (downstream).

**CORRECTIVE ACTIONS:** The operator shall submit an Amendment application, with the required \$2,229 application fee, to update and clarify the current approved mine plan to reflect existing and proposed activities by the corrective action date.

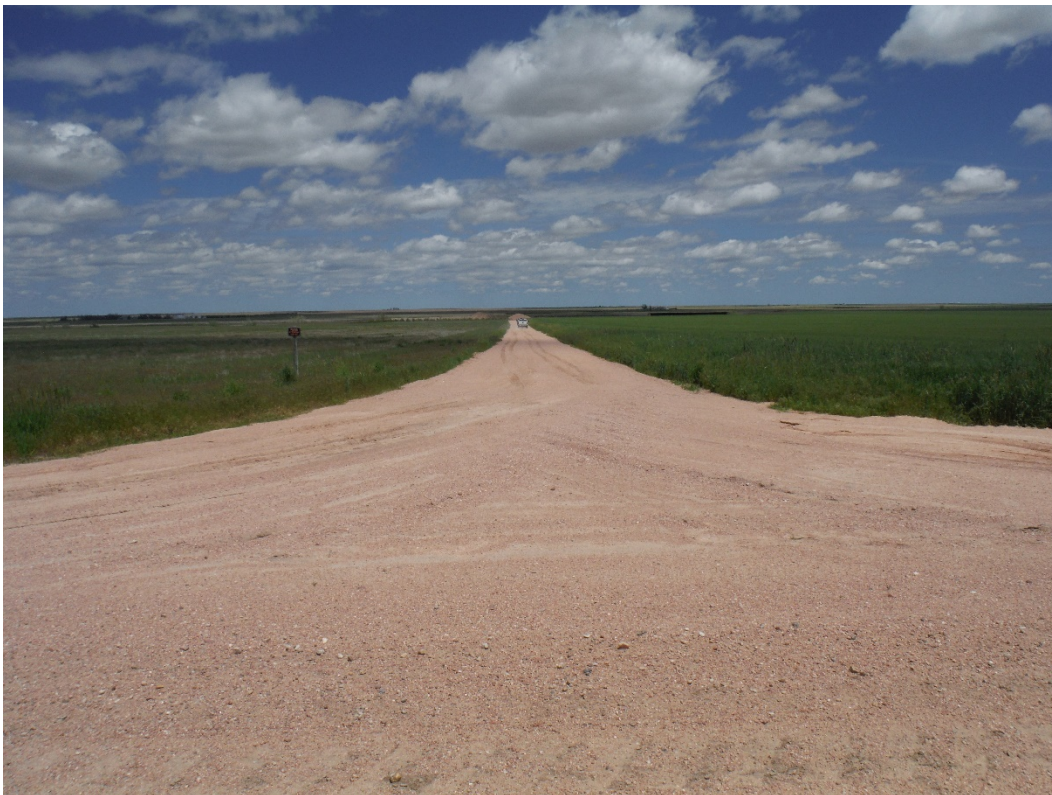
**POSSIBLE VIOLATION:** An access road, constructed for the purpose of the operation, is located outside of the approved permit boundary. This is a possible violation at this time pursuant to C.R.S. 34-32.5-116(4)(i) for failure to protect areas outside of the affected land from slides or damages occurring during the mining operation.

Additionally, the Division observed that an access road has been constructed from this pit area, directly south to County Road 40. Mr. Lockard stated that this road was created because the mine site would become inaccessible during wet conditions due to the original access road's location, which traveled down the creek channel. After researching the permit files, the Division has determined that this road is not approved in the current permit and has been constructed outside of the approved permit boundary. The Division used a recent Google Earth aerial image, which reflects the site's current configuration, to determine that this off-site disturbance created from the unapproved access road is approximately 1,500 feet in length and .84 acres in size. This is cited as a possible violation on page two of this report and a Reason to Believe a Violation Exists and Notice of Board Hearing letter will be sent with this report or under a separate cover.

Entrance of unapproved access road from County Road 40; looking east.

**CORRECTIVE ACTIONS:** This possible violation has been scheduled to be considered by the Mined Land Reclamation Board, during the August 24-25, 2016 Board meeting. Official notice of the schedule and other details for the MLRB hearing will be provided under a separate document to be sent via certified mail to the operator.

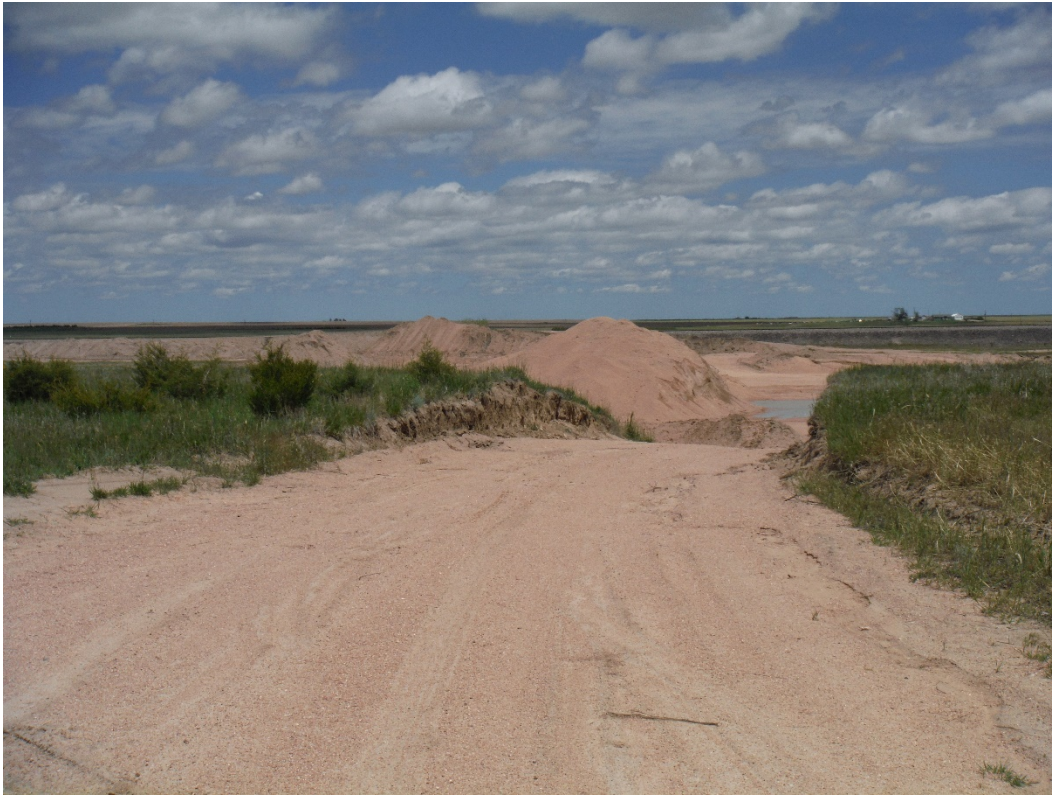
Unapproved access road cut through southern creek bank into pit area; looking north.

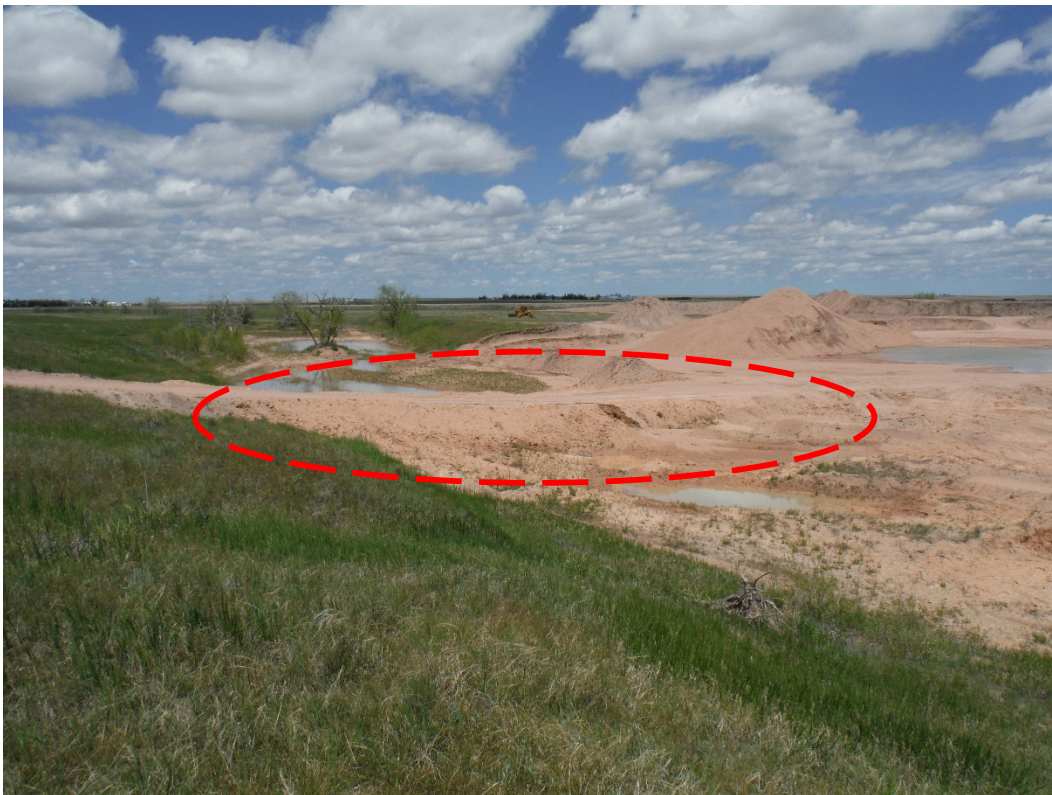
**COMPLIANCE PROBLEM #2:** The operation is currently blocking the channel of Surveyor Creek with an unapproved access road.

By constructing the unapproved road across Surveyor Creek to access the mining area, the Operator has prevented the natural flow of the creek. The material that is placed across the creek channel for the access road, appears to prevent the natural flow of the creek. The Division observed standing water in the creek channel on the upstream side of the road fill. This is cited as Compliance Problem #2 on page two of this report, requiring the Operator to remove this material from the creek channel and re-establish the natural flow of Surveyor Creek.

Material piled across the creek channel for the access road (circled in red); looking west (upstream).

**CORRECTIVE ACTIONS:** The Operator shall remove the material blocking the natural flow of Surveyor Creek on or before the corrective action deadline.

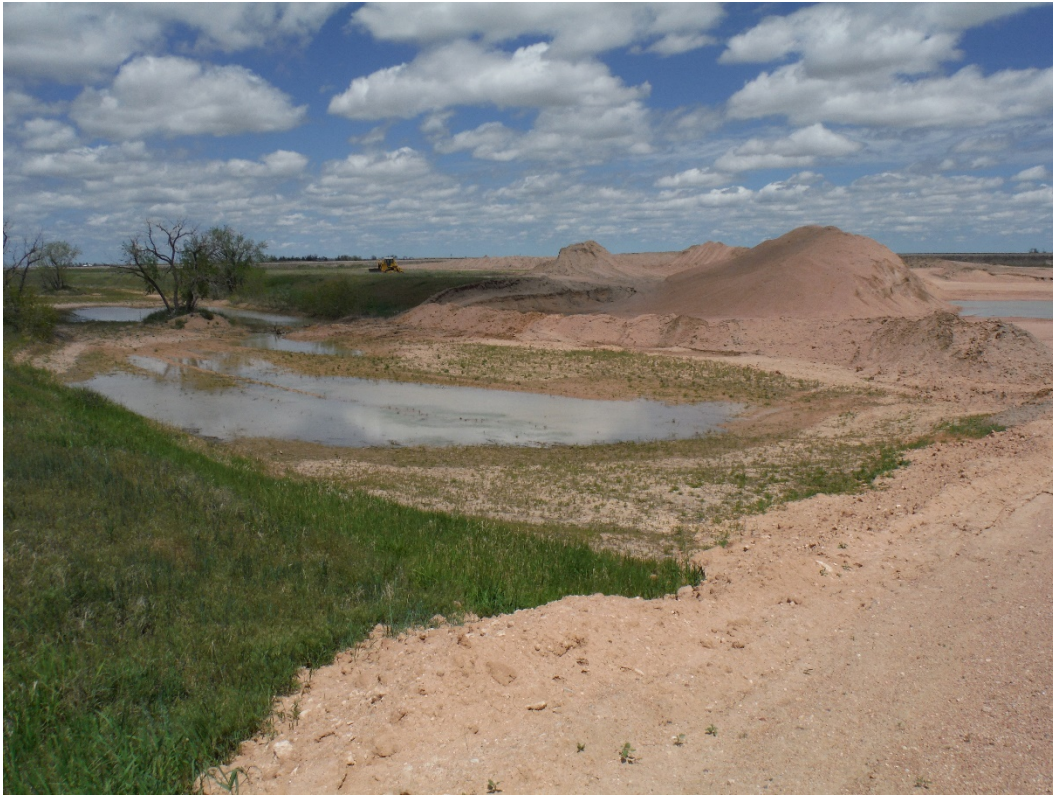
Ponded water in Surveyor Creek upstream of the access road embankment; looking northwest.
