MINERALS PROGRAM INSPECTION REPORT
PHONE: (303) 866-3567

MINE NAME: Fox No. 1 Clay Pit	MINE/PROSPECTING ID#: M-1977-219	MINERAL: Clay (general) and sandstone (silica, stone, quartzite)	COUNTY: Pueblo
INSPECTION TYPE: Monitoring	INSPECTOR(S): Tyler V. O'Donnell	INSP. DATE: March 16, 2016	INSP. TIME: 11:00
OPERATOR: Summit Brick & Tile Co.	OPERATOR REPRESENTATIVE: Mat Welte	TYPE OF OPERATION: 112c - Construction Regular Operation	
REASON FOR INSPECTION: Normal I&E Program	BOND CALCULATION TYPE: Complete Bond	BOND AMOUNT: \$83,000.00	
DATE OF COMPLAINT: NA	POST INSP. CONTACTS: None	JOINT INSP. AGENCY: None	
WEATHER: Clear	INSPECTOR'S SIGNATURE:

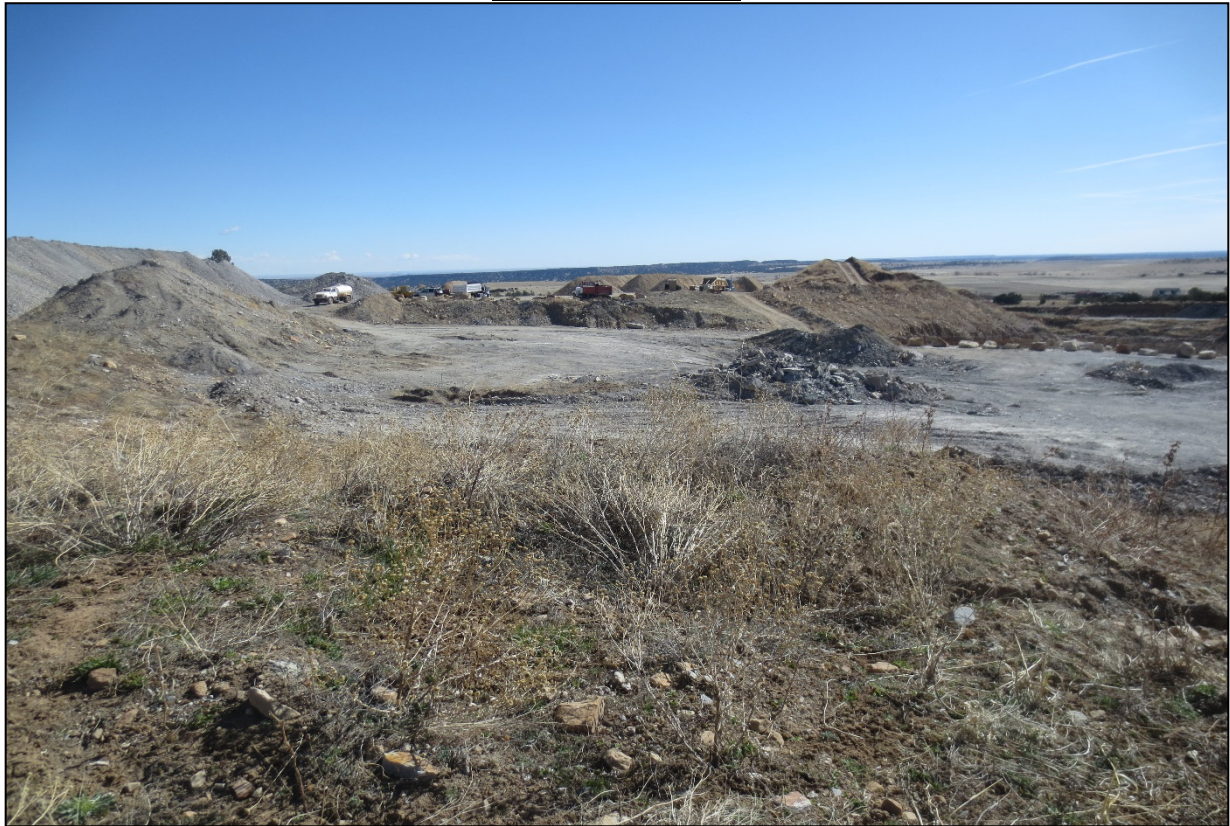
Photo 1: Active mining operations and recent product stockpiles area.

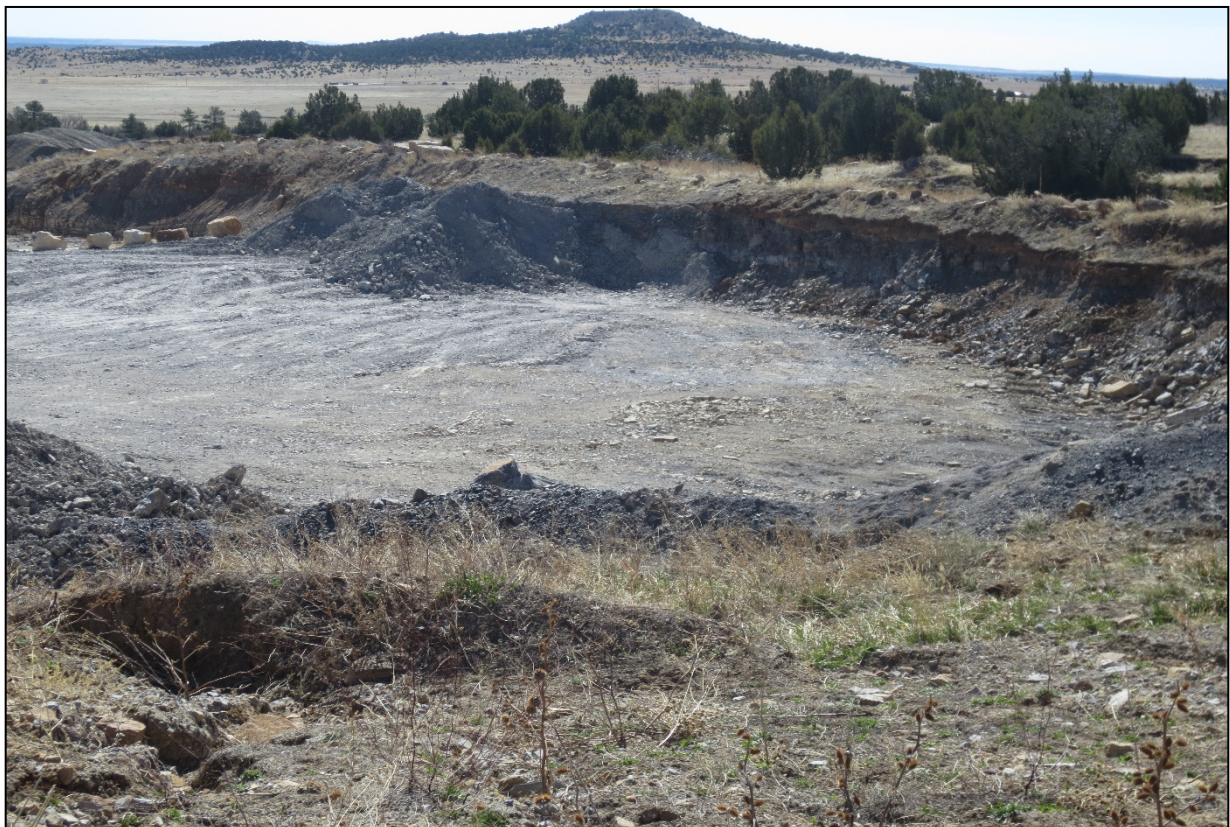
The mining operation was expanding deeper to the east. There were several stockpiles of clay, and sandstone scattered throughout the affected lands. There were several small active mining faces scattered around the site. Many of the active mining faces have created vertical highwalls. The highwalls ranged in height from about 10 to 30 feet high. The Division estimated that there was approximately 1,600 total linear feet of highwalls. When completing final reclamation, the Operator will need to grade all slopes to 3H:1V or flatter to comply with the approved reclamation plan.

Photo 1: Recent mining operations, sandstone has been mined off exposing the clay.

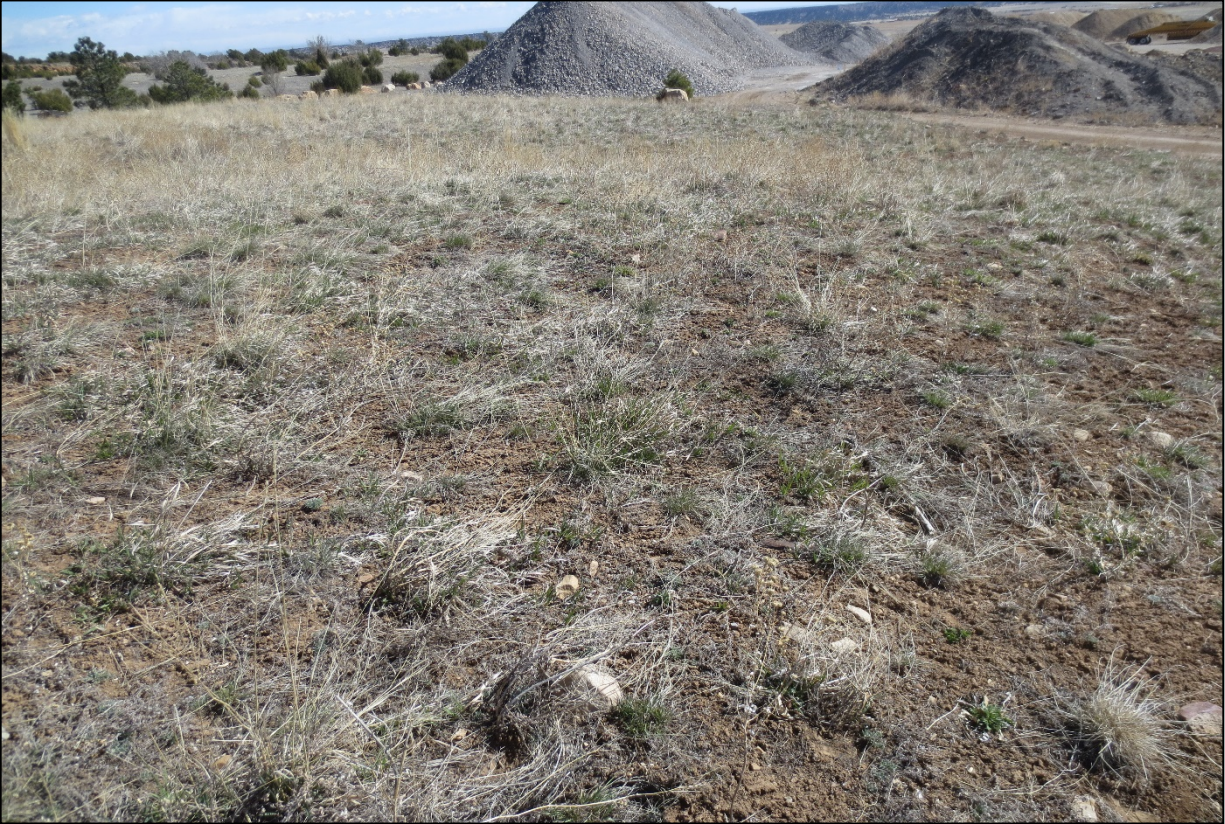
There was an approximate 3 acre area along the western side of the affected land, where the Operator has begun to complete reclamation. The area has been backfilled, graded, has had topsoil spread over it and has been revegetated. The 3 acre area has begun to establish well with desired vegetative cover. The area has begun to fill in with desired vegetative cover. The 3 acres appeared to be stable, no excessive erosion was observed.

Photo 3: Portion of the 3 acres undergoing final reclamation.

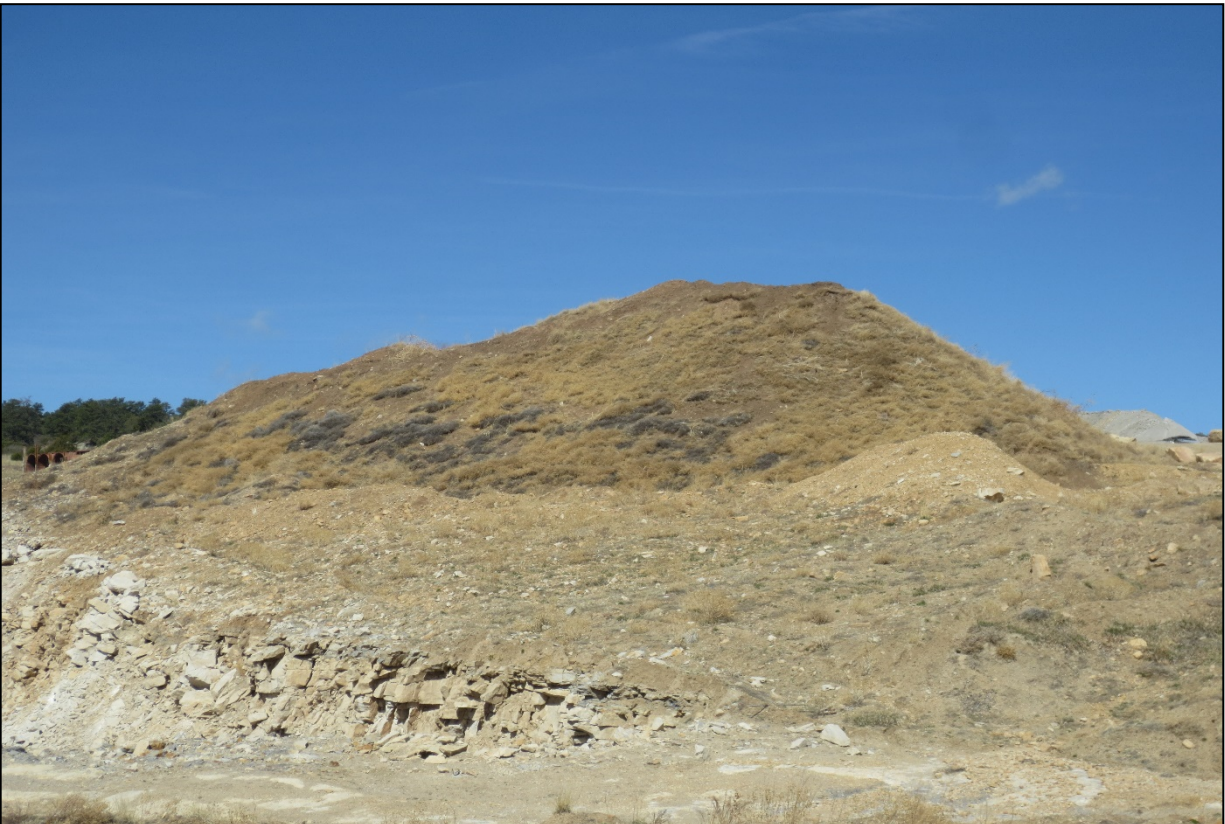
There was adequate topsoil stockpiled on site to conduct the approved reclamation plan. There were several partially vegetated topsoil stockpiles and topsoil berms within the affected lands. The topsoil stockpiles and berms had adequate vegetative cover to protect topsoil from erosion.

Photo 4: topsoil stockpile.
