MINERALS PROGRAM INSPECTION REPORT
PHONE: (303) 866-3567

MINE NAME: Cesar Pit	MINE/PROSPECTING ID#: M-1998-101	MINERAL: Sand and gravel and	COUNTY: Pueblo
INSPECTION TYPE: Preoperation Inspection	INSPECTOR(S): Tyler V. O'Donnell	INSP. DATE: March 16, 2016	INSP. TIME: 13:00
OPERATOR: Tony J. Beltramo and Sons, Inc.	OPERATOR REPRESENTATIVE: Tim Beltramo	TYPE OF OPERATION: 112c - Construction Regular Operation	
REASON FOR INSPECTION: Preoperation Inspection	BOND CALCULATION TYPE: Complete Bond	BOND AMOUNT: \$219,000.00	
DATE OF COMPLAINT: NA	POST INSP. CONTACTS: None	JOINT INSP. AGENCY: None	
WEATHER: Clear	INSPECTOR'S SIGNATURE: <i>Tyler O'Donnell</i>	SIGNATURE DATE: July 26, 2016

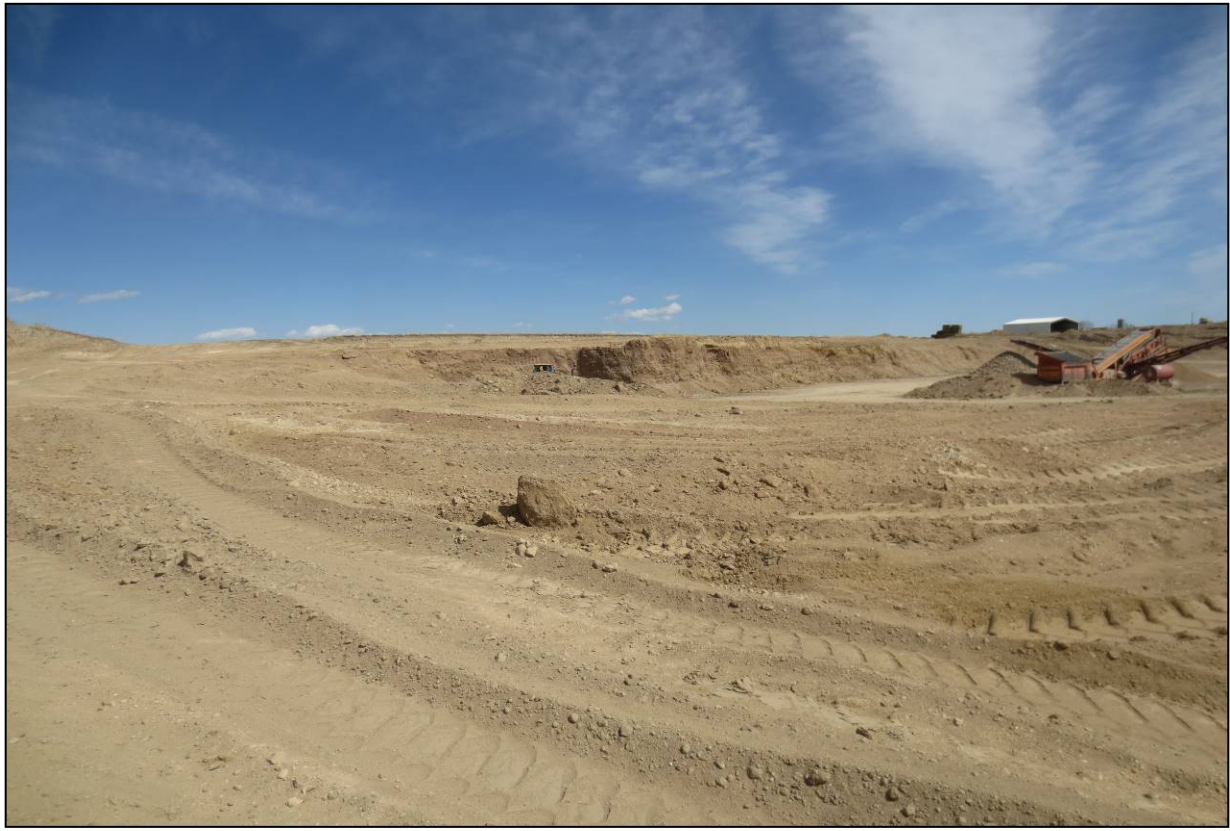
Photo 1: Active Mining area along the, south of the Cesar's access road.

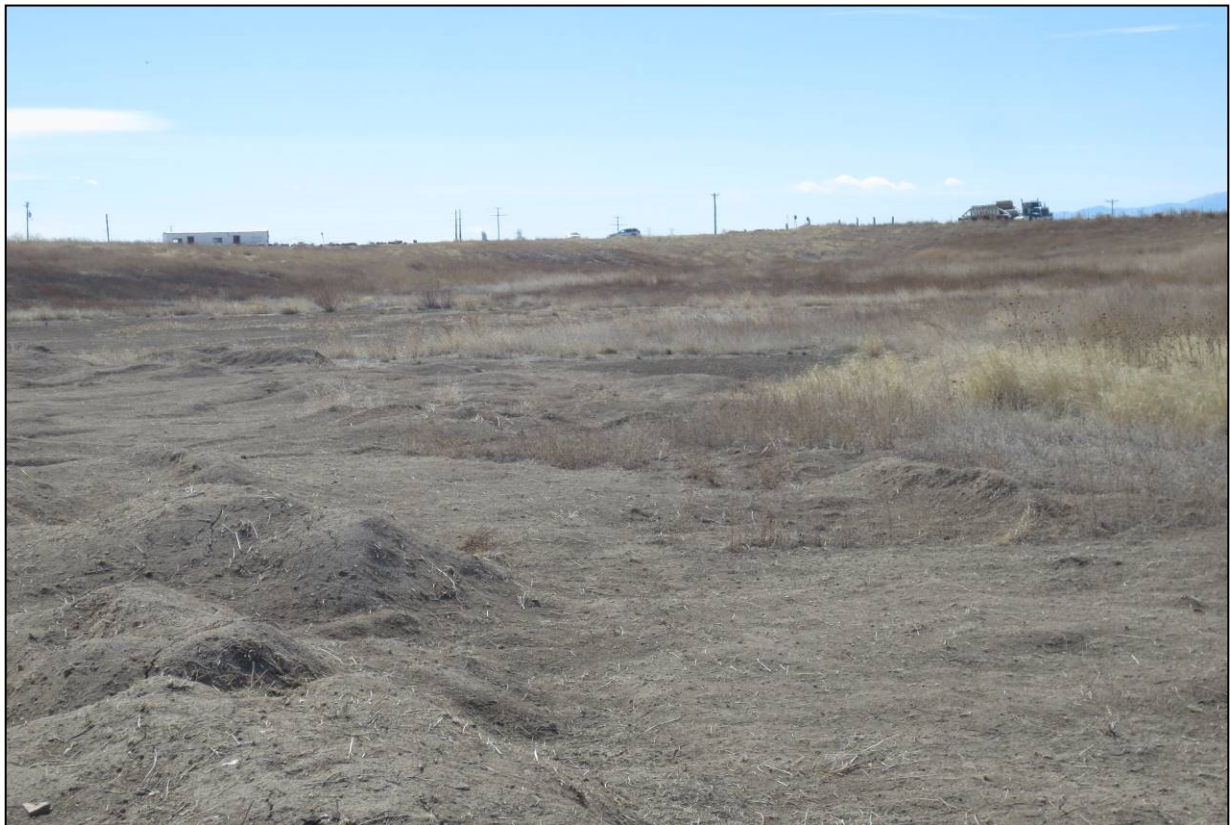
Photo 2: Area to be reclaimed in the southern portion of the site near the Scale house. A few Tamarisk Trees remain in the bottom of the pit.

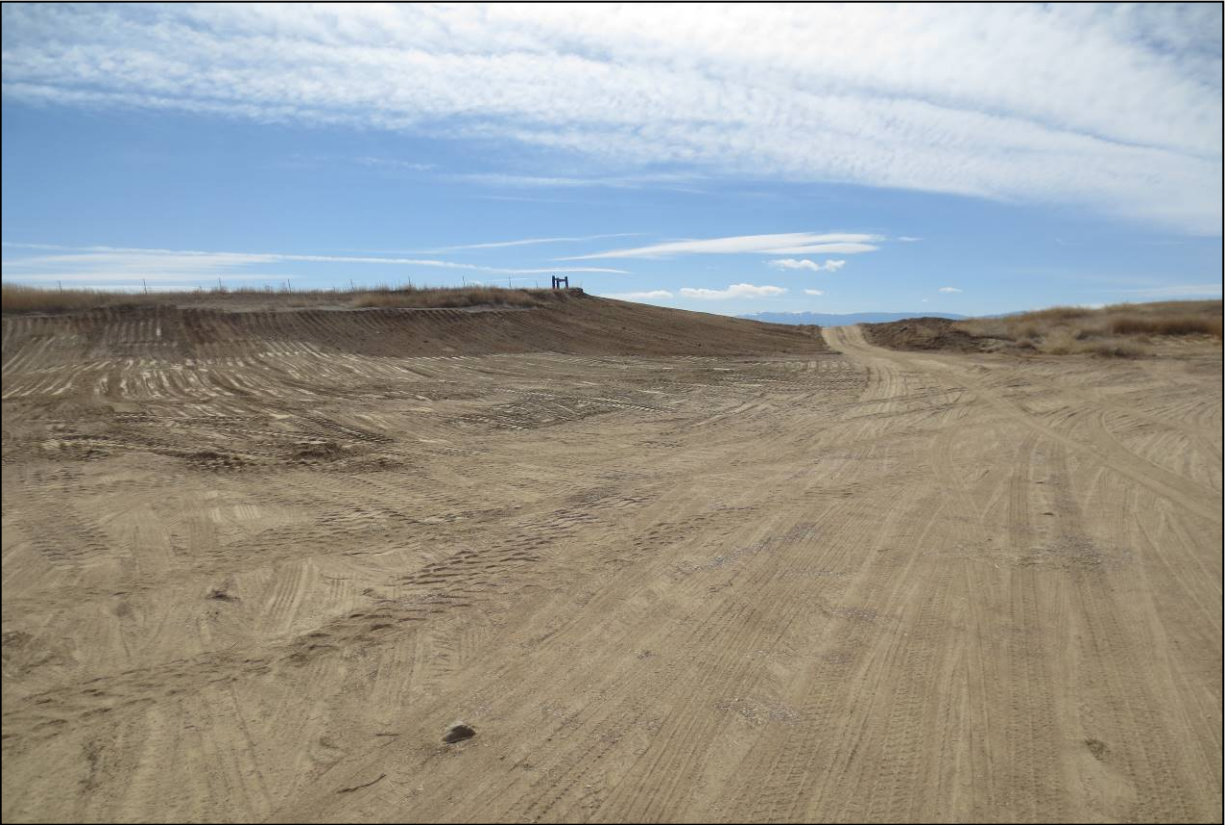
Photo 3: Recently regraded highwall in the northern portion of the pit.

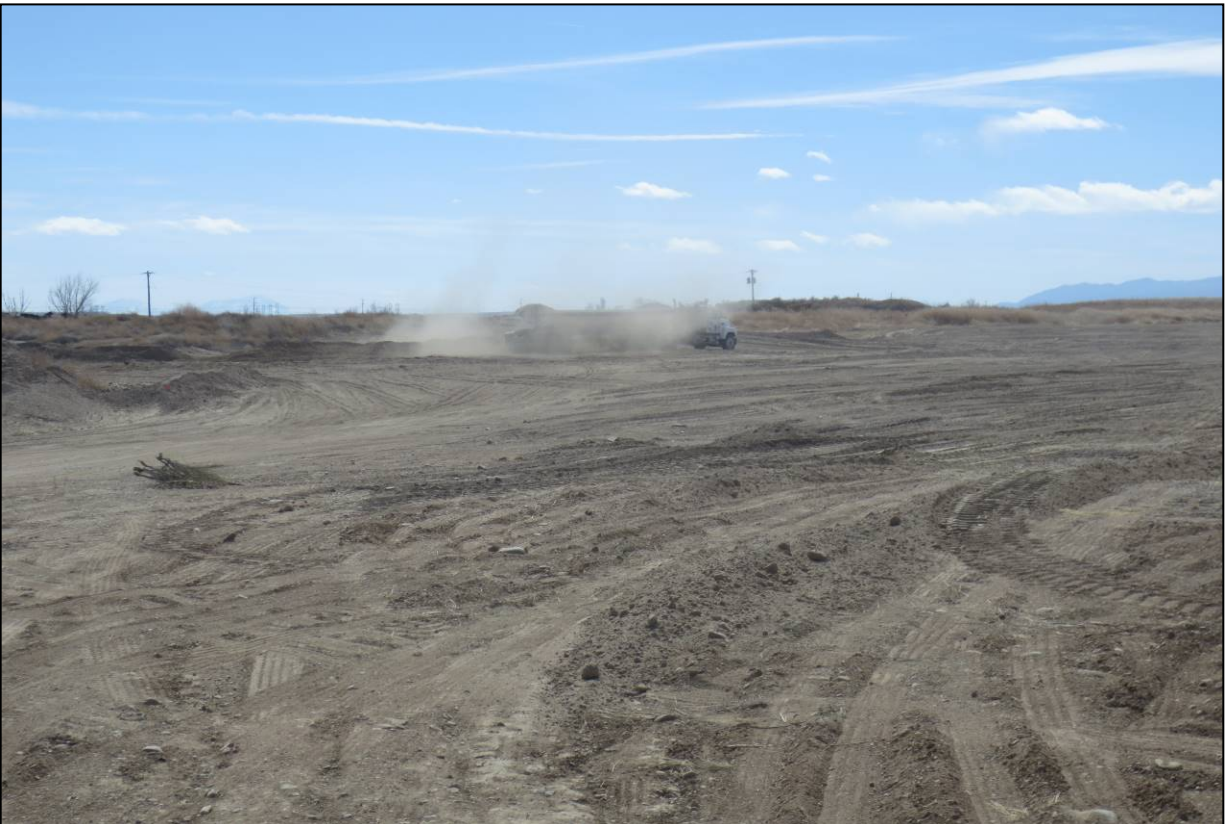
Photo 4: Topsoil being imported and spread in the northern portion of the site.
