MINERALS PROGRAM INSPECTION REPORT
PHONE: (303) 866-3567

MINE NAME: Pueblo County Aggregate Project	MINE/PROSPECTING ID#: M-2016-009	MINERAL: Gravel	COUNTY: Pueblo
INSPECTION TYPE: Preoperation Inspection	INSPECTOR(S): Tyler V. O'Donnell	INSP. DATE: May 5, 2016	INSP. TIME: 10:00
OPERATOR: Fremont Paving & Redi-Mix, Inc.	OPERATOR REPRESENTATIVE: John Ary	TYPE OF OPERATION: 112c - Construction Regular Operation	
REASON FOR INSPECTION: Preoperation Inspection	BOND CALCULATION TYPE: Complete Bond	BOND AMOUNT: No Bond Held	
DATE OF COMPLAINT: NA	POST INSP. CONTACTS: None	JOINT INSP. AGENCY: None	
WEATHER: Clear	INSPECTOR'S SIGNATURE:

OBSERVATIONS

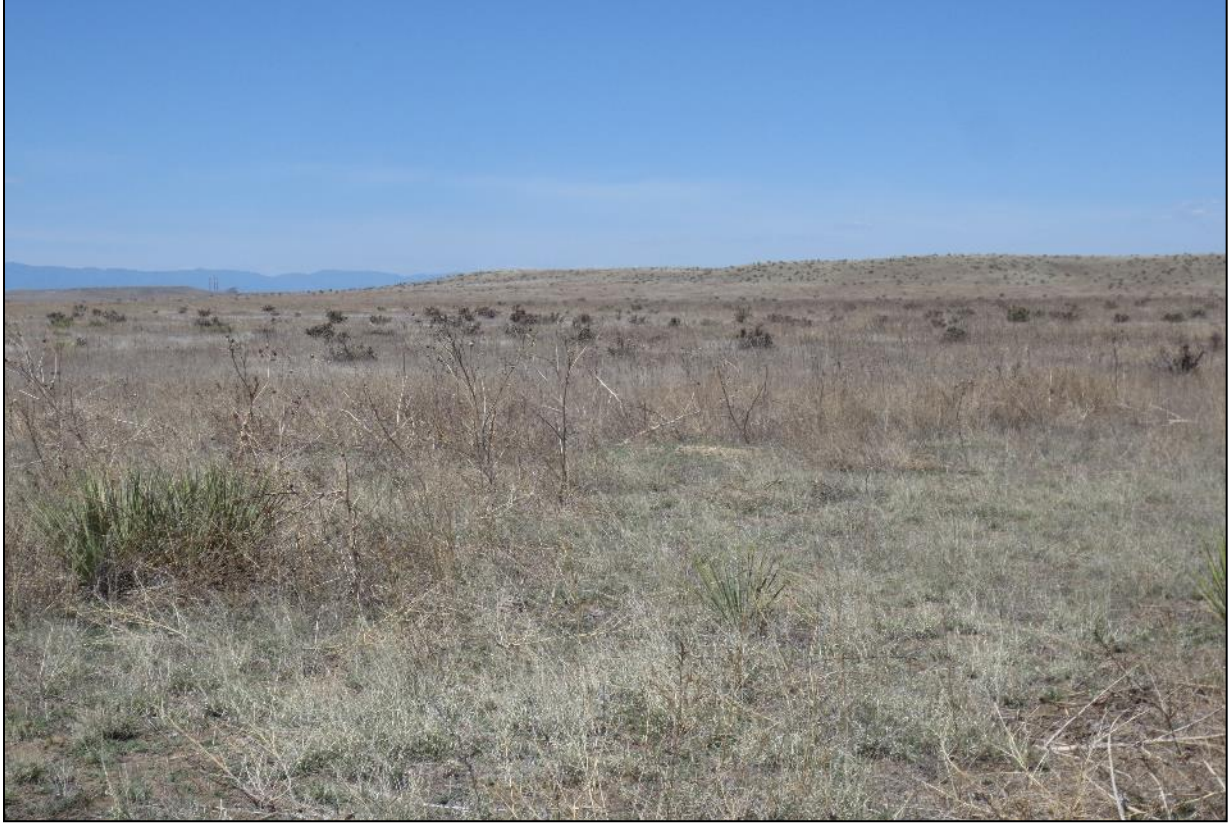
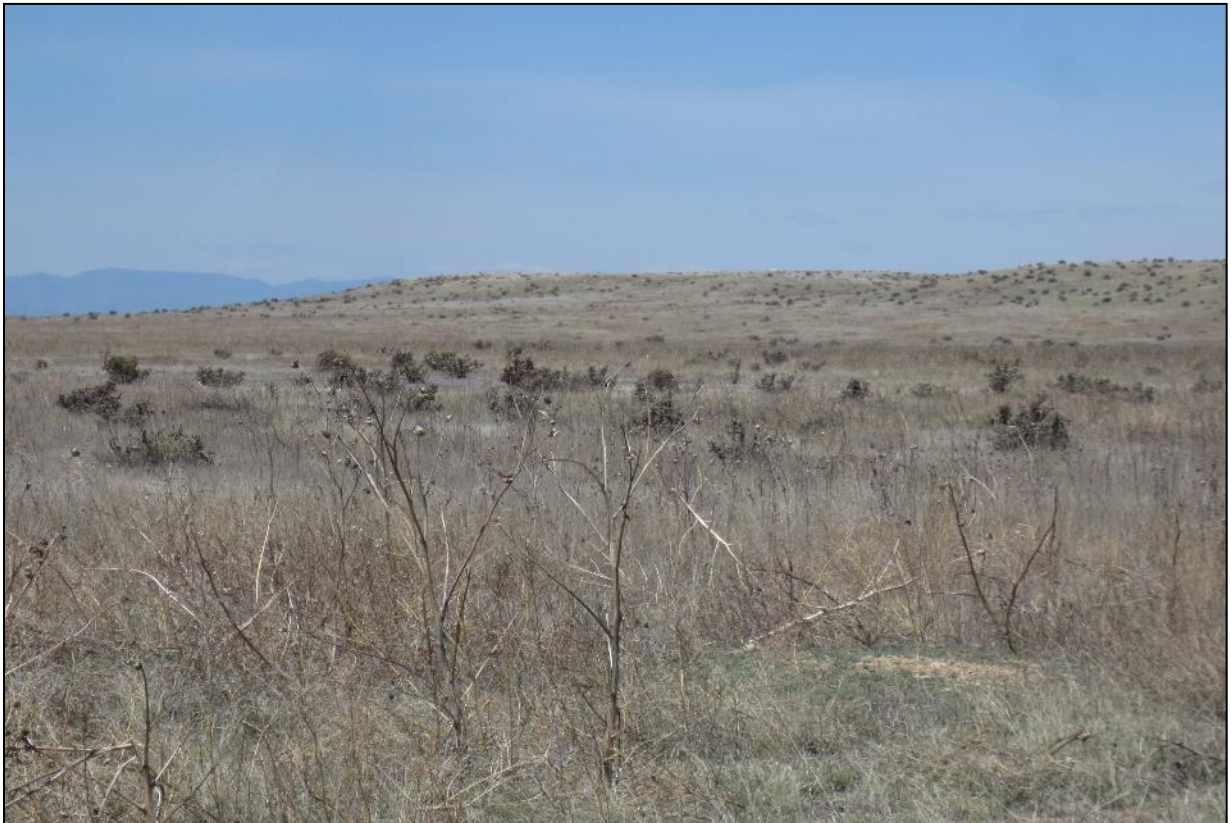
Photo 1: Badger Hills, mining operations will take place on top of the hills.

Photo 2: Badger Hills, mining operations will take place on top of the hills.

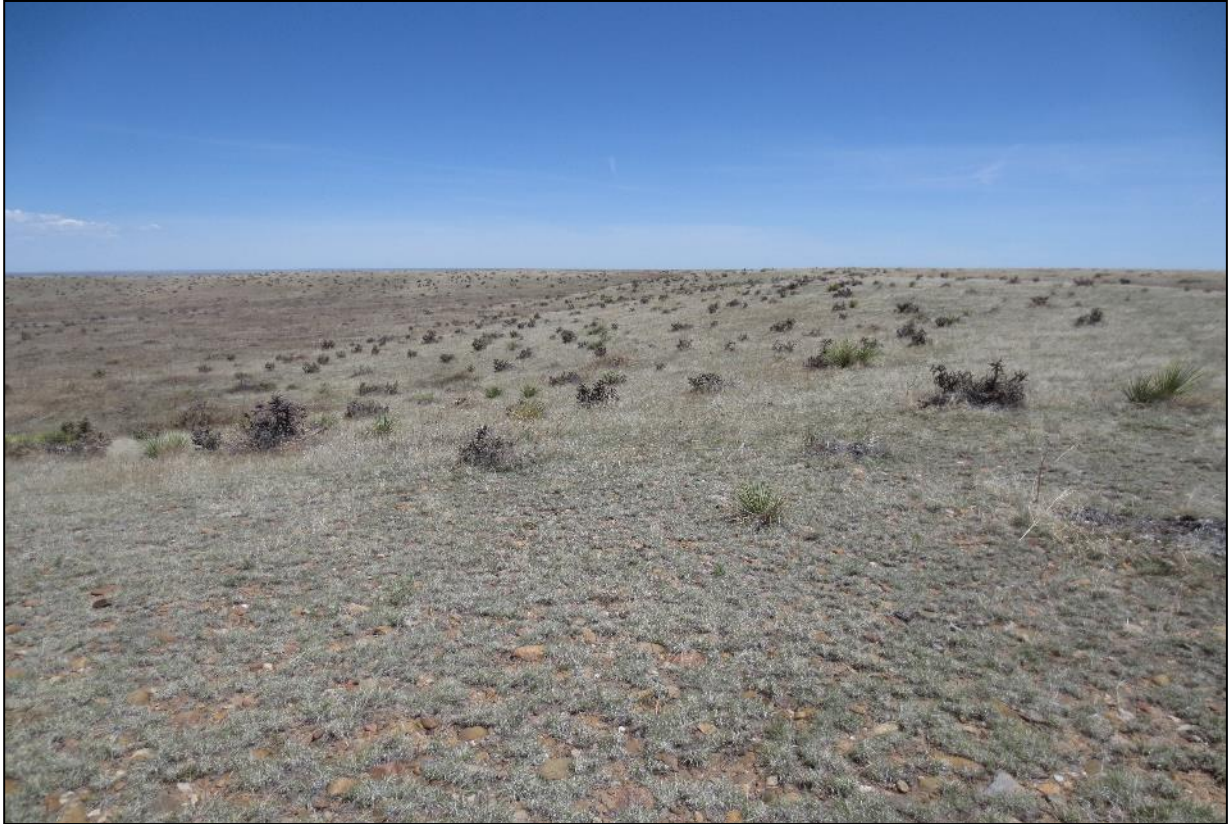
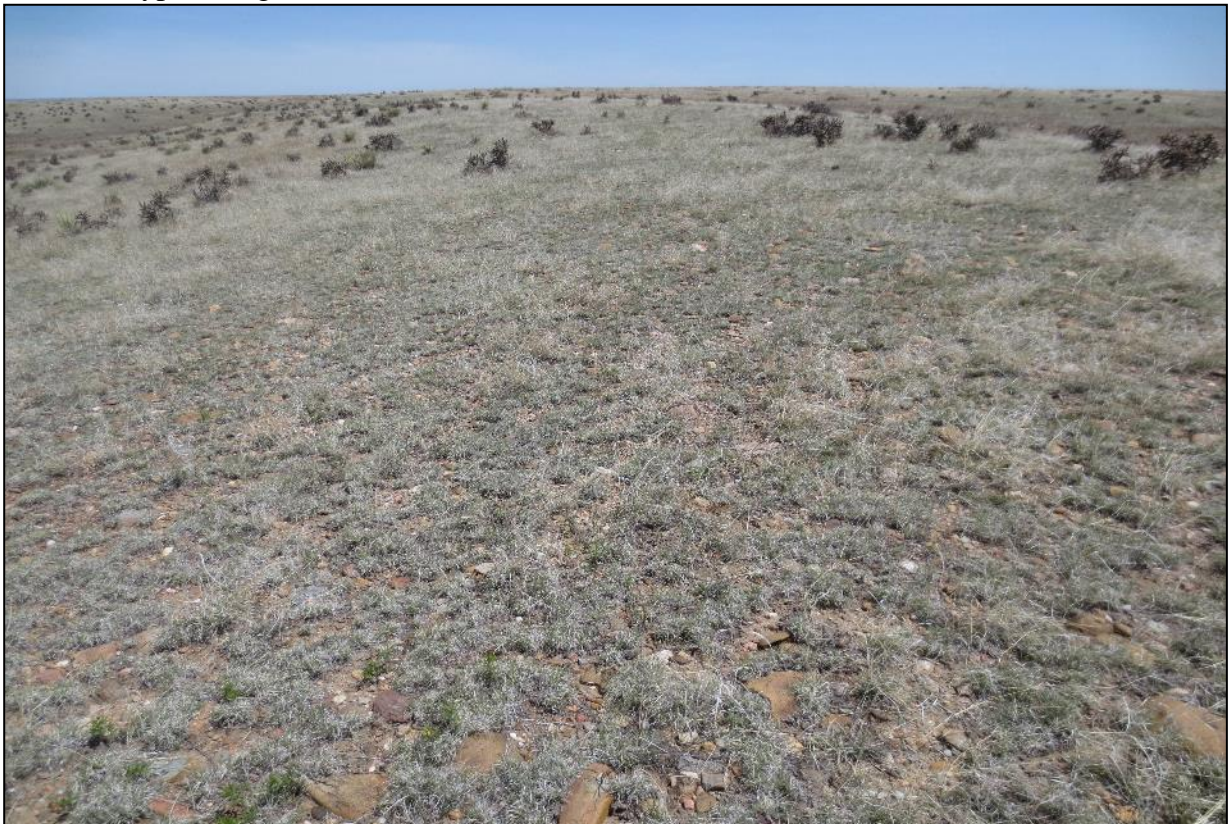
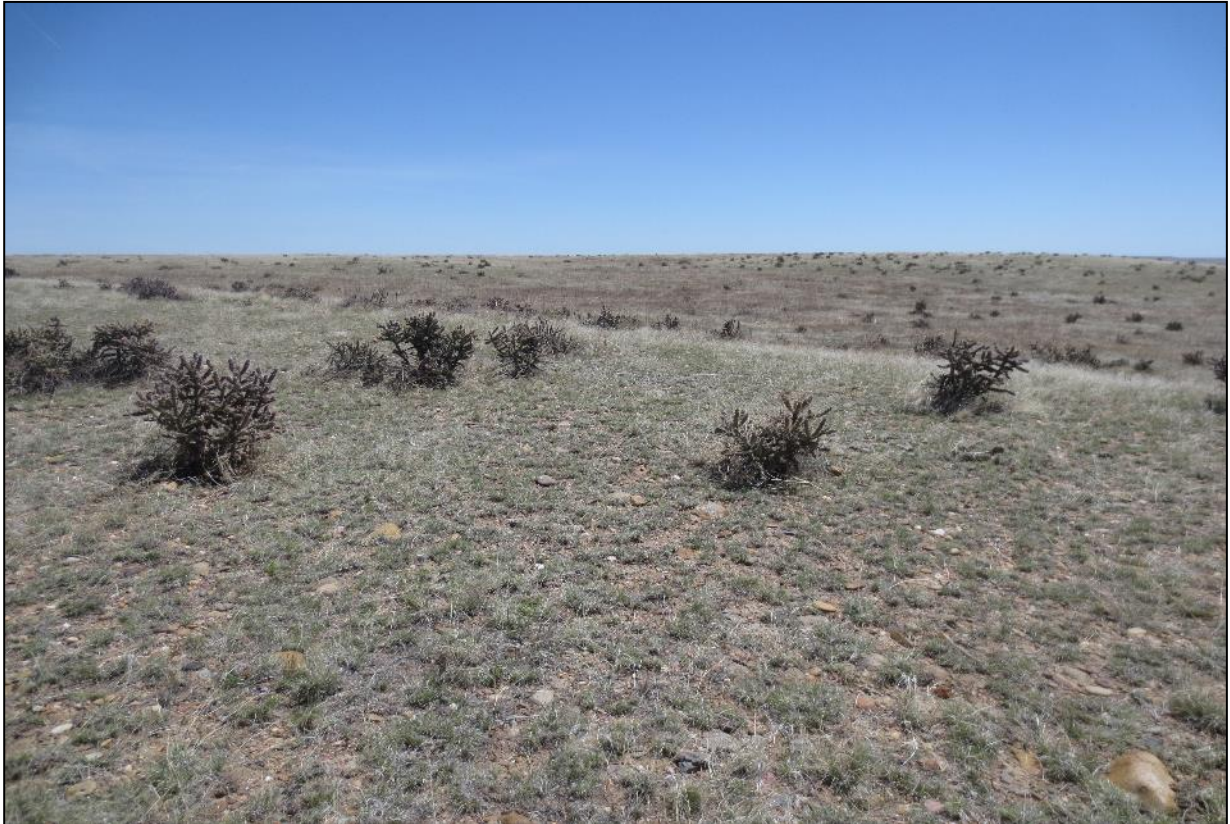
Photo 3: Top of the Barger Hills, mining will start at the crest of the terrace and progress inwards. Typical vegetative cover.

Photo 4: Top of the Barger Hills, mining will start at the crest of the terrace and progress inwards. Typical vegetative cover.

Photo 5: Top of the Barger Hills, mining will start at the crest of the terrace and progress inwards. Typical vegetative cover.

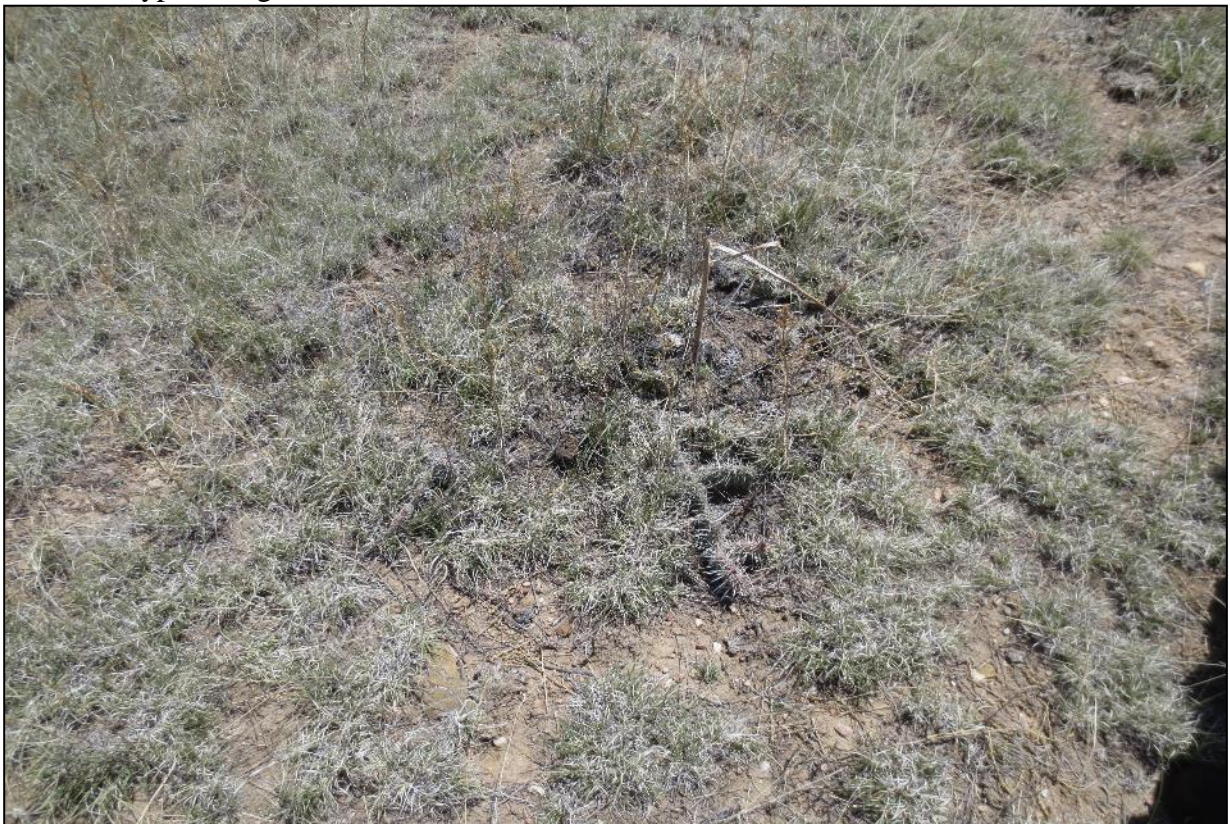
Photo 6: Typical vegetative cover on top of the Barger Hills..

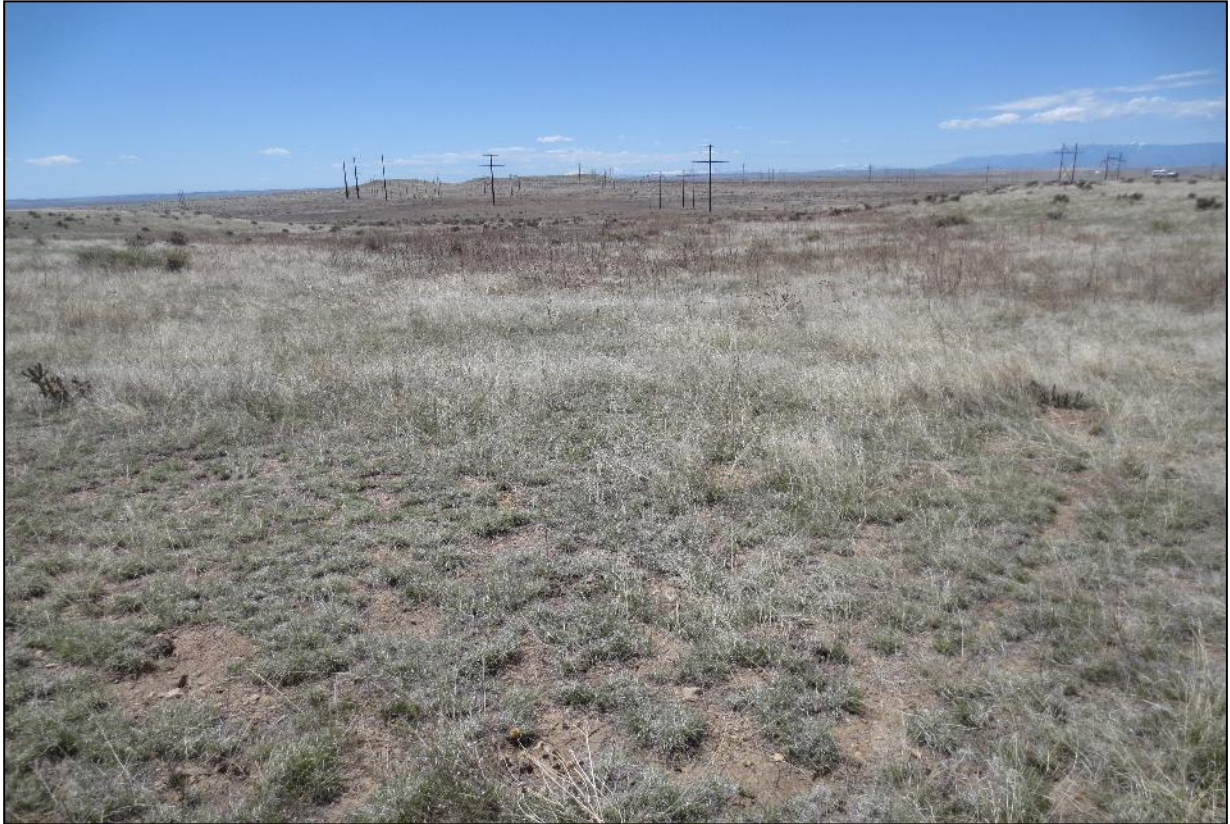
Photo 7: Typical vegetative cover on top of the Barger Hills.

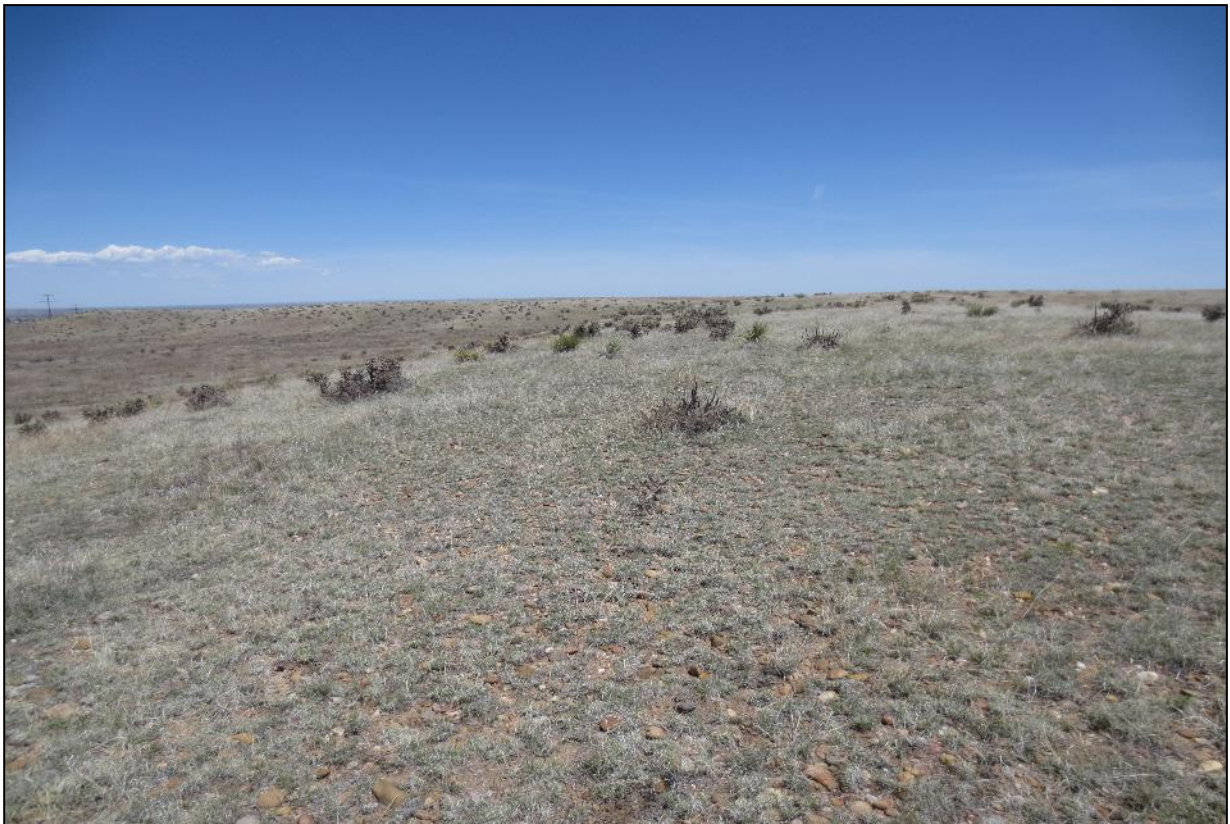
Photo 8: Typical vegetative cover on top of the Barger Hills.
