MINERALS PROGRAM INSPECTION REPORT
PHONE: (303) 866-3567

MINE NAME: O'Bannon Pit	MINE/PROSPECTING ID#: M-1980-201	MINERAL: Sand and gravel	COUNTY: Rio Grande
INSPECTION TYPE: Monitoring	INSPECTOR(S): Travis H. Marshall	INSP. DATE: July 14, 2016	INSP. TIME: 15:00
OPERATOR: Mathias Concrete, Inc.	OPERATOR REPRESENTATIVE: Marshall Mathias	TYPE OF OPERATION: 112c - Construction Regular Operation	
REASON FOR INSPECTION: Normal I&E Program	BOND CALCULATION TYPE: Complete Bond	BOND AMOUNT: \$19,400.00	
DATE OF COMPLAINT: NA	POST INSP. CONTACTS: None	JOINT INSP. AGENCY: None	
WEATHER: Clear	INSPECTOR'S SIGNATURE:

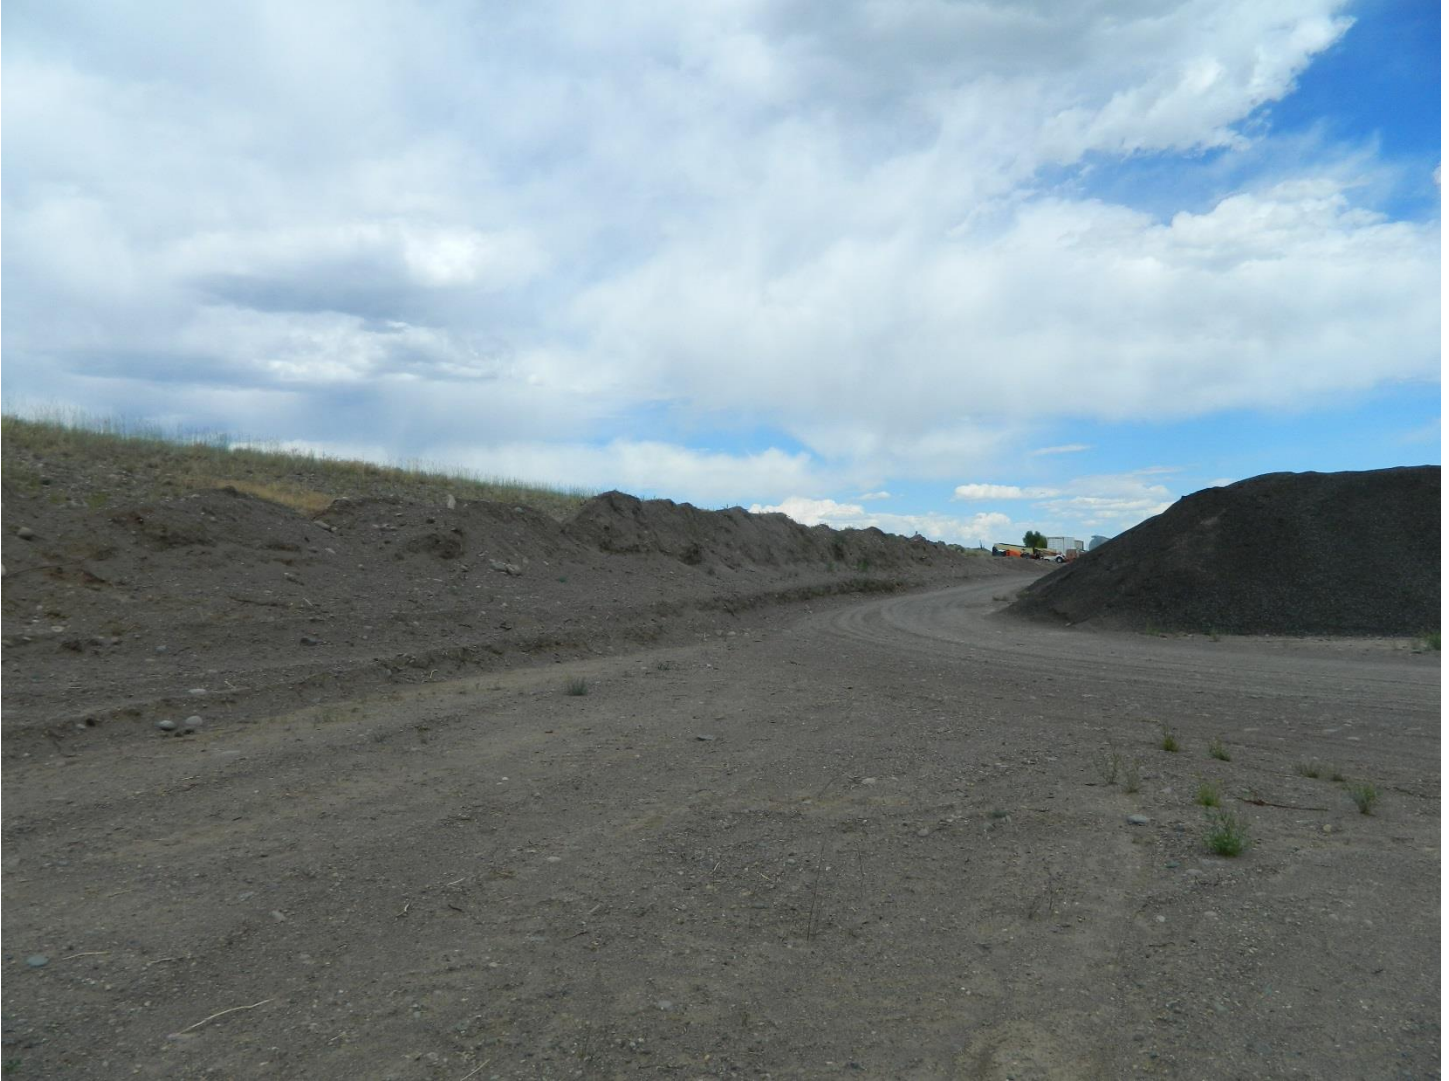
The site was active during the inspection. Four Corners Materials was actively operating a hot plant during the inspection. Various stockpiles of construction material and rip rap were observed around the permit area. A portion of the reclaimed slope located along the northern permit boundary was disturbed to allow for equipment and trucks to access the hot plant. This is not seen as a problem but may increase the surety amount that is required to perform the approved reclamation.

The portion of the re-graded slopes along the northern pit boundary that have been disturbed.

In an effort to ensure that the reclamation bond is adequate to perform the required reclamation Division will conduct a reclamation bond review. The reclamation bond estimate will be sent to the operator under separate cover.
