COLORADO DIVISION OF RECLAMATION, MINING AND SAFETY MINERALS PROGRAM INSPECTION REPORT

MINE NAME:	MINE/PROSPECTING ID#:	MINERAL:	COUNTY:
Hay Camp Pit	M-1990-025	Gravel	Montezuma
INSPECTION TYPE:	INSPECTOR(S):	INSP. DATE:	INSP. TIME:
Surety-Related Inspection	Lucas J. West	July 21, 2016	12:00
OPERATOR:	OPERATOR REPRESENTATIVE:	TYPE OF OPERATION:	
Montezuma County	Randy Smith	112c - Construction Regular Operation

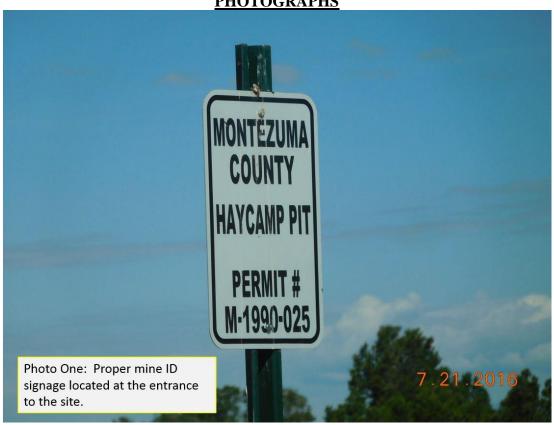
Proper mine identification signage was observed at the entrance to the site shown in Photo One. The site was active during the inspection. This was not a complete inspection, therefore the active portions of the site were not inspected. The area that was inspected included the 21.62 acres of land that will be part of the acreage reduction request.
