MINERALS PROGRAM INSPECTION REPORT

MINE NAME: Munsch Pit	MINE/PROSPECTING ID#: M-2000-018	MINERAL: Sand and gravel	COUNTY: Cheyenne
INSPECTION TYPE: Monitoring	INSPECTOR(S): Elliott R. Russell	INSP. DATE: June 29, 2016	INSP. TIME: 08:00
OPERATOR: Cheyenne County	OPERATOR REPRESENTATIVE: Jim Brown	TYPE OF OPERATION: 110c - Construction Limited Impact

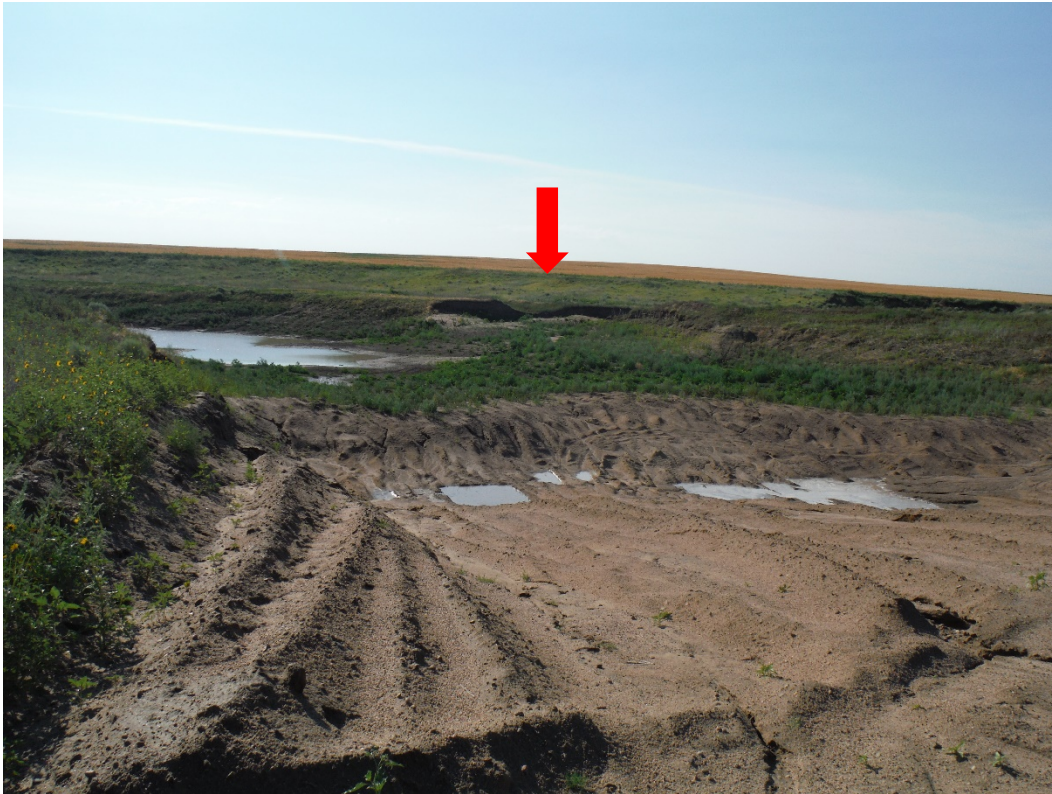
During the inspection, the Division observed a significant erosion feature located near the southeast corner of the pit

where the creek channel has breached the southeast slope of the site. The breach is located just downstream of the topsoil stockpile along the southern permit boundary. A head cut has formed in the creek channel and was approximately 10-15 feet deep and over 100 feet long. It appears Ladder Creek is completely re-directed into the pit. Mr. Brown indicated there was a severe storm event in the area in the spring of 2015 which lead to flooding and caused Ladder Creek to have significant flows. Water was currently ponded in the pit and the Division observed flood debris throughout the pit, indicating the entire pit was inundated at one time, likely during the severe storm event. Upon further investigation at the site, the Division has determined the erosion event was caused because the mining excavation came too close to the creek bank. Additionally, the topsoil stockpile, piled along the southern permit boundary, had not been extended the entire length of the meander, which may have prevented water from overtopping the creek bank and flowing into the pit. The mining operation is impounding all water from Ladder Creek and thus, the site has failed to minimize disturbance to the prevailing hydrologic balance of the affected land and surrounding area. This is cited as Possible Violation #1 on page 2 of this report.

Overview of Pit #1 (location of the creek breach identified by red arrow); looking southeast.

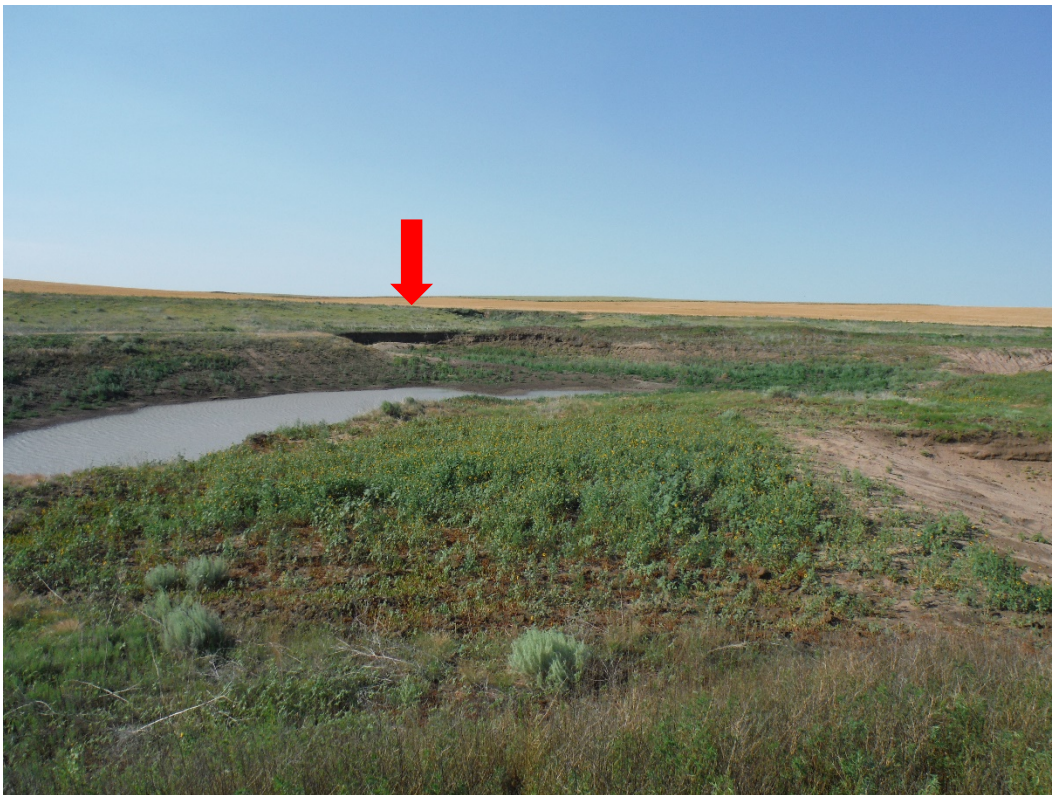
POSSIBLE VIOLATION #1: Ladder Creek has breached into the pit and the site is improperly impounding surface drainage/runoff. This is a possible violation at this time pursuant to C.R.S. 34-32.5-116(4)(h) for failure to minimize disturbance to the prevailing hydrologic balance.

Additional overview of Pit #1 (location of the creek breach identified by red arrow), note the standing water; looking southeast.

CORRECTIVE ACTIONS: This possible violation has been scheduled to be considered by the Mined Land Reclamation Board, during the September 28-29, 2016 Board meeting. Official notice of the schedule and other details for the MLRB hearing will be provided under a separate document to be sent via certified mail to the operator.

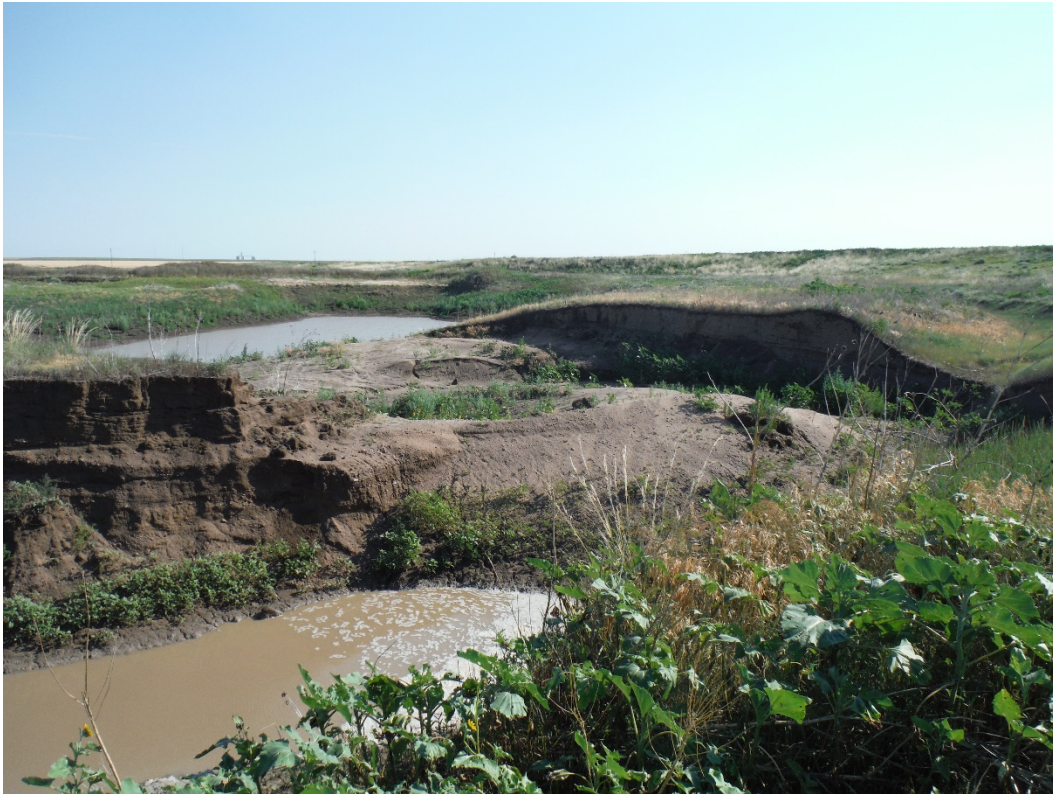
Significant erosion feature caused by creek breach; looking north into the permit from the southern creek bank.

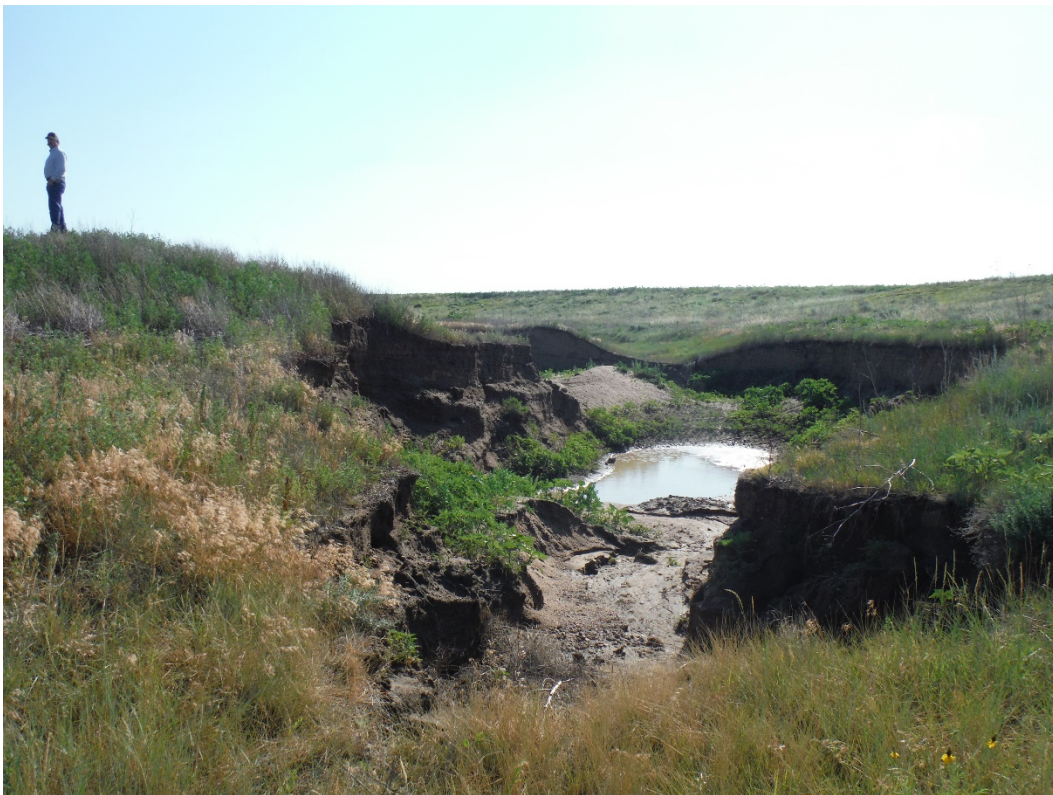
Significant erosion feature caused by creek breach; looking east from within Ladder Creek.

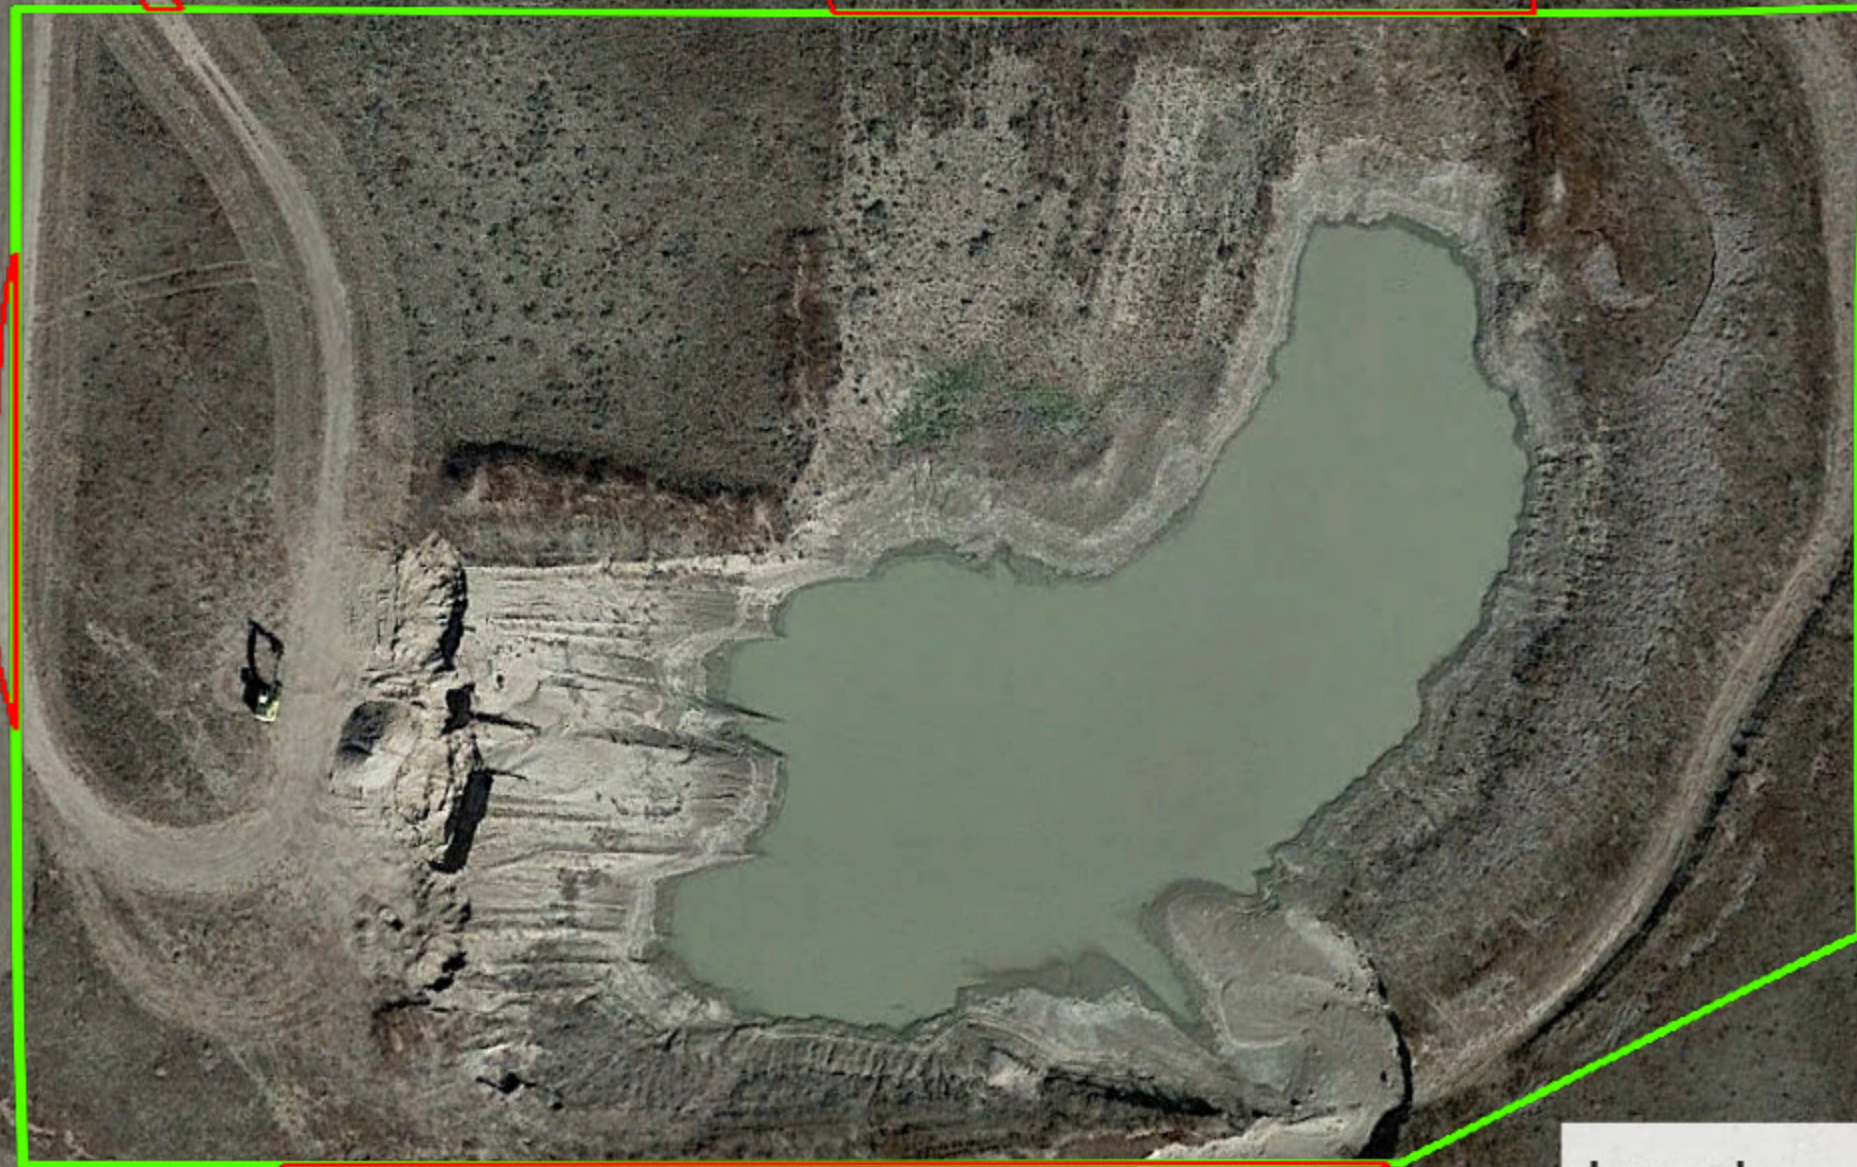
Inspection Report Map

POSSIBLE VIOLATION #2: Land has been affected outside of the approved permit boundary. This is a possible violation at this time pursuant to C.R.S. 34-32.5-116(4)(i) for failure to protect areas outside of the affected land from slides or damages occurring during the mining operation.

After the inspection, the Division reviewed the permit file and determined the mining activities, as well as the erosional head cut feature, have affected lands outside of the approved permit boundary. Using the approved 5/12/2005 AM-01 Mine Plan Map, the Division has prepared a Google Earth map which shows the approximate location of the permit boundary; both maps are attached for reference. The permit boundary was determined using dimensions/distances, provided on the 5/12/2005 AM-01 Mine Plan Map, from County Road M and County Road 43. The Division has determined the boundary marker delineating the eastern point along the southern boundary is incorrectly placed in the field; this has been added Compliance Problem #1 on page 2 of this report. Using the aerial image, the Division has determined the erosional feature discussed above has actually affected lands outside of the approved permit boundary. Additionally, portions of the access road and the topsoil stockpiles along the northern and southern boundaries have also affected lands outside of the approved permit boundary. The total size of disturbance located outside of the approved permit boundary is approximately .8 acres. This is cited as Possible Violation #2 on page 2 of this report.

CORRECTIVE ACTIONS: This possible violation has been scheduled to be considered by the Mined Land Reclamation Board, during the September 28-29, 2016 Board meeting. Official notice of the schedule and other details for the MLRB hearing will be provided under a separate document to be sent via certified mail to the operator.
