**COLORADO**Division of Reclamation,
Mining and Safety

MINERALS PROGRAM INSPECTION REPORT**PHONE: (303) 866-3567**

MINE NAME: Williams Pit No. 1	MINE/PROSPECTING ID#: M-2010-054	MINERAL: Borrow material for	COUNTY: Huerfano
INSPECTION TYPE: Monitoring	INSPECTOR(S): Tyler V. O'Donnell	INSP. DATE: May 12, 2016	INSP. TIME: 09:30
OPERATOR: Timothy D. Williams & Betty J. Williams	OPERATOR REPRESENTATIVE: Timothy and Betty Williams	TYPE OF OPERATION: 110c - Construction Limited Impact	
REASON FOR INSPECTION: Normal I&E Program	BOND CALCULATION TYPE: Complete Bond	BOND AMOUNT: \$27,100.00	
DATE OF COMPLAINT: NA	POST INSP. CONTACTS: None	JOINT INSP. AGENCY: None	
WEATHER: Clear	INSPECTOR'S SIGNATURE:

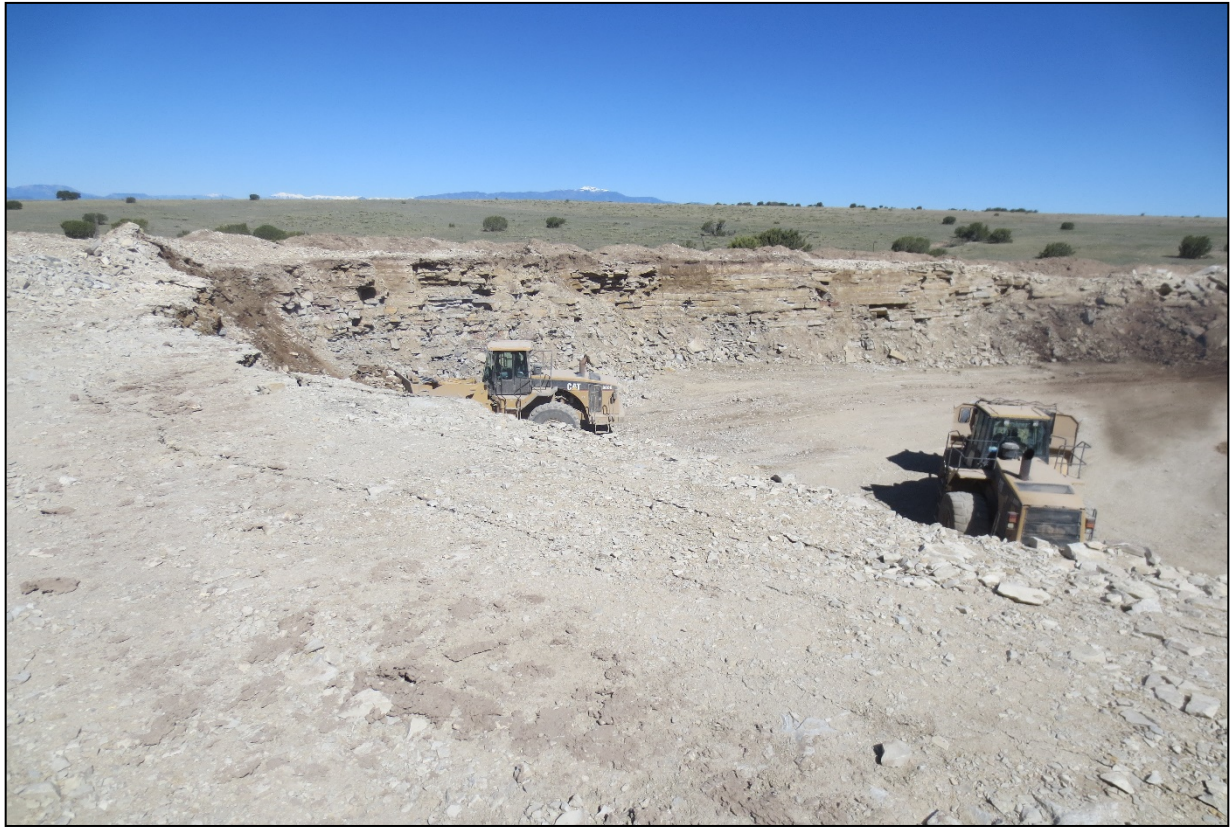
The recent mining operation has created a small box shape cut in the southwest corner of the affected lands, the highwall was approximately 30 feet high. The Operator had salvaged topsoil in the advance of mining and placed topsoil in a berm along the southern portion of the permit boundary. Processed material was being stockpiled in the southeastern portion of the permit boundary. When completing reclamation all affected land must be graded to 3H:1V or flatter.

Photo 1: Active Mining in the southwestern corner of the permit boundary.

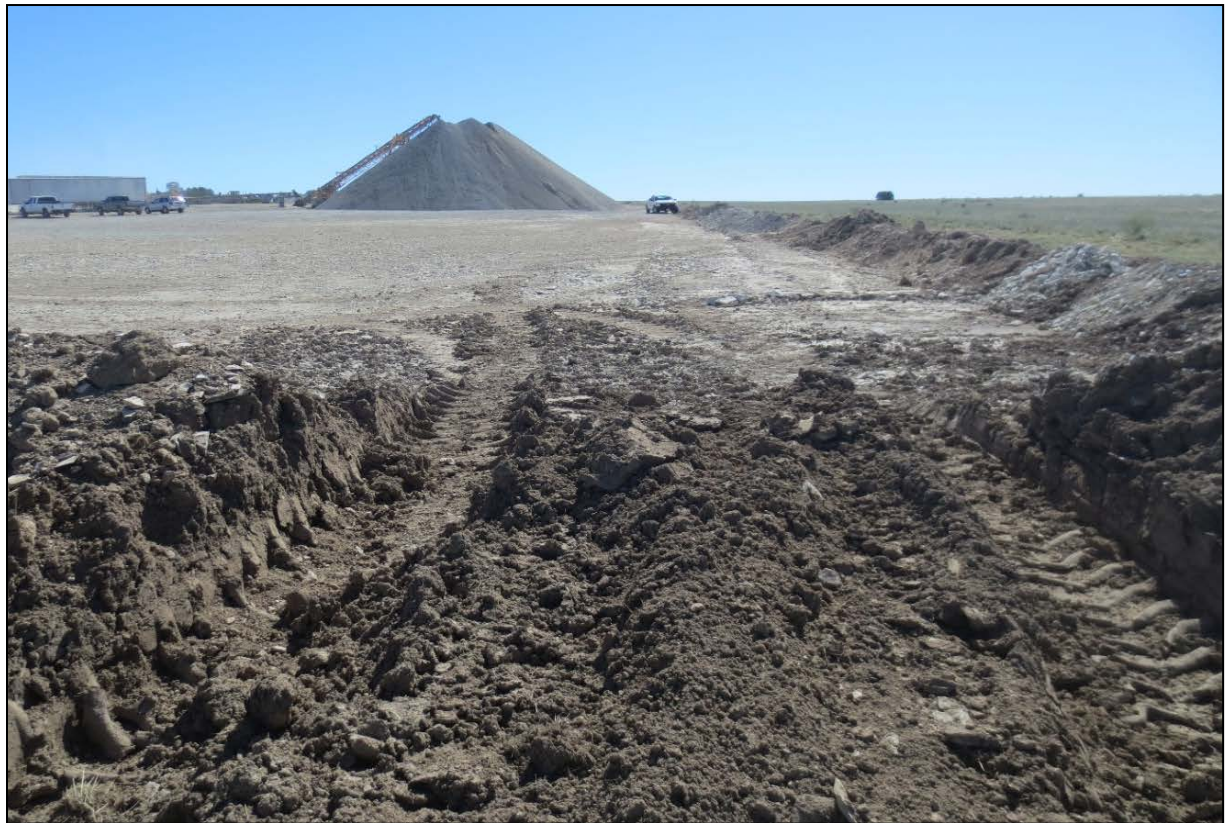
It appears that topsoil had been salvaged in advance of mining. There was a topsoil berm along the southern permit boundary. The foot print of the area where processing and stockpiling was taking place had also had topsoil salvaged, the topsoil was stored in the northeastern corner of the permit boundary. The amount of topsoil salvaged appears to be adequate to complete final reclamation.

Photo 2: Right hand side of the photo, topsoil is bermed up along the southern permit boundary.

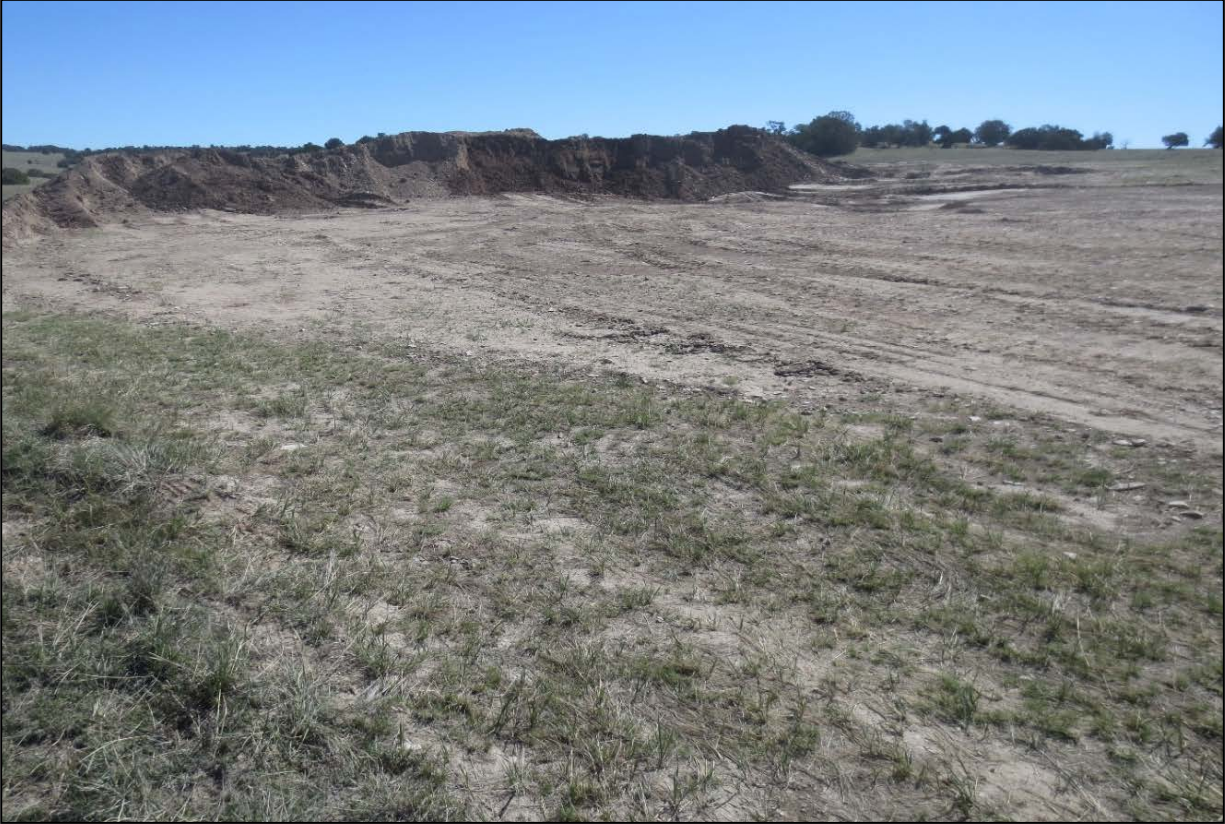
Photo 3: Topsoil stockpile in the northeastern portion of the permit boundary.

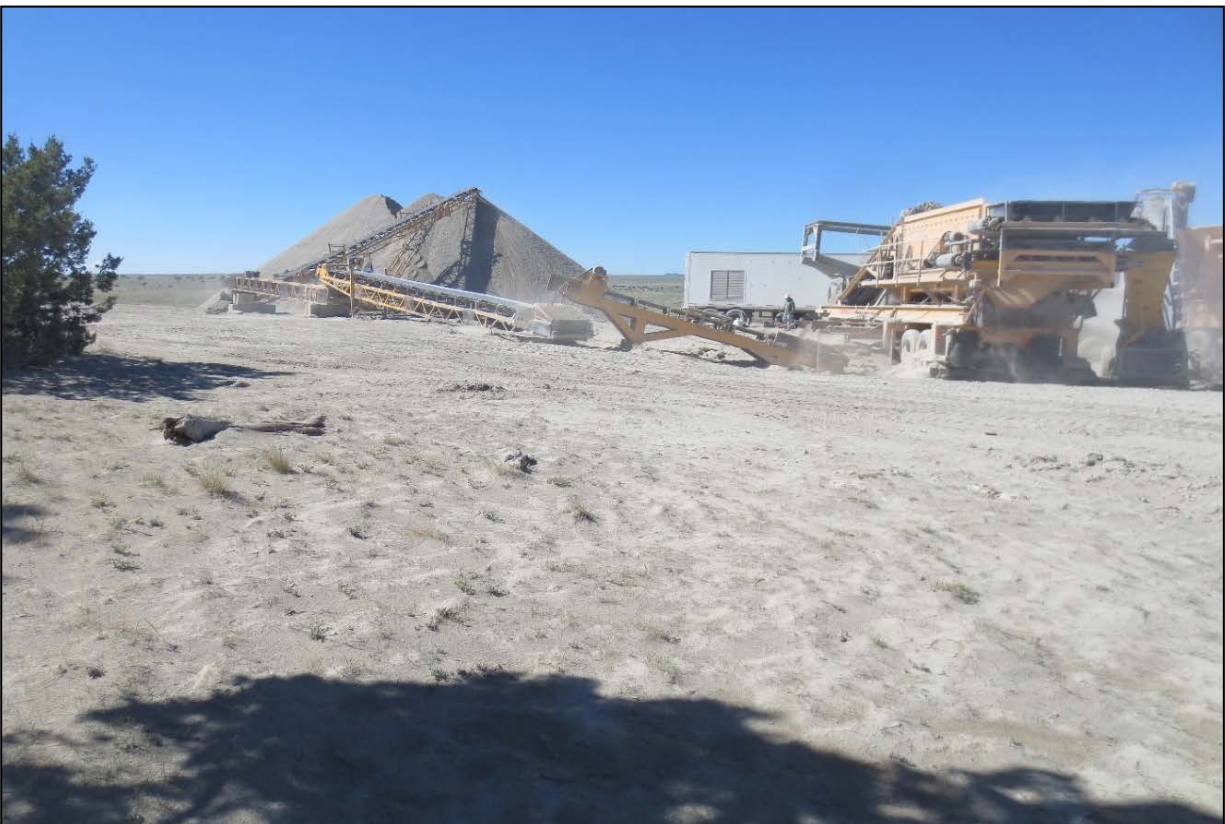
Photo 4: Active processing and stockpiling.
