Division of Reclamation,
Mining and Safety

MINERALS PROGRAM INSPECTION REPORT

MINE NAME: Cresson Project	MINE/PROSPECTING ID#: M-1980-244	MINERAL: Gold	COUNTY: Teller
INSPECTION TYPE: Monitoring	INSPECTOR(S): Timothy A. Cazier	INSP. DATE: July 19, 2016	INSP. TIME: 09:35
OPERATOR: Cripple Creek & Victor Gold Mining Company	OPERATOR REPRESENTATIVE: Clara Trippel	TYPE OF OPERATION: 112d-3 - Designated Mining Operation

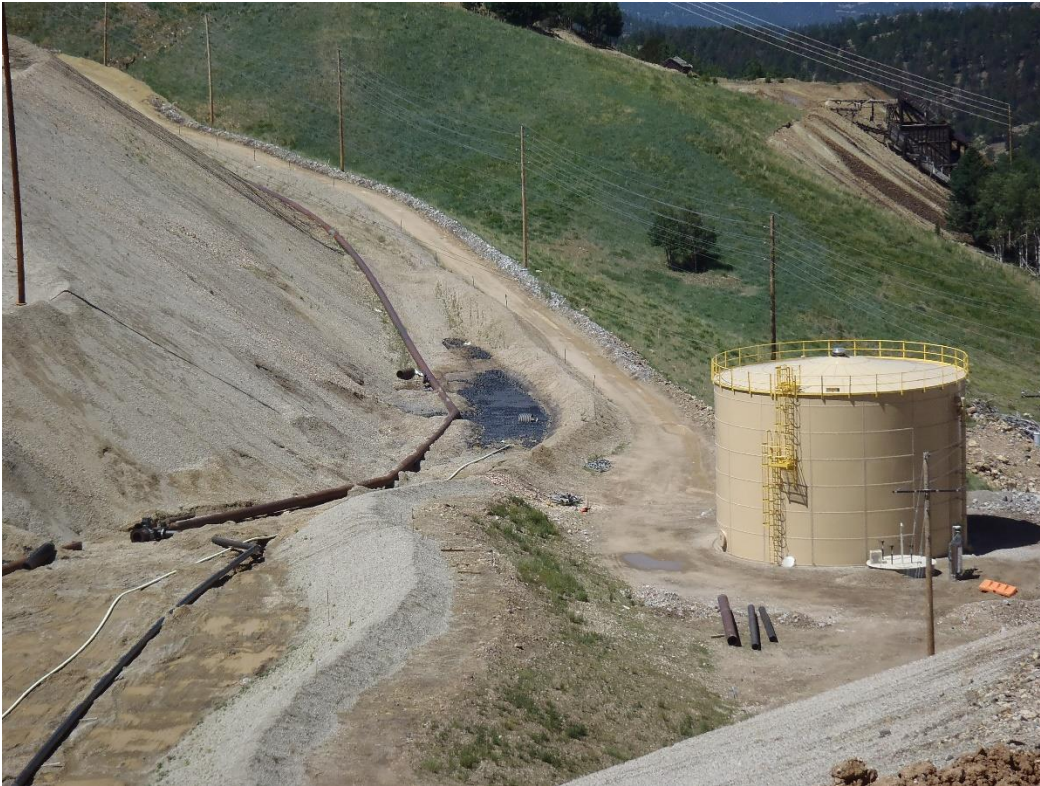
- a) Mill Discharge – The area observed collecting mill water discharge during the June 16, 2016 inspection (see **Photo 1**) was a result of valve in the discharge “can” (see **Photo 2**) not being properly seated. Mr. Rodabough indicated this problem had been corrected and the manual valve that allows the pipes to the AGVLF infiltration wells to back drain should flow to the infiltration wells need to be stopped is now in the closed position. He indicated the only time the mine would need to allow backflow to drain to the pond area would be if the infiltration wells were not working and/or there was danger of the pipe lines to the infiltration wells freezing.

Photo 1. Secondary infiltration trench on north side of Phase IV AGVLF (looking west).

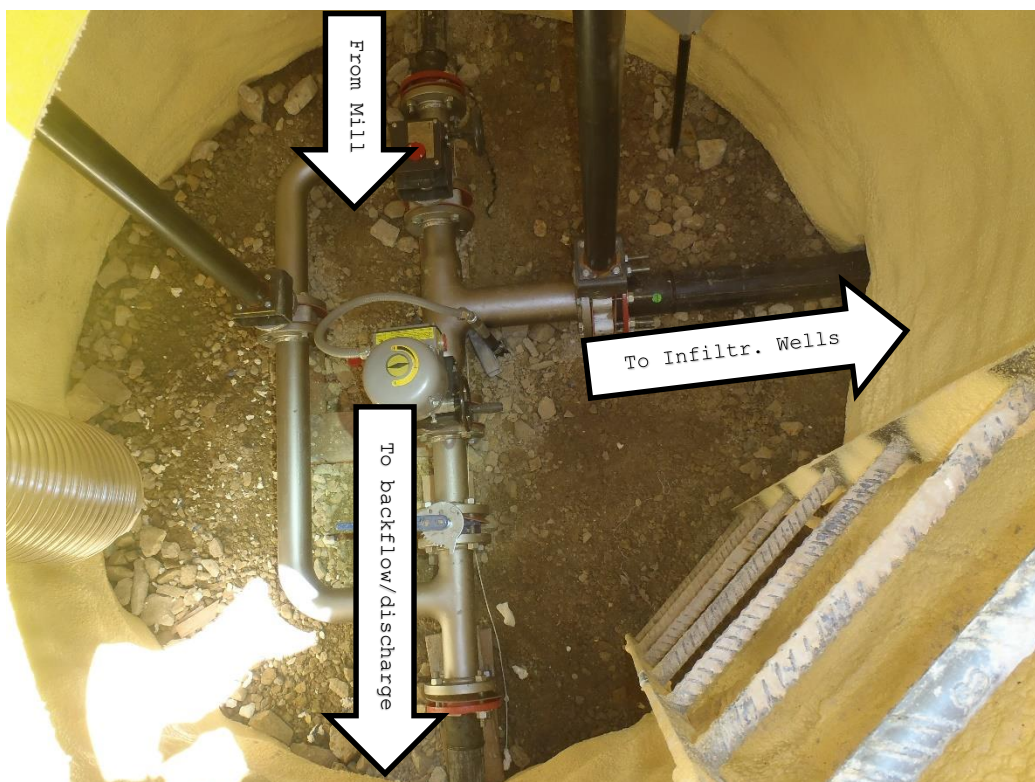
Photo 2. Interior of Mill platform valve box ("can").

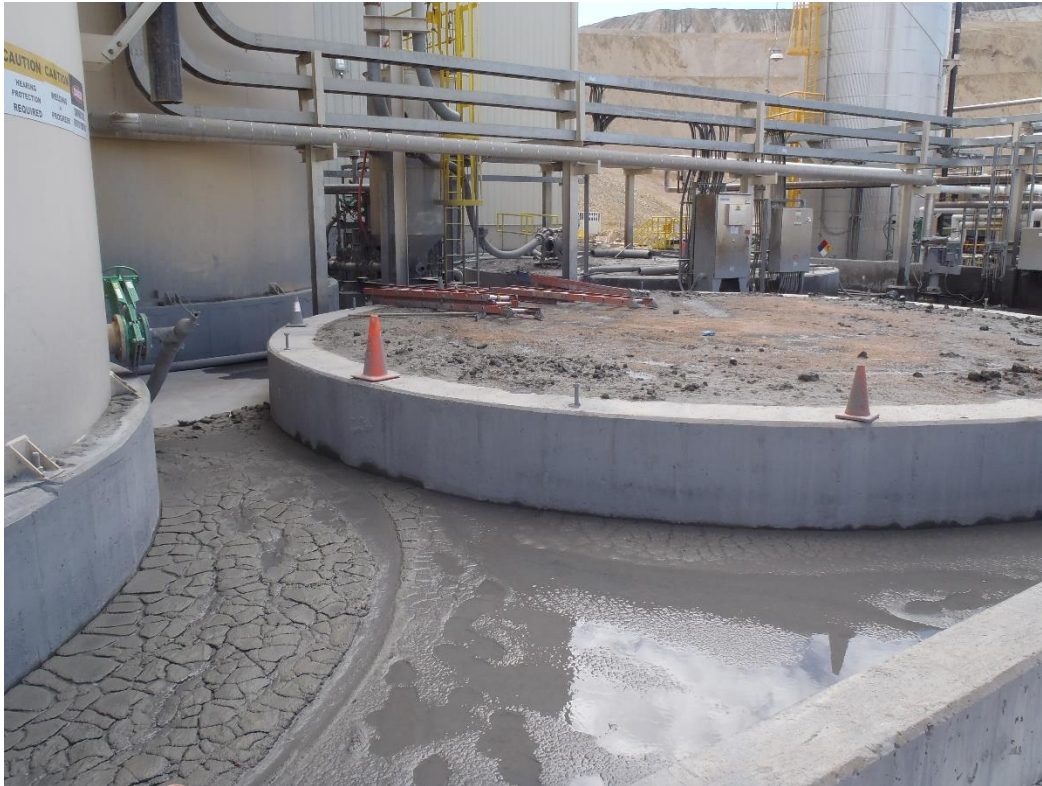
- b) Leach Circuit Secondary Containment – The Division observed slurry from the leach tanks in the secondary containment area (see **Photo 3**). Mr. Rodabough stated that it was from a tank clean out and the mine was in the process of cleaning it up. The Division later verified that the use of the secondary containment for tank maintenance is approved per AM-10/MLE2. CC&V provided the Division with photographic evidence (via email) of the secondary containment area having been cleaned up on July 26, 2016 (see **Photo 4**). Mr. Rodabough stated the mine had had to revert to the smaller capacity positive displacement pumps to move the leach circuit slurry in the secondary containment area back into the leach circuit because the viscosity of the slurry was too high for the new centrifugal pumps. He further indicated the mine is looking for better pump options.

Photo 3. Observed slurry from leach tank maintenance in the secondary containment area.

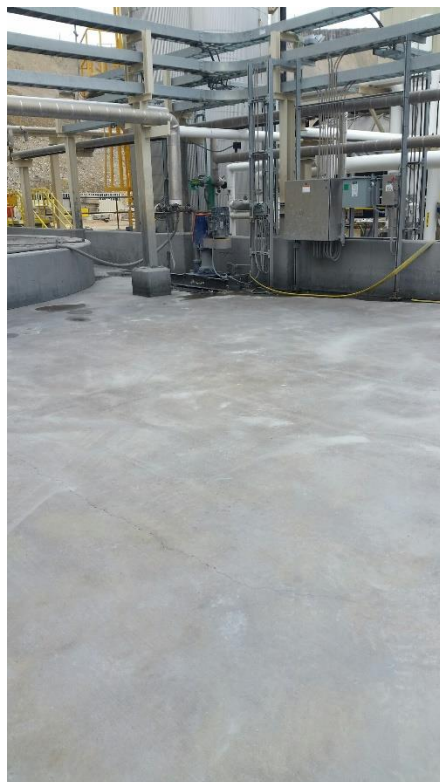
Photo 4. Secondary containment area having been cleaned up (July 26, 2016).

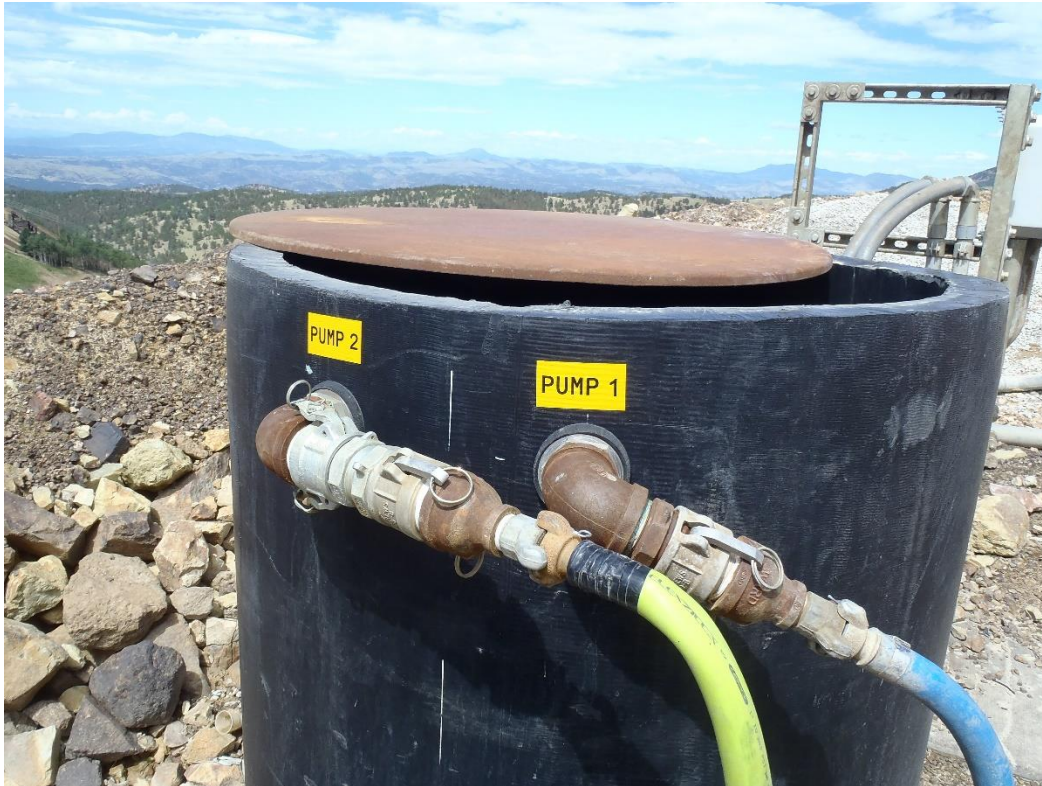
- c) Mill platform seep – The seep area was observed. It remained dry and did not appear to have had any additional seepage since the May 12, 2016 inspection. Mr. Rodabough provided additional explanation on the mill platform water containment system, pointing out the mill sump (see **Photo 5**) in the SW corner of the mill platform. He explained this sump captures meteoric water and fire suppression system leakage water reaching the liner system under the mill. The water in the sump was observed to be on the order of 30 feet from the top of the sump (see **Photo 6**). He stated this water has a pH of about 2 due to contact with the waste rock used to construct the mill platform. He also stated the water in the sump is pumped back to the mill circuit via temporary lines that will become permanent.

Photo 5. Mill water containment system sump in SW corner of mill platform.

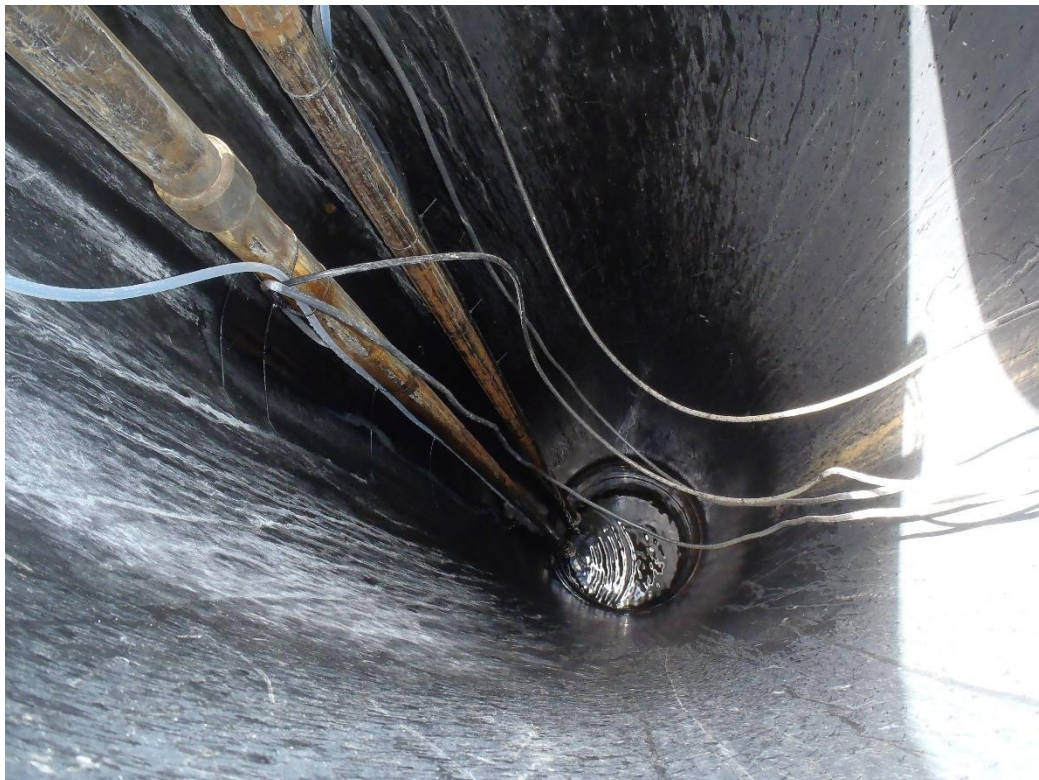
Photo 6. Water in Mill sump observed to be approx.. 30 feet from the top of the sump.

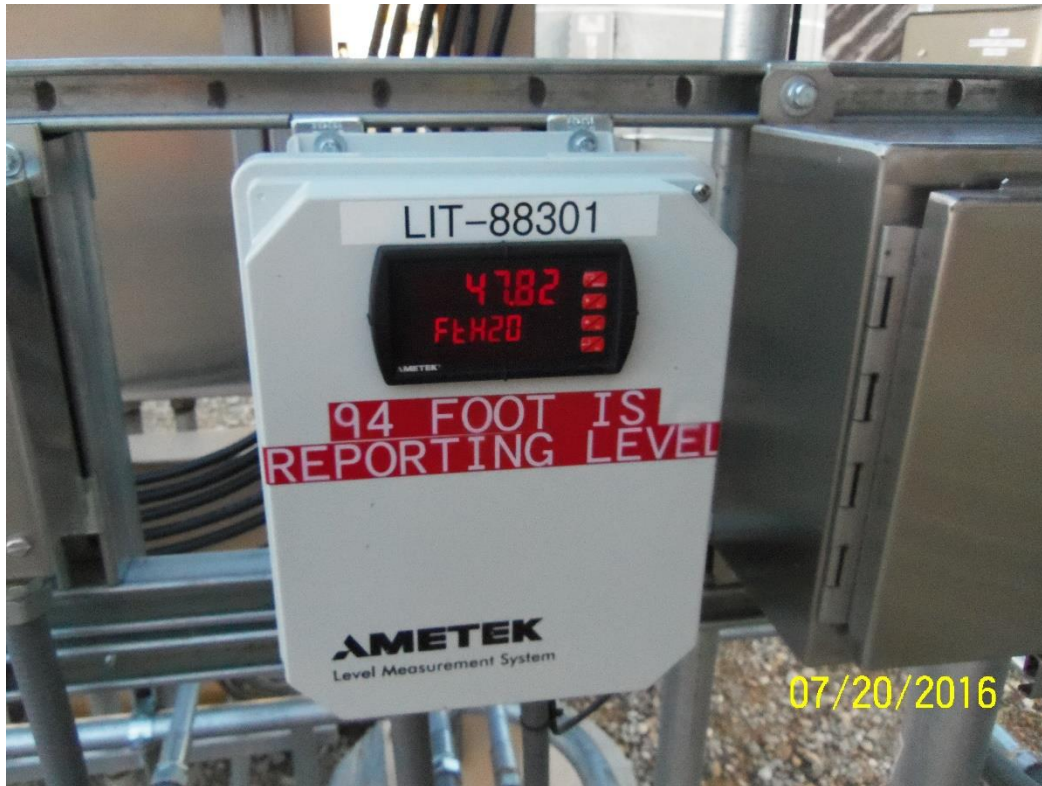
SGVLF Inspection: Water levels were observed on the four High Volume Solution Collection System (HVSCS) transducer displays and the nearby piezometer that is expected by mine personnel to be outside the drawdown cone of the four HVSCS pumps. Discussions with Mr. Denny Deemer and Mr. Laurin Colby (both with CC&V) indicated the PSSA 80 percent capacity level for the HVSCS transducers is 94 feet. This 94-foot depth apparently applies to the nearby piezometer as well. The Division requested the various transducers be labeled for future consistent reference. Ms. Trippel provided photographic evidence of identification placards (see **Photo 7**) for each transducer being labeled via email on July 20, 2016. The following provides a summary of the observed water levels:

A post-inspection review of this data suggests a discrepancy. If the piezometer is outside the influence of the drawdown cone for the four HVSCS pumps, then it should have a greater depth, yet the piezometer depth is approximately 17 feet below that of the pump transducers. A review of the PSSA as-constructed drawings suggests the discrepancy may be because the piezometer is constructed outside the PSSA sump such that the bottom of the sump is considerably higher than the bottom of the PSSA pump risers. If this is the case, the 94-foot depth should not be applicable to the piezometer. The piezometer outside the drawdown cone area is the most important check in the SGVLF PSSA to ensure the pool is below the 80 percent volume as is the limit in the approved AM-10/MLE2 permit. **This apparent discrepancy in water level readings is cited as a potential problem on page 2 of this report.**

Photo 7. SGVLF PSSA transducer identification placards (from CC&V, post inspection).

CORRECTIVE ACTIONS: CC&V must resolve to the Division's satisfaction the apparent discrepancy in the SGVLF PSSA piezometer limit with respect to the 80 percent storage capacity.

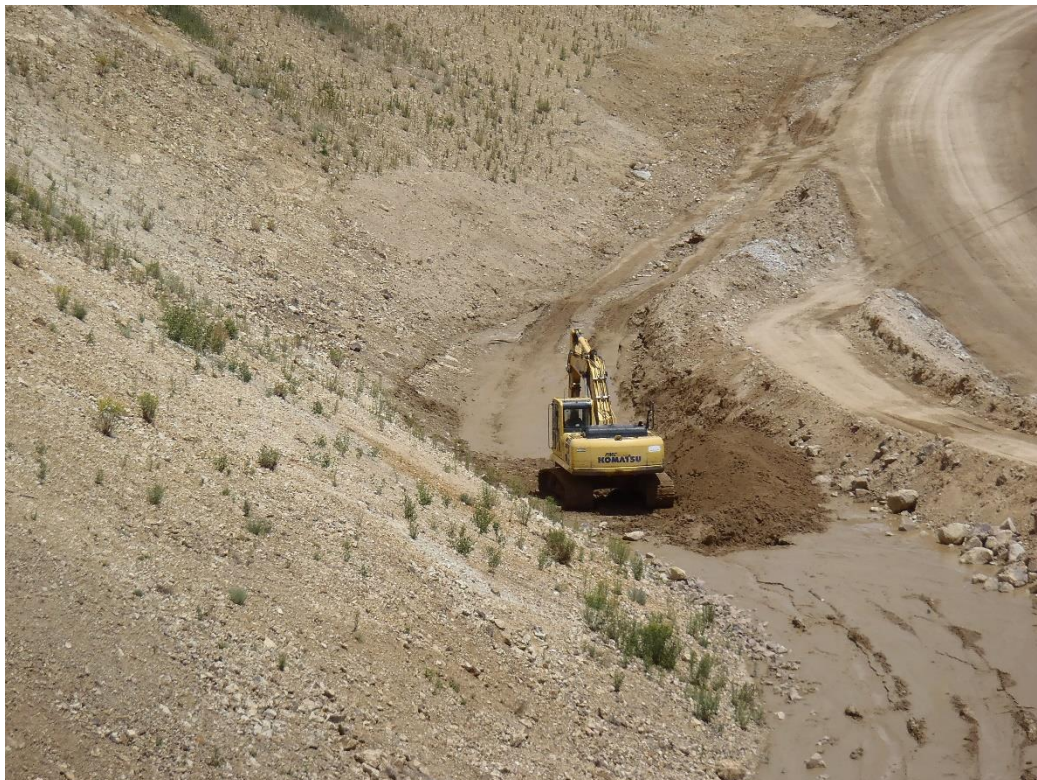
Stormwater Channel Inspection: Mr. Ron DiDonato accompanied the Division and Ms. Trippel on inspections for the Phase I and II stormwater diversion channels in the SGVLF area. The Phase I channel is now mostly haul road, but the last several hundred feet emptying into Phase I sediment pond at the southern toe of Topsoil Stockpile #34 are riprap-lined channel. Equipment was observed removing sediment from this section of the Phase I diversion channel (see **Photo 8**). Most segments of the Phase II diversion channel have been

Photo 8. SGVLF Phase I diversion channel maintenance.

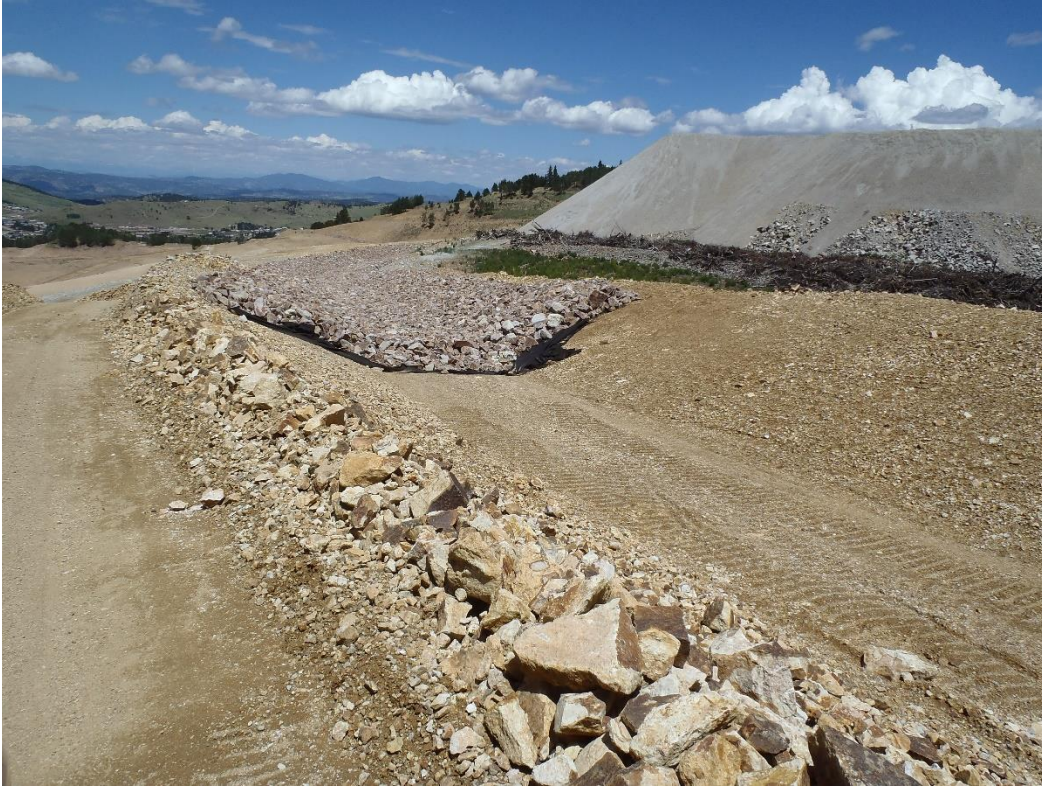
constructed, but segments where access is needed (near the existing SGVLF haul road crossing and the upper end of the channel needed for construction access) and near the area recently back filled with structural fill (see **Photo 9**) are yet to be completed. The Phase II sediment pond was dry (see **Photo 10**) and appeared to be deeper than 10 feet from the bottom to the spillway invert on the north end of the pond. Ms. Trippel said she would ask the engineer of record to confirm whether or not the Phase II sediment pond fell under the jurisdiction of the State Engineers Office for jurisdictional dams.

Photo 9. SGVLF Phase II diversion channel construction.

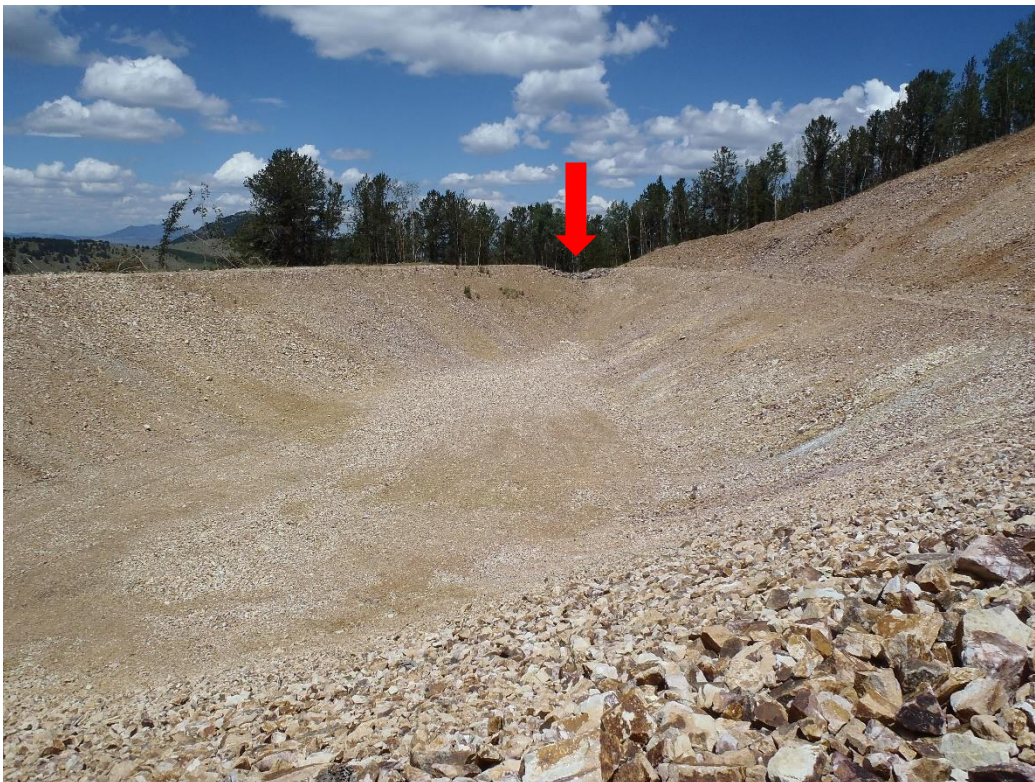
Photo 10. SGVLF Phase II diversion sediment pond (looking NW).
{note spillway on far end}

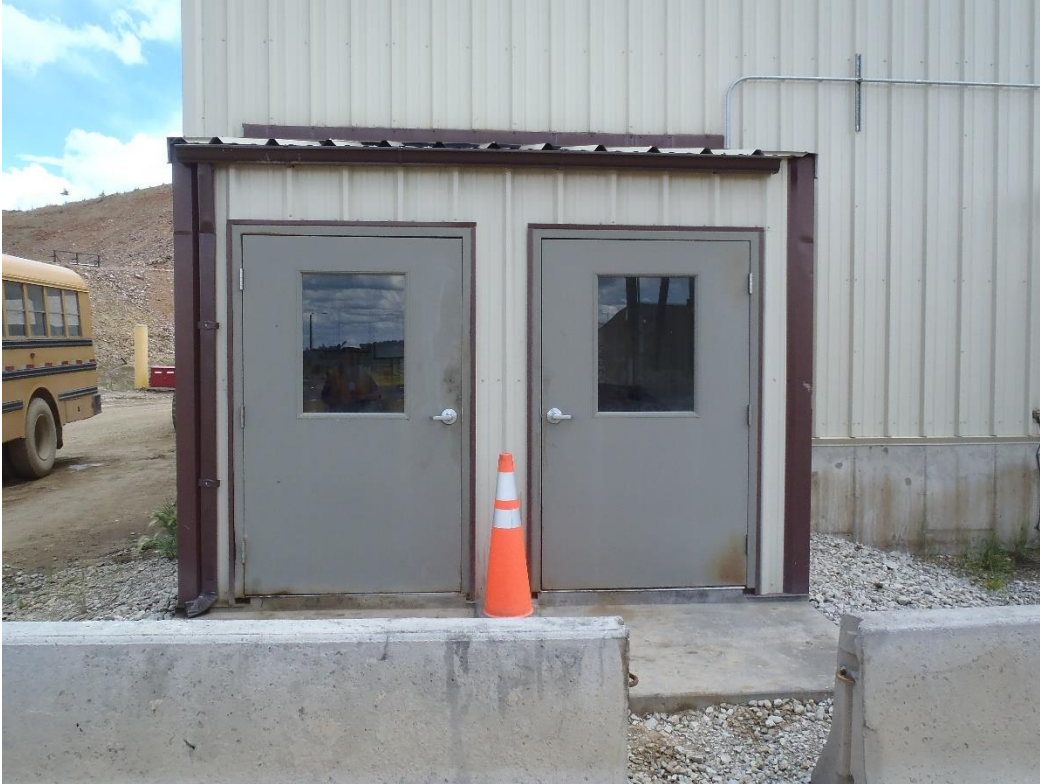
Ironclad Maintenance Shops Inspection: Mr. Clint Shaefer accompanied the Division and Ms. Trippel on the inspection of the Ironclad Maintenance Shops. Mr. Shaefer pointed out the newly enclosed lubricant transfer station (see **Photo 11**) at the large truck maintenance shop, designed to contain occasional spills during the transfer process. He indicated he would like to implement a similar enclosure on the west end of the warehouse/small truck maintenance shop (see **Photo 12**). No problems were observed.

Photo 11. Newly enclosed large truck maintenance shop lubricant transfer station.

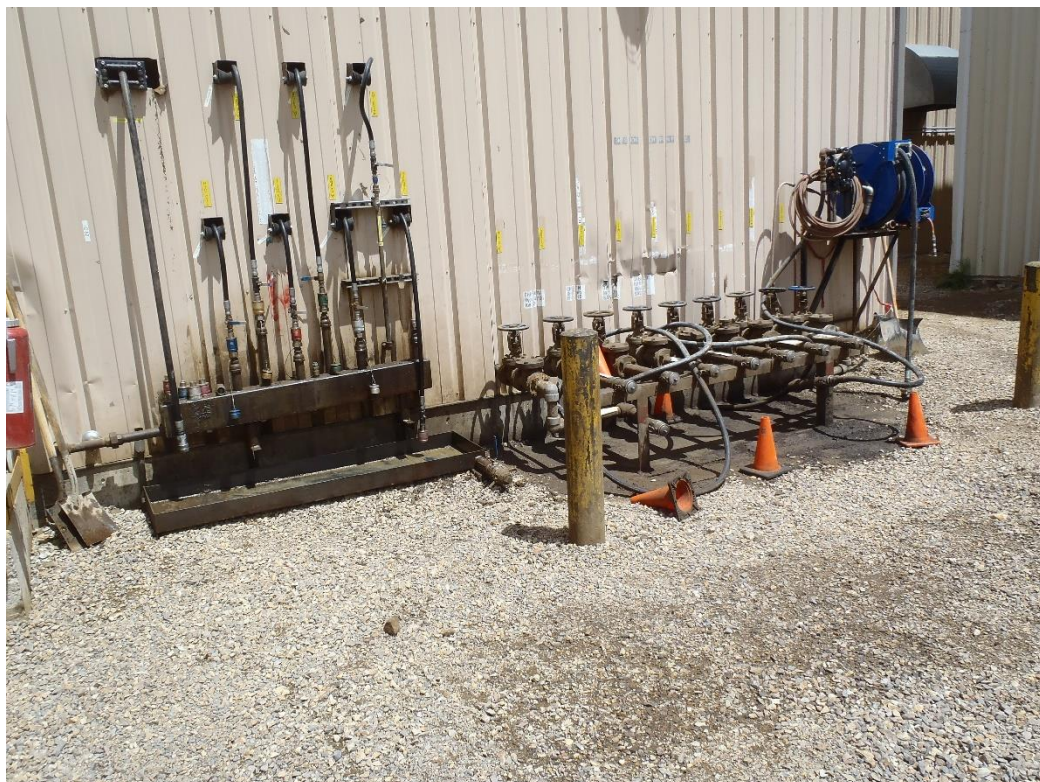
Photo 12. Location for future enclosed maintenance shop lubricant transfer station.

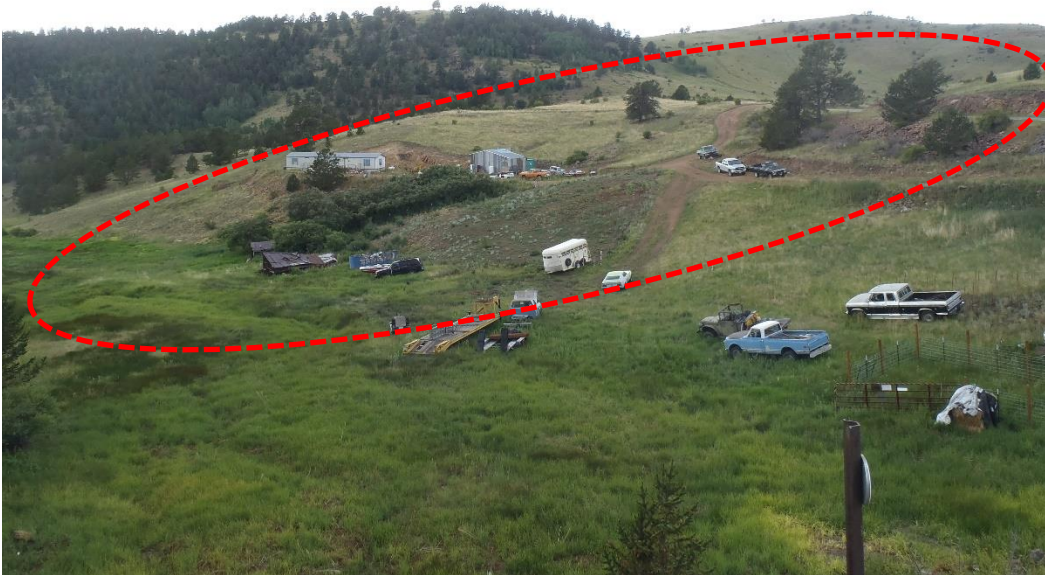
Photo 13. AR-03 release area near HWY 67 (looking west).

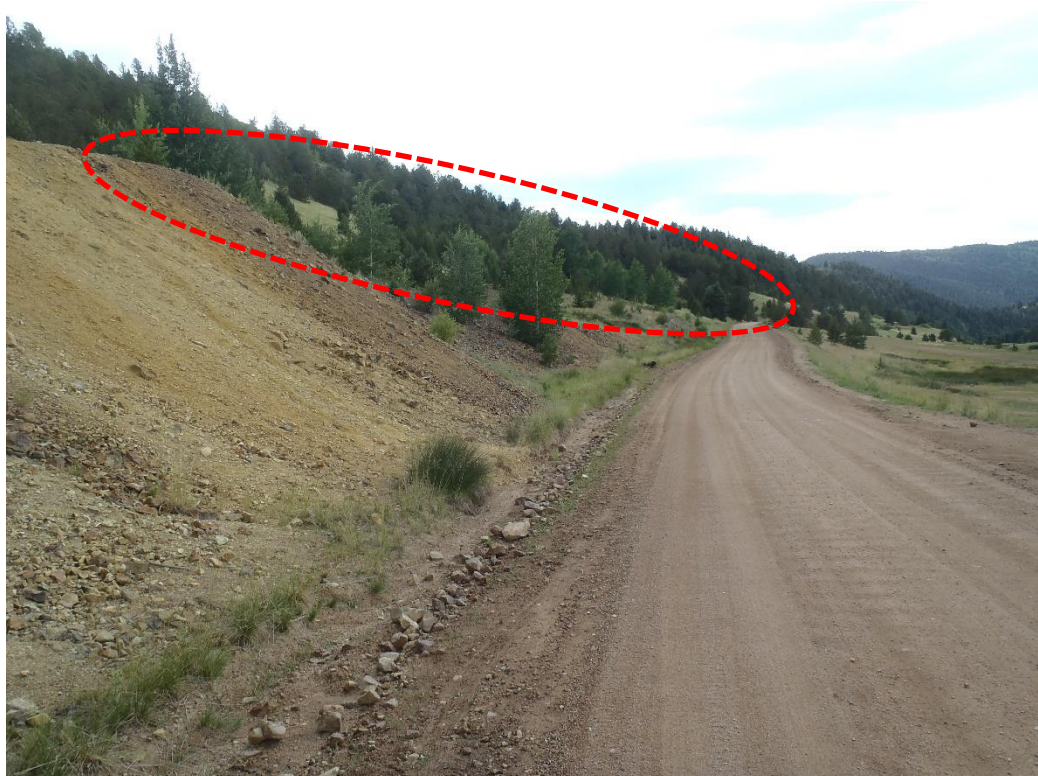
Photo 14. AR-03 release area near Shelf Road (looking south).
