MINERALS PROGRAM INSPECTION REPORT**PHONE: (303) 866-3567**

MINE NAME: Martin Pit 1-A	MINE/PROSPECTING ID#: M-1990-140	MINERAL: Sand and gravel	COUNTY: Moffat
INSPECTION TYPE: Preoperation Inspection	INSPECTOR(S): Amy C. Yeldell	INSP. DATE: July 19, 2016	INSP. TIME: 11:30
OPERATOR: Duran & Pearce Contractors, Inc.	OPERATOR REPRESENTATIVE: Jim & Derek Duran	TYPE OF OPERATION: 110c - Construction Limited Impact

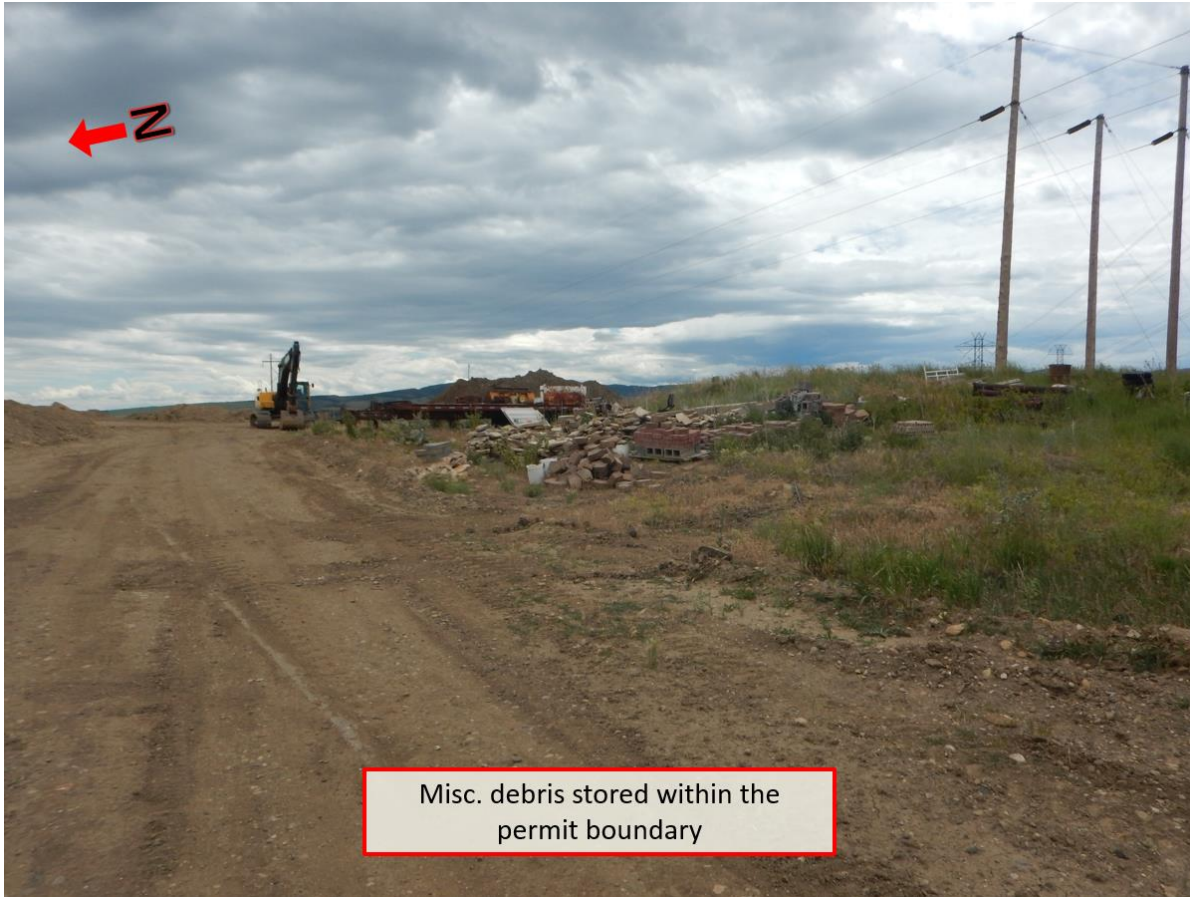
The majority of affected land is used for storage of stockpiles, inert fill, misc. debris and equipment. Two excavators were observed. There are non-mining related trailers and debris stored within the permit boundary. This misc. debris should be kept in a neat and orderly fashion. Trash and other refuse shall not be stored within the permit boundary.

Misc. debris stored within the permit boundary

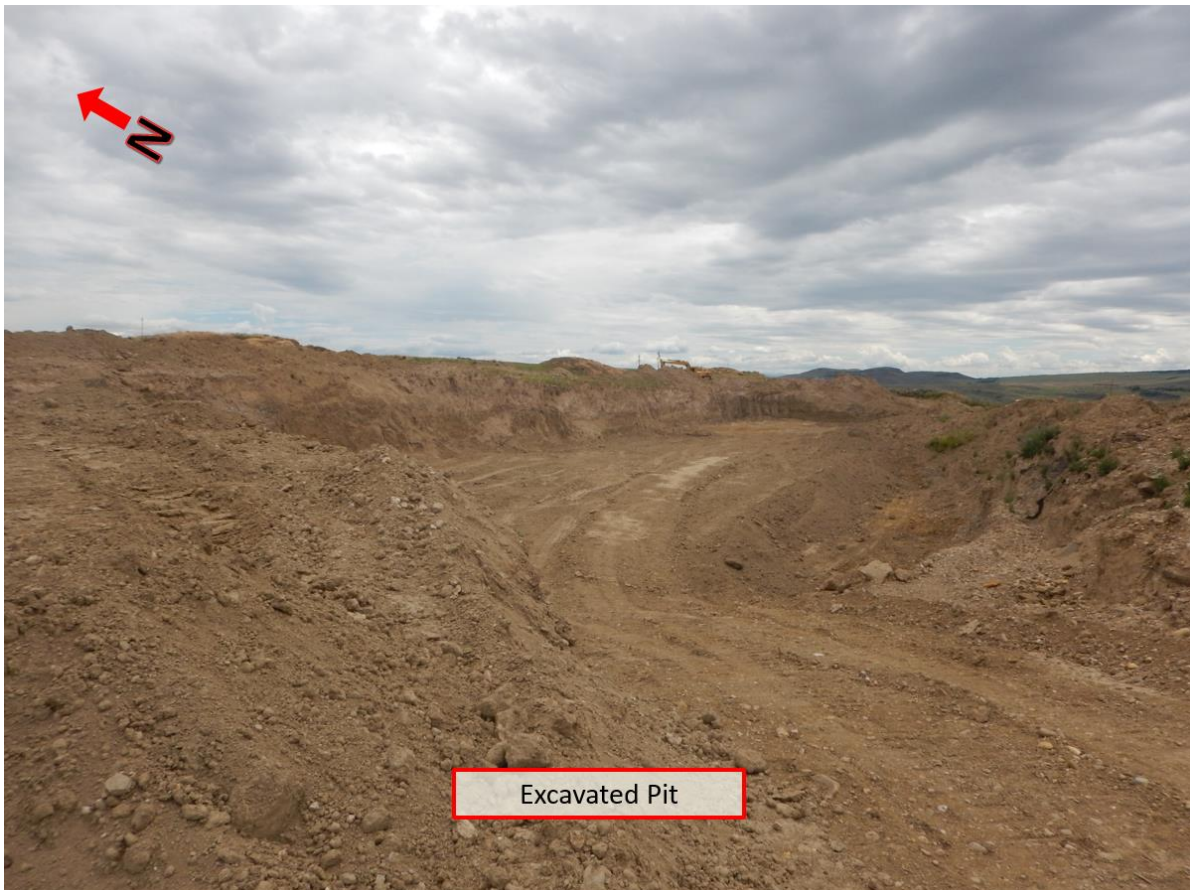
This site appeared to be active at the time of the inspection though no actual equipment in operation was observed. The pit excavation currently is approximately 40' W x 150' L x 20' D. Approximately 6 acres is affected within the 110c boundary. On the site there is one main stockpile that is approximately 15'H by 20'W x 20'D. Additional smaller piles of various types of material are also stored. All stockpiles appear to be stable and slopes approximately 2:1. Material excavated is used by Duran & Pearce Contractors and not sold to the general public.

Excavated Pit

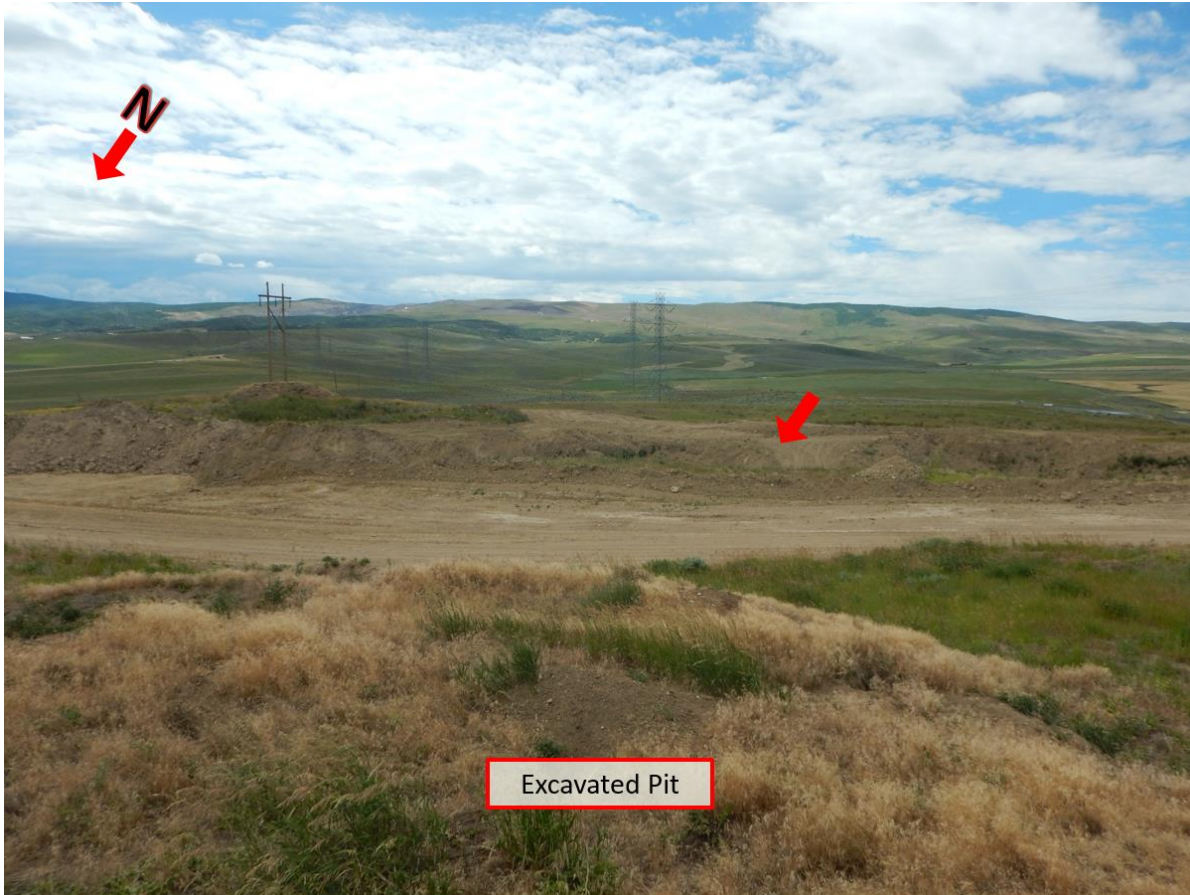
Excavated Pit

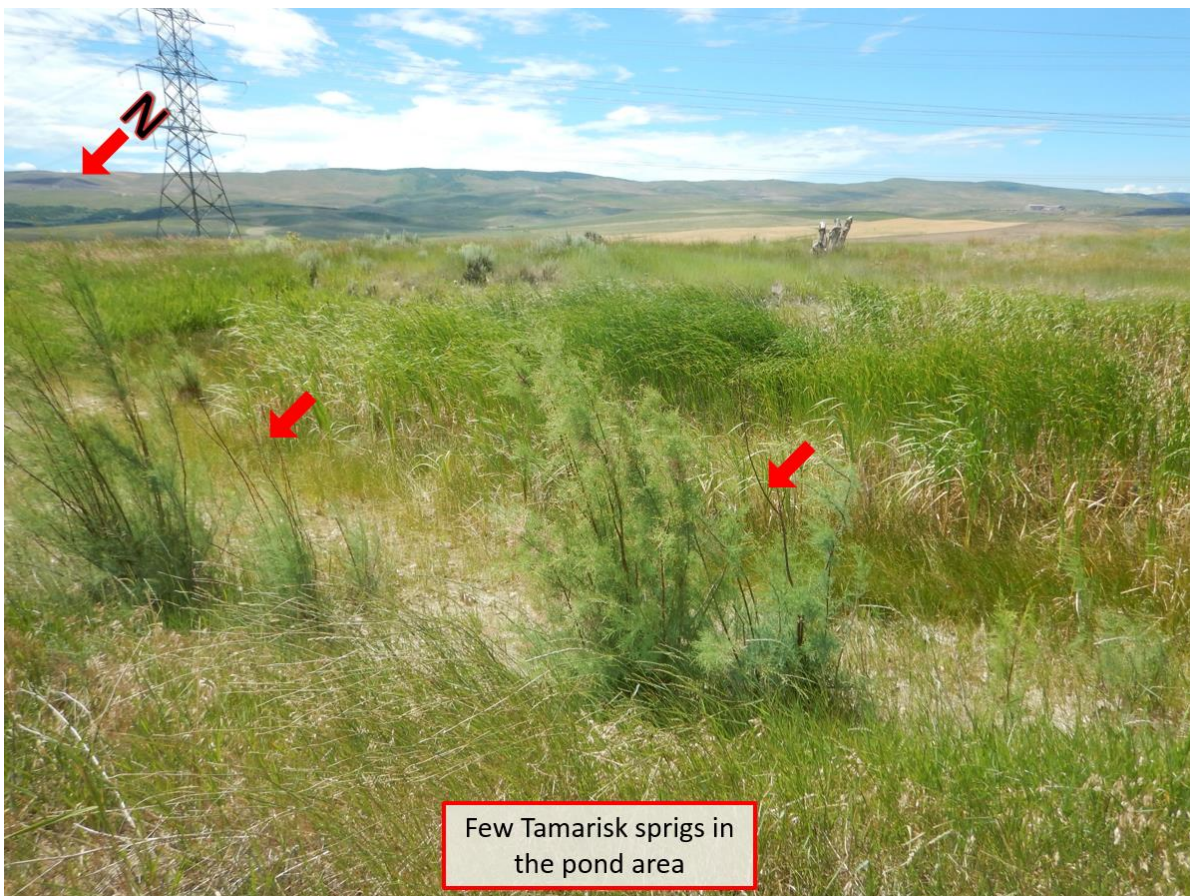
PROBLEM/POSSIBLE VIOLATION: Problem: Tamarisk (salt cedar) trees are present within or have volunteered into the permit area and are becoming established. This is a problem for failure to employ weed control methods for a state listed noxious weed species within the permitted area, and to reduce the spread of weeds to nearby areas as required by Section 3.1.10 (6) of the rule.

Few Tamarisk sprigs in
the pond area

CORRECTIVE ACTIONS: The operator shall remove and treat all present Tamarisk trees within the permit boundary. Please provide the Division with photo documentation by the corrective action date.
