MINERALS PROGRAM INSPECTION REPORT
PHONE: (303) 866-3567

MINE NAME: Wagner Rock	MINE/PROSPECTING ID#: M-1999-018	MINERAL: Sand and gravel and	COUNTY: Moffat
INSPECTION TYPE: Monitoring	INSPECTOR(S): Amy C. Yeldell	INSP. DATE: July 19, 2016	INSP. TIME: 12:30
OPERATOR: Wagner Construction Inc.	OPERATOR REPRESENTATIVE: Jay Wagner	TYPE OF OPERATION: 110c - Construction Limited Impact	
REASON FOR INSPECTION: Normal I&E Program	BOND CALCULATION TYPE: Complete Bond	BOND AMOUNT: \$14,005.00	
DATE OF COMPLAINT: NA	POST INSP. CONTACTS: None	JOINT INSP. AGENCY: None	
WEATHER: Clear	INSPECTOR'S SIGNATURE:

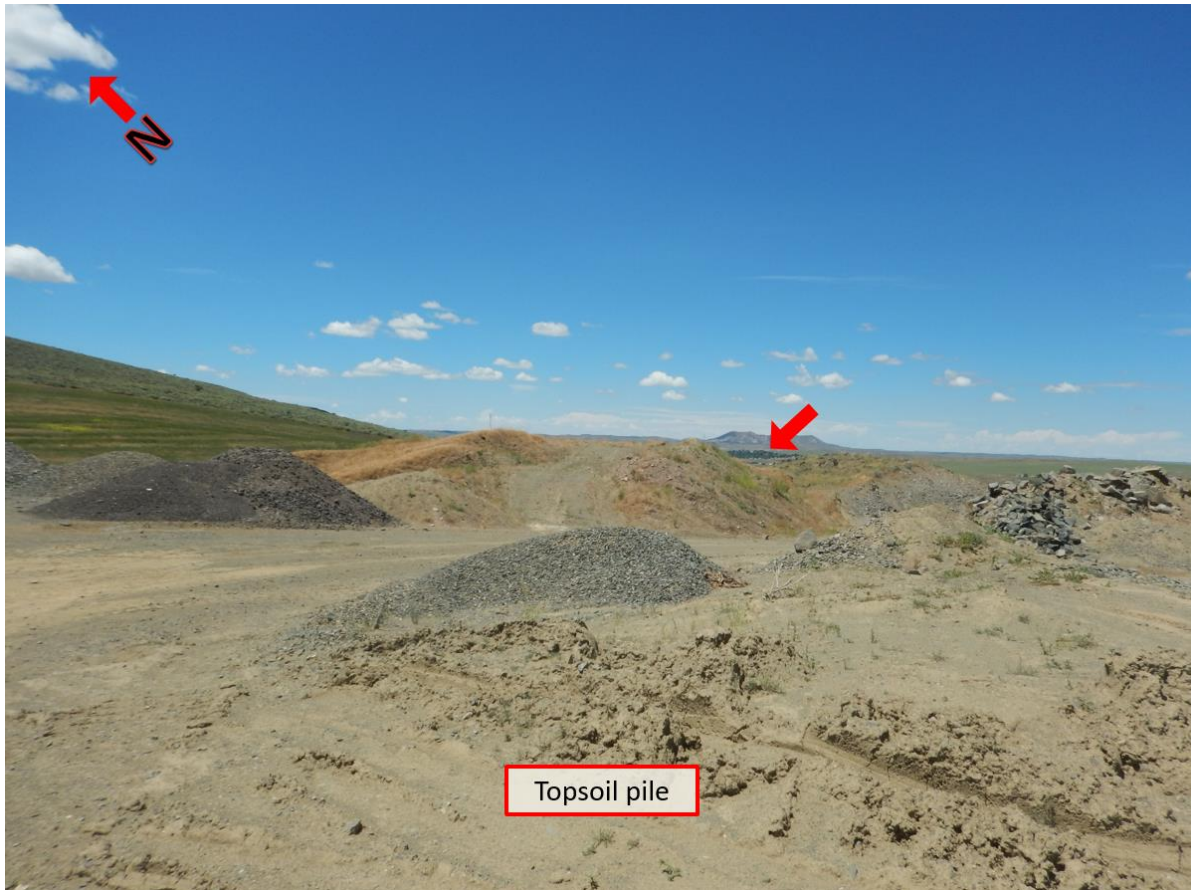
The topsoil pile is located just to the south of the west pit, it consists of excavated topsoil material as well as reject fines. The topsoil pile appears to be adequate volume for reclamation. The operator is encouraged to more aggressively manage weeds on the topsoil pile to avoid accidental seeding of non-desired species.

Topsoil pile

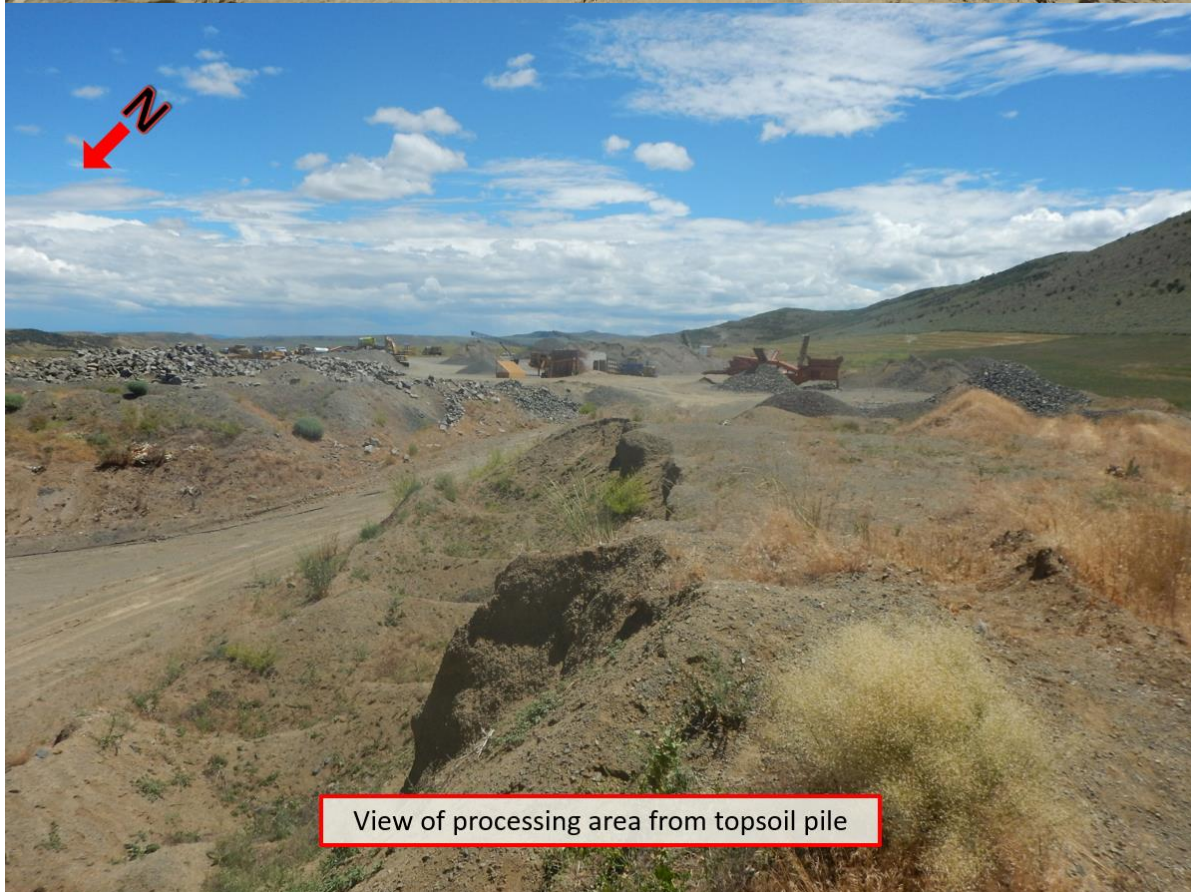
This site processes material by crushing and sorting it according to size. No washing of material or asphalt and cement operations occurs. No blasting occurs at this site. A scale and scale house have been constructed at the entrance of the mine site. Also observed was a secondary containment structure. No fuel is stored at this site. Portable slip tanks are used to fuel all equipment.

View of processing area from topsoil pile
