## MINERALS PROGRAM INSPECTION REPORT

<b>MINE NAME:</b> Hogue/River Pit	<b>MINE/PROSPECTING ID#:</b> M-1992-066	<b>MINERAL:</b> Gravel	<b>COUNTY:</b> Routt
<b>INSPECTION TYPE:</b> Monitoring	<b>INSPECTOR(S):</b> Amy C. Yeldell	<b>INSP. DATE:</b> July 20, 2016	<b>INSP. TIME:</b> 08:00
<b>OPERATOR:</b> Duckels Construction, Inc. dba Yampa Aggre	<b>OPERATOR REPRESENTATIVE:</b> David Epstein	<b>TYPE OF OPERATION:</b> 112c - Construction Regular Operation

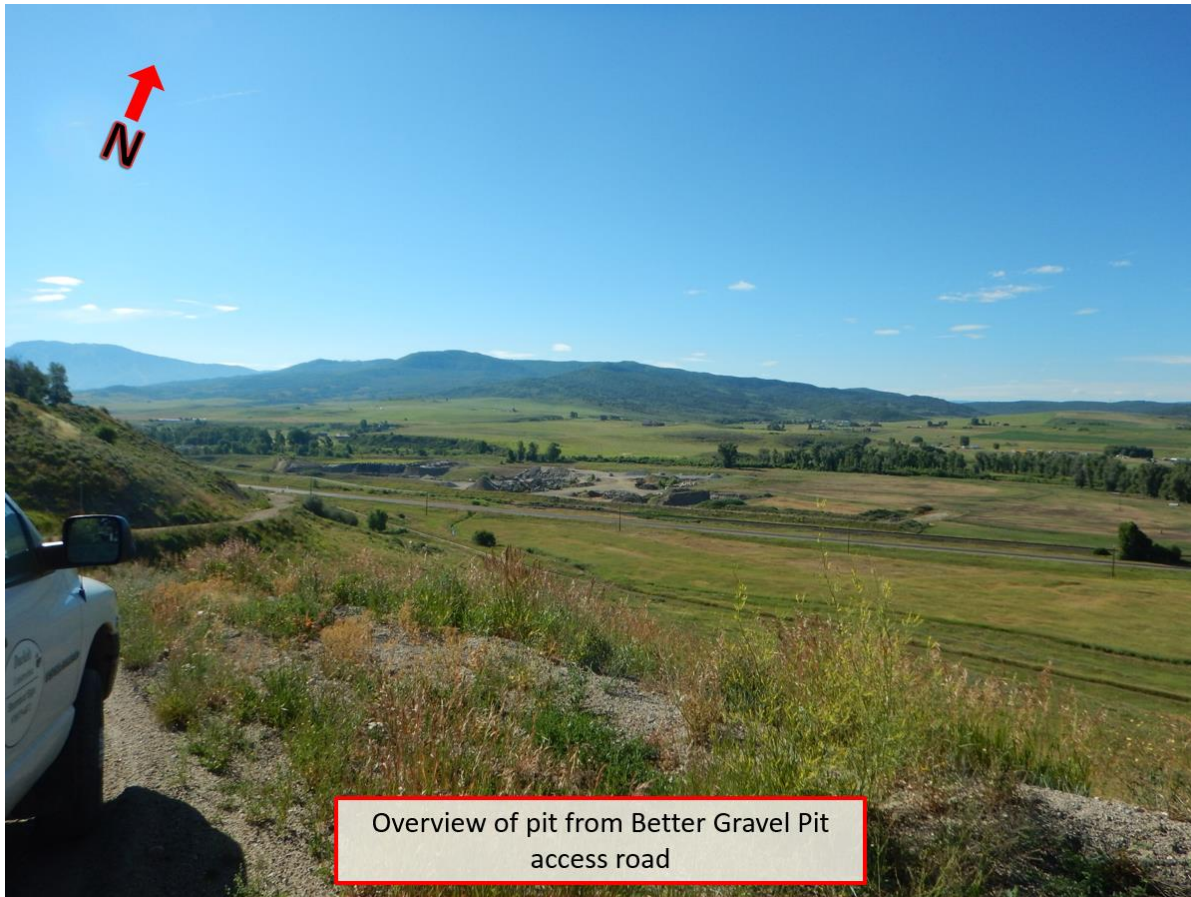
Overview of pit from Better Gravel Pit  
access road
