## MINERALS PROGRAM INSPECTION REPORT

| <b>MINE NAME:</b><br>Henderson Mine | <b>MINE/PROSPECTING ID#:</b><br>M-1977-342 | <b>MINERAL:</b><br>Molybdenum | <b>COUNTY:</b><br>Clear Creek, Grand |
| <b>INSPECTION TYPE:</b><br>Monitoring | <b>INSPECTOR(S):</b><br>Peter S. Hays | <b>INSP. DATE:</b><br>July 19, 2016 | <b>INSP. TIME:</b><br>09:30 |

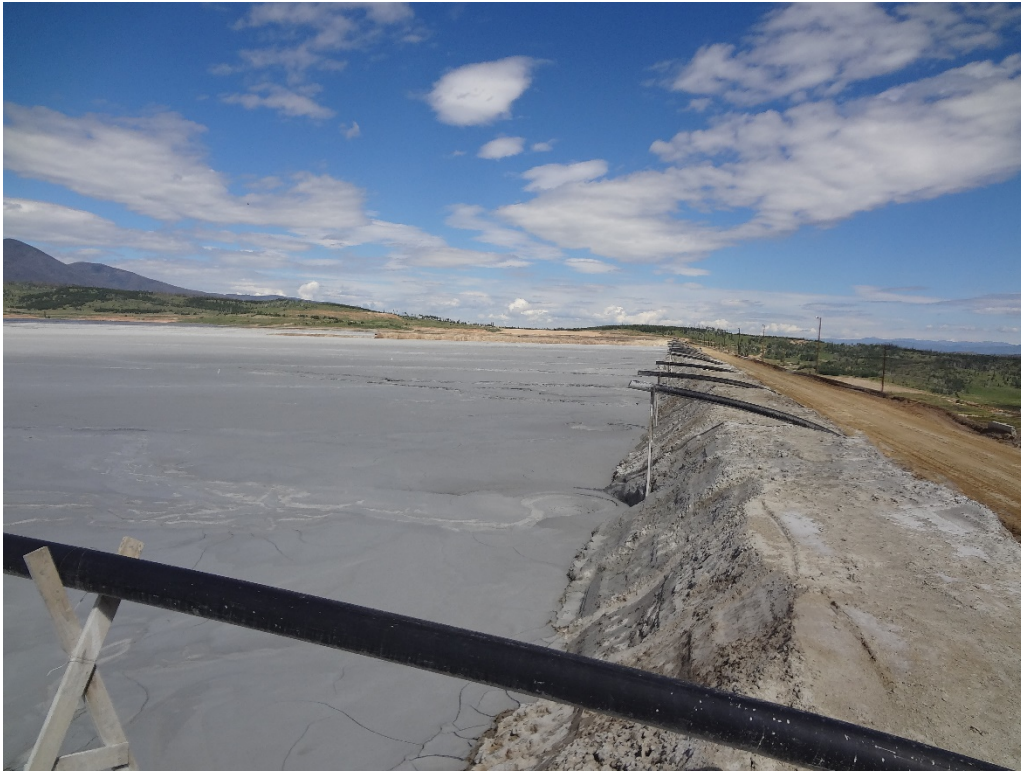
Cell 1 of 1-Dam looking north

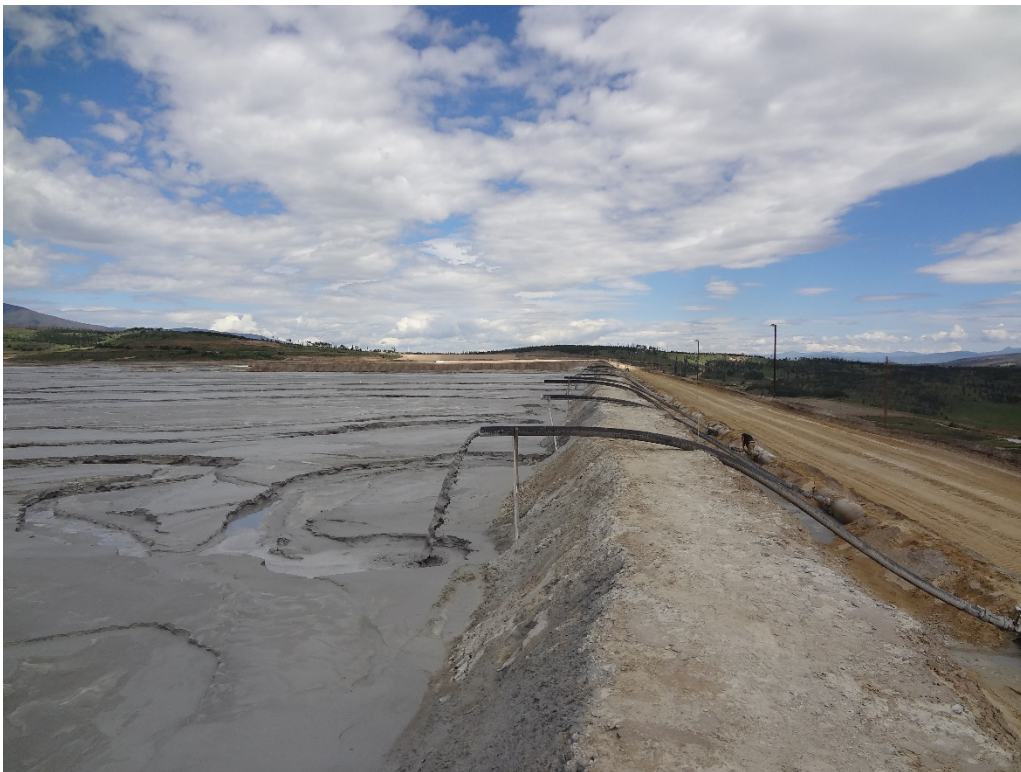
Cell 2 of 1-Dam looking north

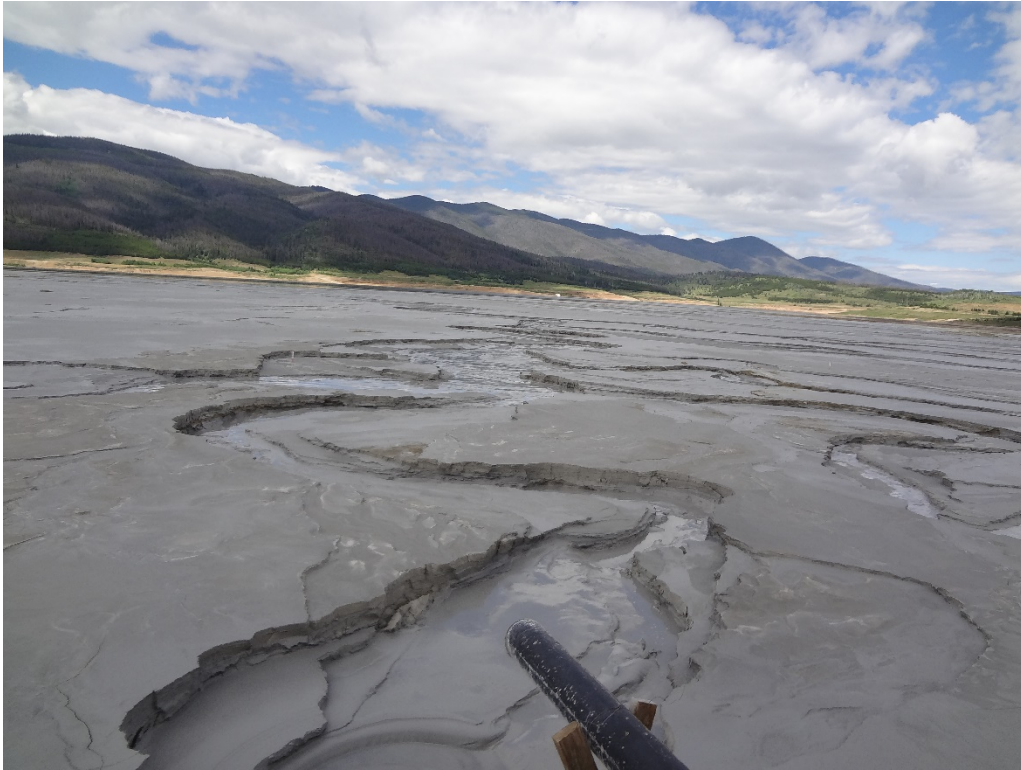
Typical deposition in Cell 2 of 1-Dam

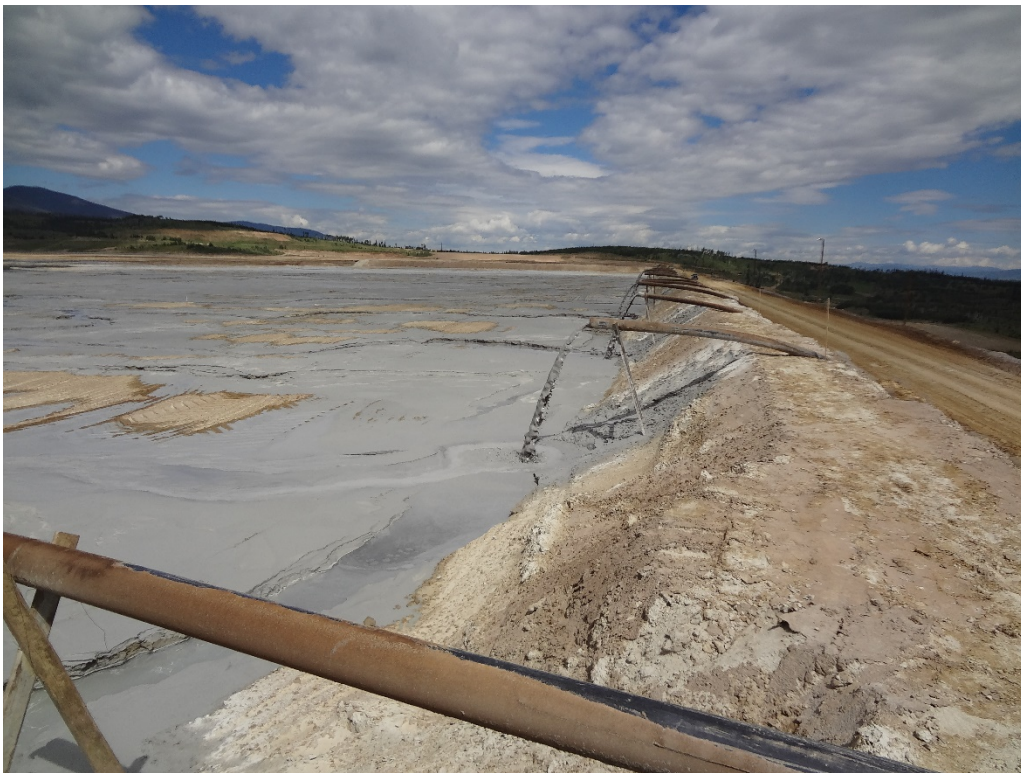
Cell 3 of 1-Dam looking north

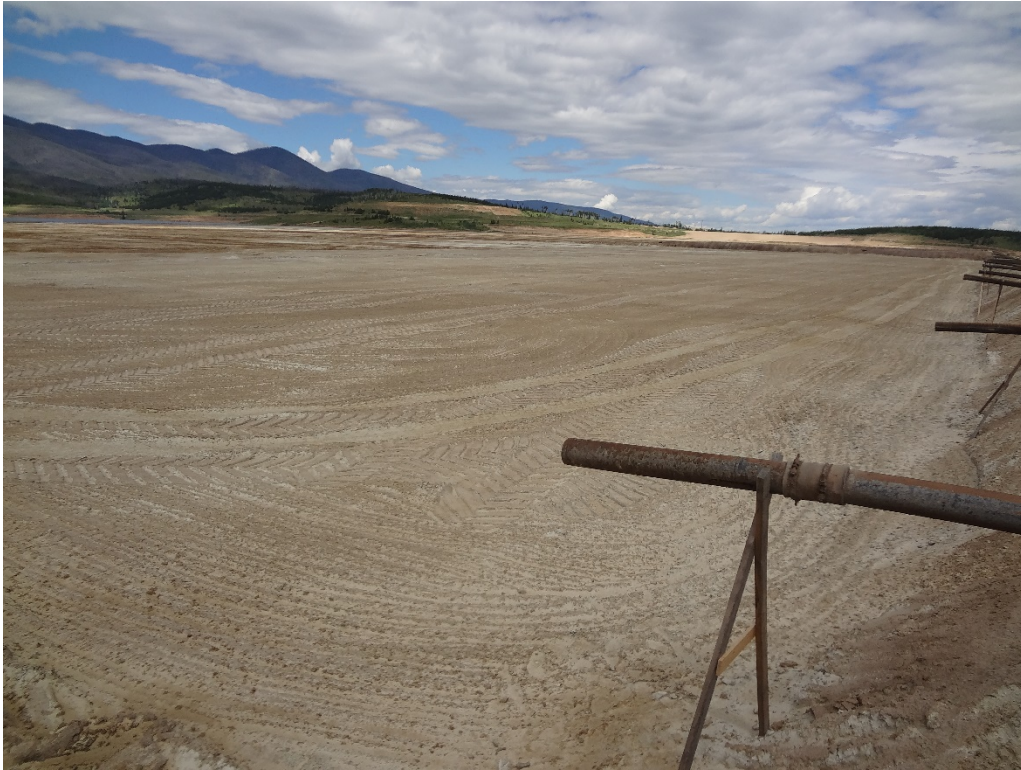
Cell 4 of 1-Dam looking northwest

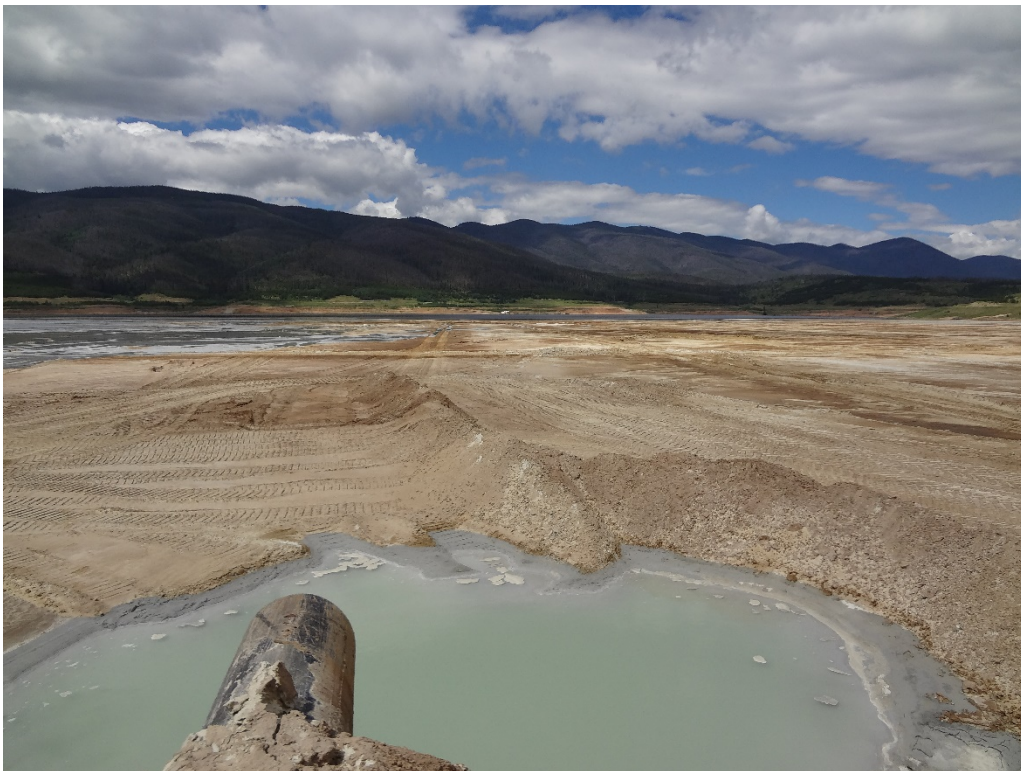
Leadoff between Cells 3 and 4 of 1-Dam looking west

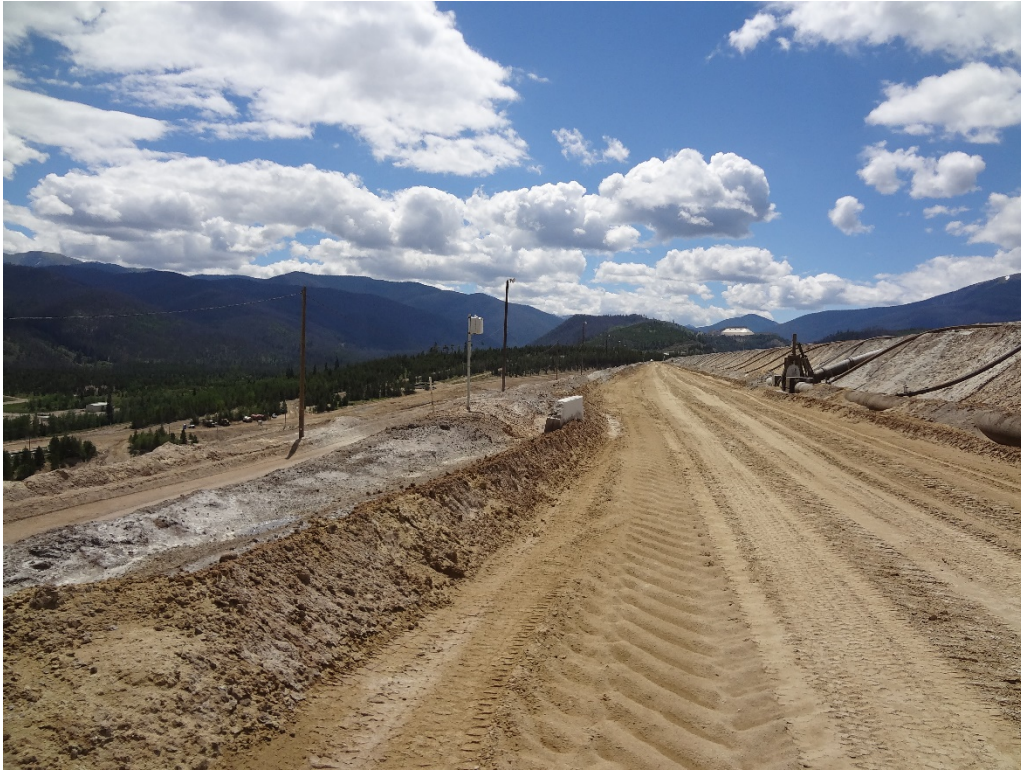
Current upper tailing impoundment road looking south

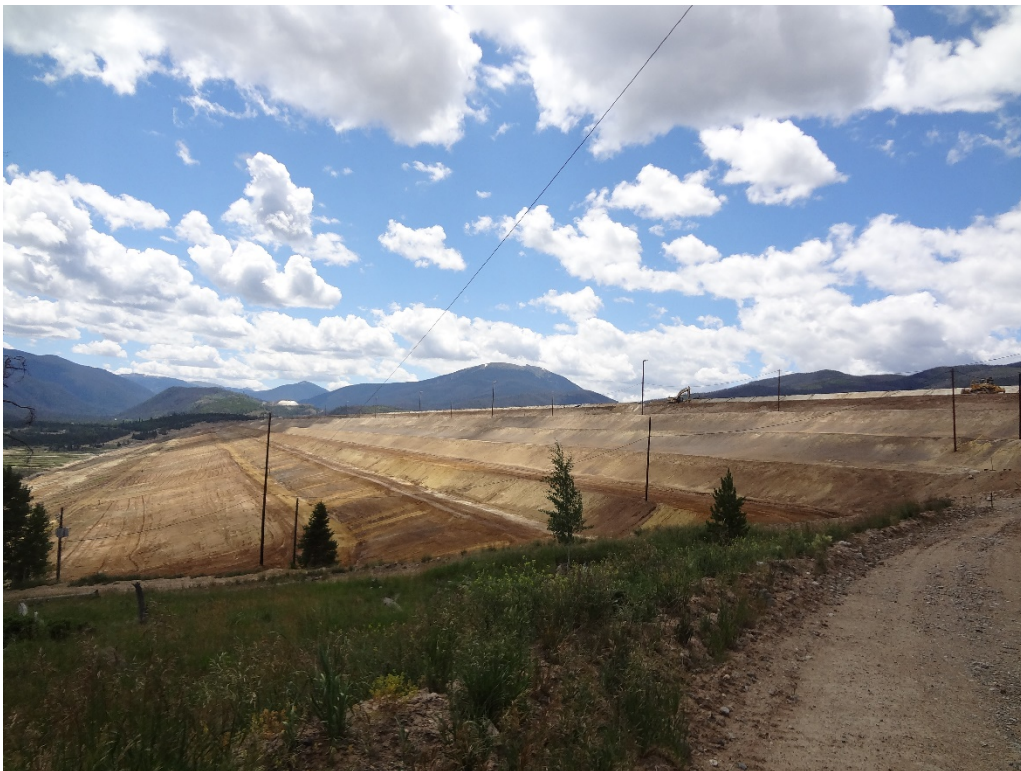
Face of 1-Dam from north end

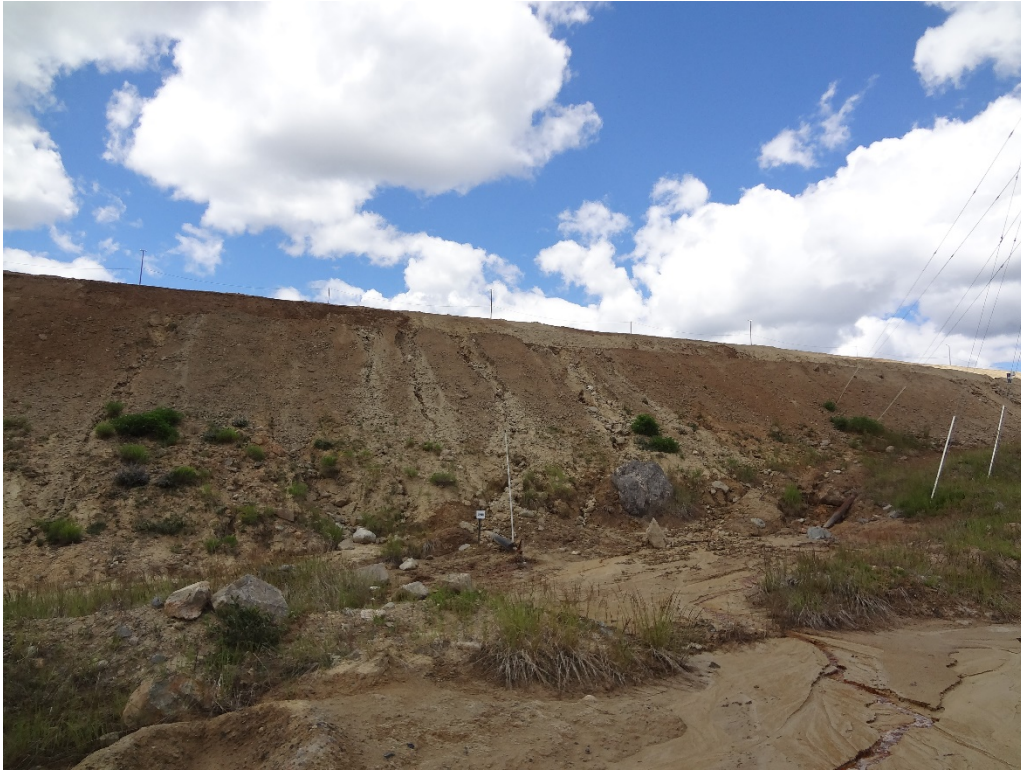
Typ. Horizontal drain in toe of 1-Dam

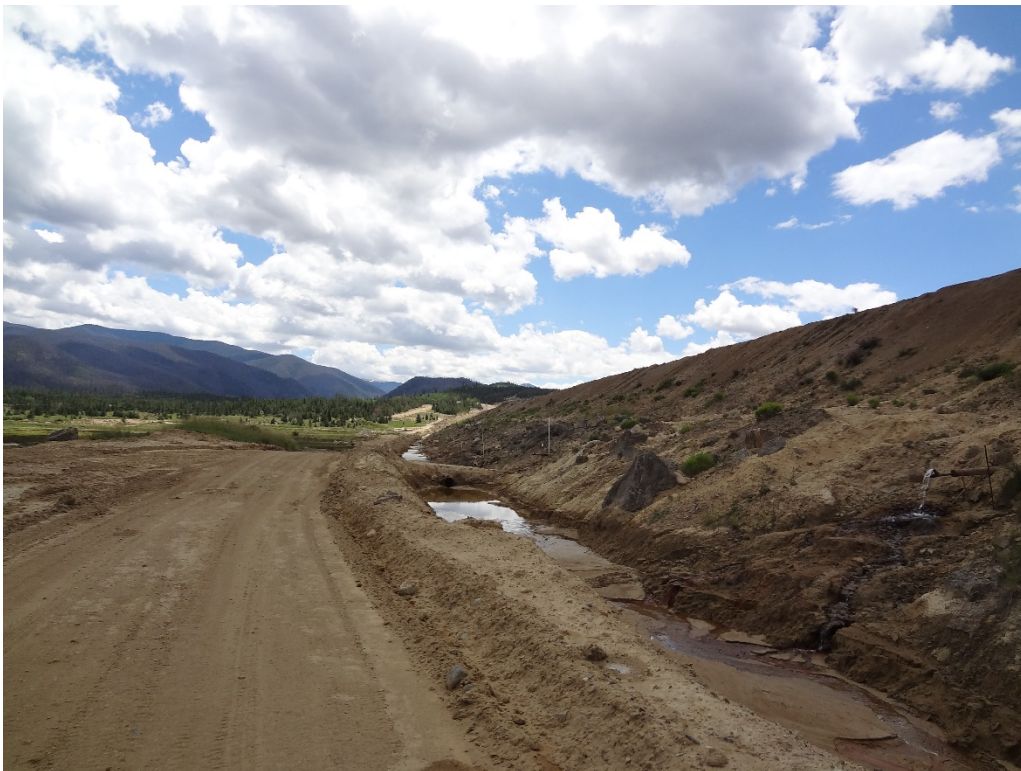
Toe ditch and horizontal drains at toe of 1-Dam

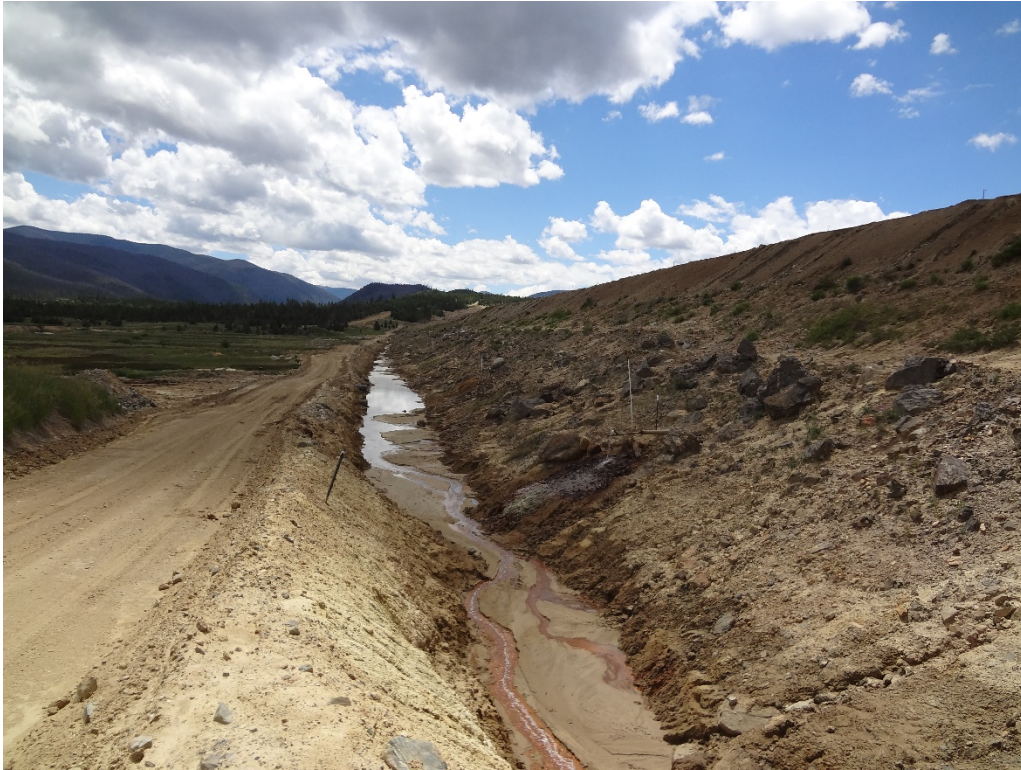
Toe ditch and horizontal drains at toe of 1-Dam

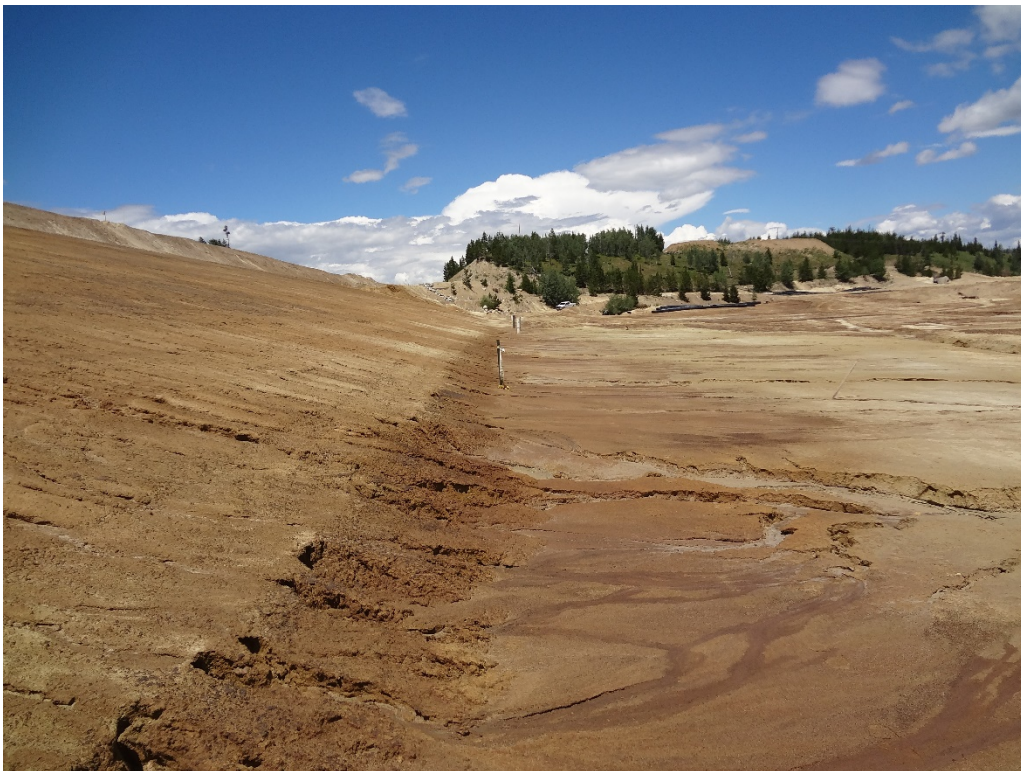
Toe of 3-Dam step looking south at piezometers
