MINERALS PROGRAM INSPECTION REPORT

MINE NAME: Disappointment Valle	MINE/PROSPECTING ID#: M-1980-038	MINERAL: Sand and gravel	COUNTY: San Miguel
INSPECTION TYPE: Multi Person Inspection	INSPECTOR(S): Lucas J. West	INSP. DATE: July 20, 2016	INSP. TIME: 14:00
OPERATOR: Ron Ebberts	OPERATOR REPRESENTATIVE: None	TYPE OF OPERATION: 110c - Construction Limited Impact	
REASON FOR INSPECTION: Normal I&E Program	BOND CALCULATION TYPE: Complete Bond	BOND AMOUNT: \$10,376.72	
DATE OF COMPLAINT: NA	POST INSP. CONTACTS: None	JOINT INSP. AGENCY: None	
WEATHER: Clear	INSPECTOR'S SIGNATURE:

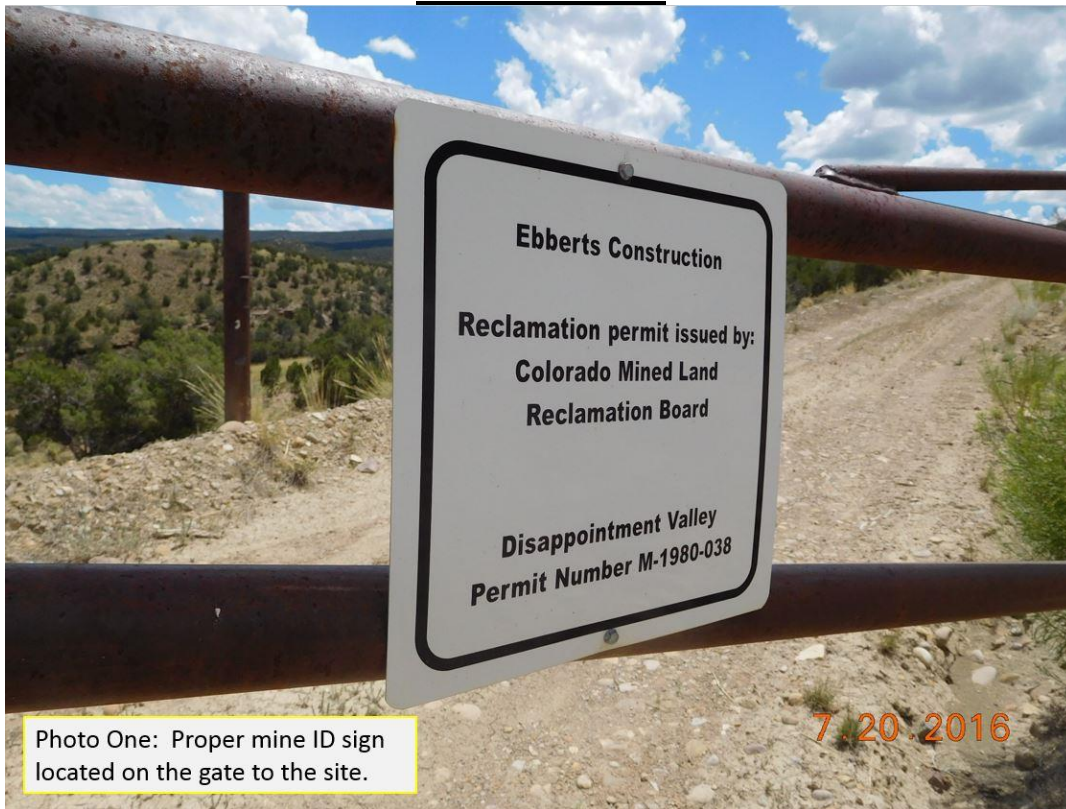
Photo One shows the proper mined identification sign located at the entrance to the site. The site was not active during the inspection and no operator representative was present during the inspection. The Operator was not contacted prior to the inspection, Division staff was in the area performing a separate inspection and visited the site while passing by. The permit boundaries were clearly marked with berms and all disturbance was contained within the boundaries. The site consists of 9.4 permitted acres with approximately 4 acres currently disturbed.

Photo One: Proper mine ID sign located on the gate to the site.

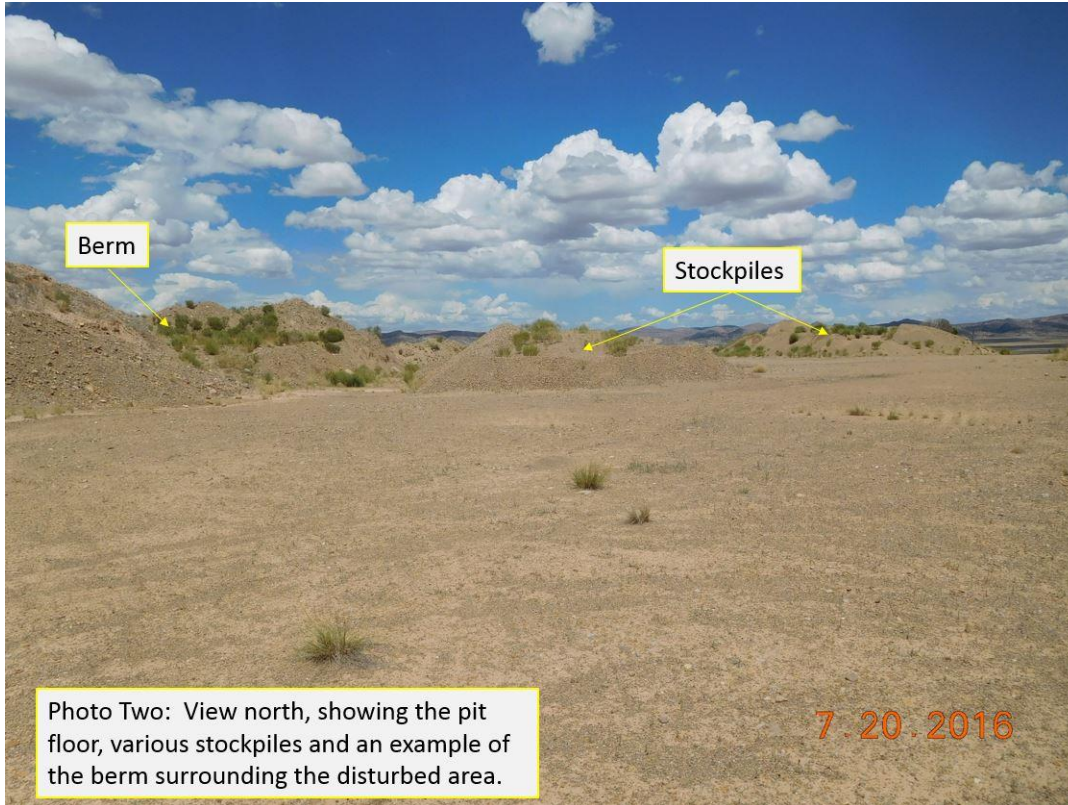
No equipment was observed during the inspection. Several small stockpiles were observed on the pit floor, as seen in Photo Two. All stockpiles located on site appeared to be stable and in good condition. The Mining face, a small highwall which is shown in Photo Three appeared to stable and in good condition. No fuel or hazardous materials were being stored on site.

Photo Two: View north, showing the pit floor, various stockpiles and an example of the berm surrounding the disturbed area.
