**COLORADO**Division of Reclamation,  
Mining and Safety

**MINERALS PROGRAM INSPECTION REPORT****PHONE: (303) 866-3567**

<b>MINE NAME:</b> Willis Pit	<b>MINE/PROSPECTING ID#:</b> M-1992-003	<b>MINERAL:</b> Sand and gravel	<b>COUNTY:</b> Huerfano
<b>INSPECTION TYPE:</b> Monitoring	<b>INSPECTOR(S):</b> Tyler V. O'Donnell	<b>INSP. DATE:</b> May 12, 2016	<b>INSP. TIME:</b> 15:30
<b>OPERATOR:</b> Silver Mountain Preserve, Inc.	<b>OPERATOR REPRESENTATIVE:</b> Tom Shaw	<b>TYPE OF OPERATION:</b> 110c - Construction Limited Impact	
<b>REASON FOR INSPECTION:</b> Normal I&E Program	<b>BOND CALCULATION TYPE:</b> Partial Bond	<b>BOND AMOUNT:</b> \$14,900.00	
<b>DATE OF COMPLAINT:</b> NA	<b>POST INSP. CONTACTS:</b> None	<b>JOINT INSP. AGENCY:</b> None	
<b>WEATHER:</b> Clear	<b>INSPECTOR'S SIGNATURE:</b>

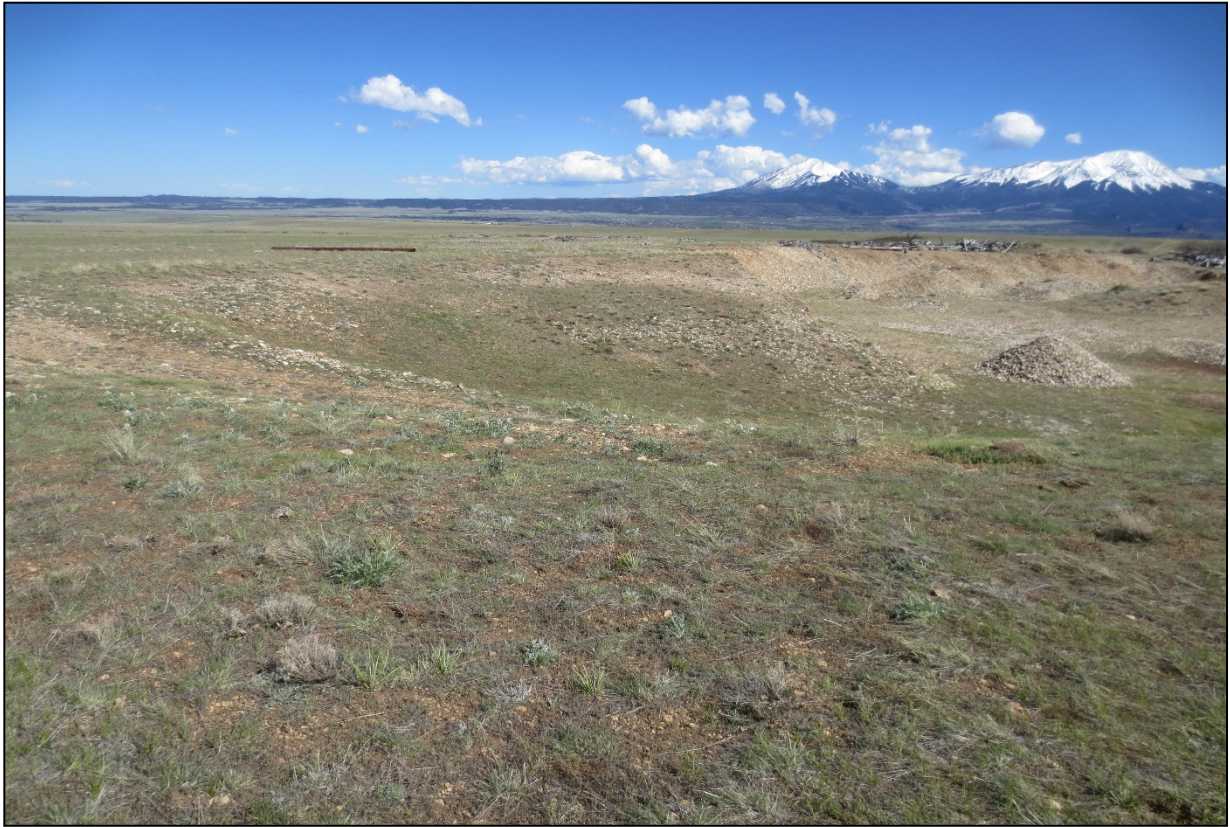
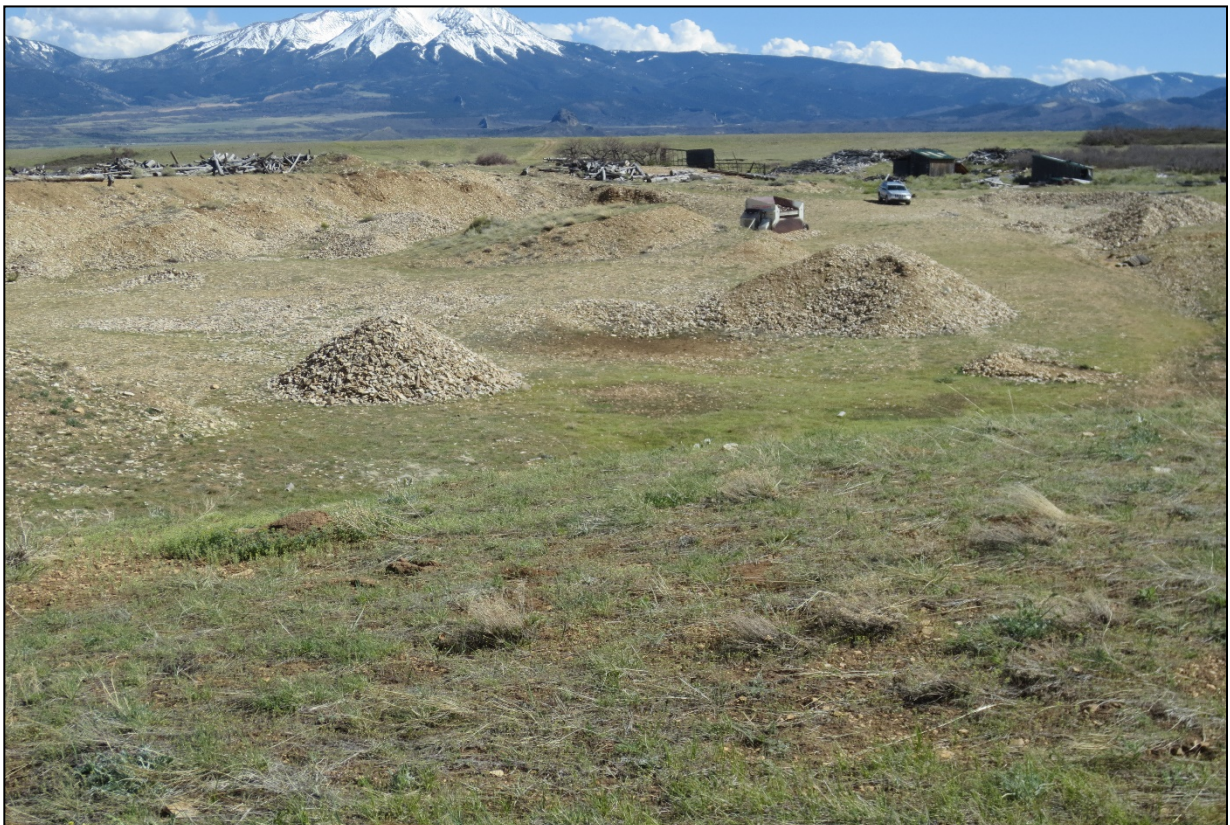
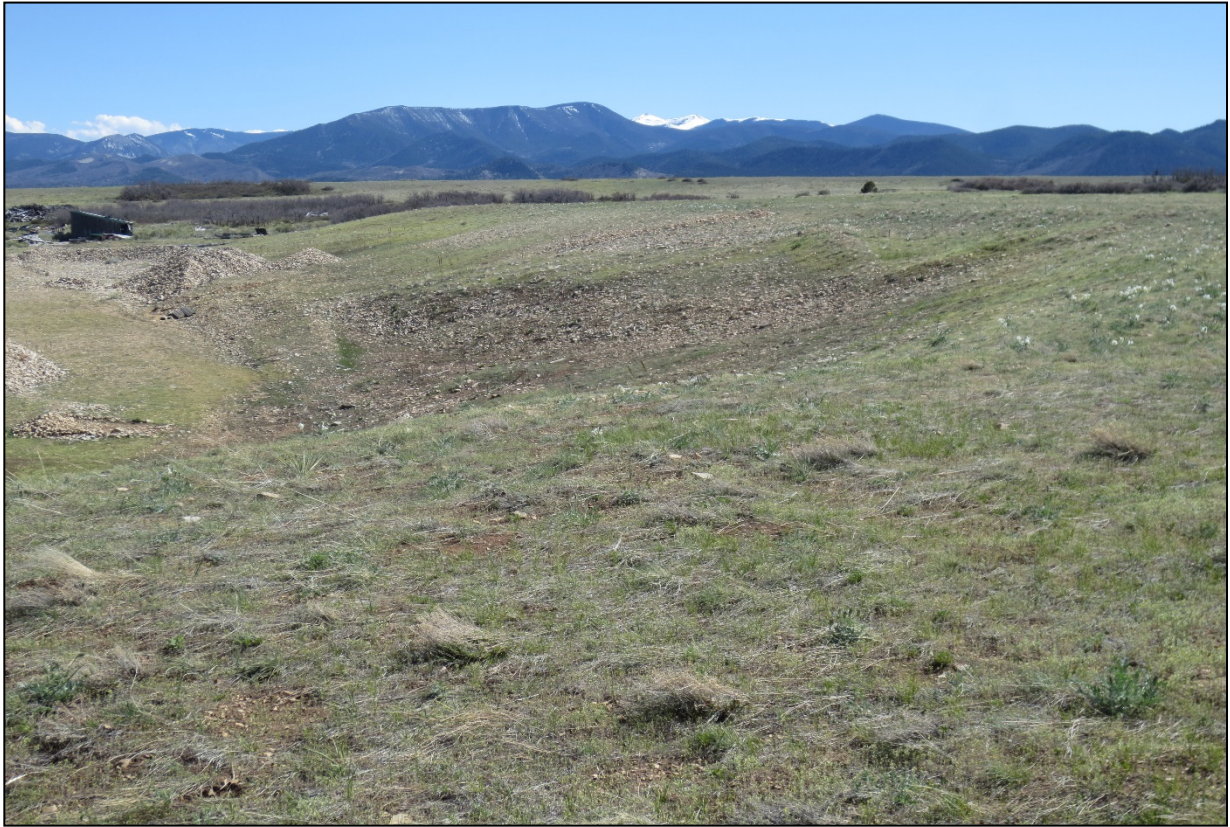
**PHOTOGRAPHS**

No problems or possible violations were observed during the inspection. During the inspection, the sky was clear and the ground was dry. The site has remained inactive for what appears to be a long period of time. At the present time it appears that the mining operation has affected approximately 4.5 acres throughout the life of mine. There were several stockpiles of product scattered around the pit floor. There was a small screen plant at the bottom of the pit floor. It appears that the mining operation was progressing to the east. The Operator has been conducting partial concurrent reclamation. The western pit slopes have been graded to 3H:1V or flatter, and have begun to fill in with desired vegetative cover. There was a highwall along the eastern side of the pit, the highwall was roughly 15 feet high. There was no evidence of excessive erosion. There appeared to be no significant impacts to the prevailing hydrologic balance. No noxious weeds were observed. The reclamation cost estimate for this site was updated during the file review for this inspection. It was determined that the current required financial warranty amount is adequate.
