MINERALS PROGRAM INSPECTION REPORT

MINE NAME: McEndaffer Mine	MINE/PROSPECTING ID#: M-2010-034	MINERAL: Borrow material	COUNTY: Weld
INSPECTION TYPE: Preoperation Inspection	INSPECTOR(S): Peter S. Hays	INSP. DATE: August 2, 2016	INSP. TIME: 10:15
OPERATOR: Syzygy Enterprises LLC	OPERATOR REPRESENTATIVE: Jim McFarland	TYPE OF OPERATION: 110c - Construction Limited Impact	
REASON FOR INSPECTION: Pre-Operation Inspection	BOND CALCULATION TYPE: None	BOND AMOUNT: \$17,000.00	
DATE OF COMPLAINT: NA	POST INSP. CONTACTS: None	JOINT INSP. AGENCY: None	
WEATHER: Clear	INSPECTOR'S SIGNATURE:

August 2, 2016
Pre-Operational Inspection Map
M-2010-034

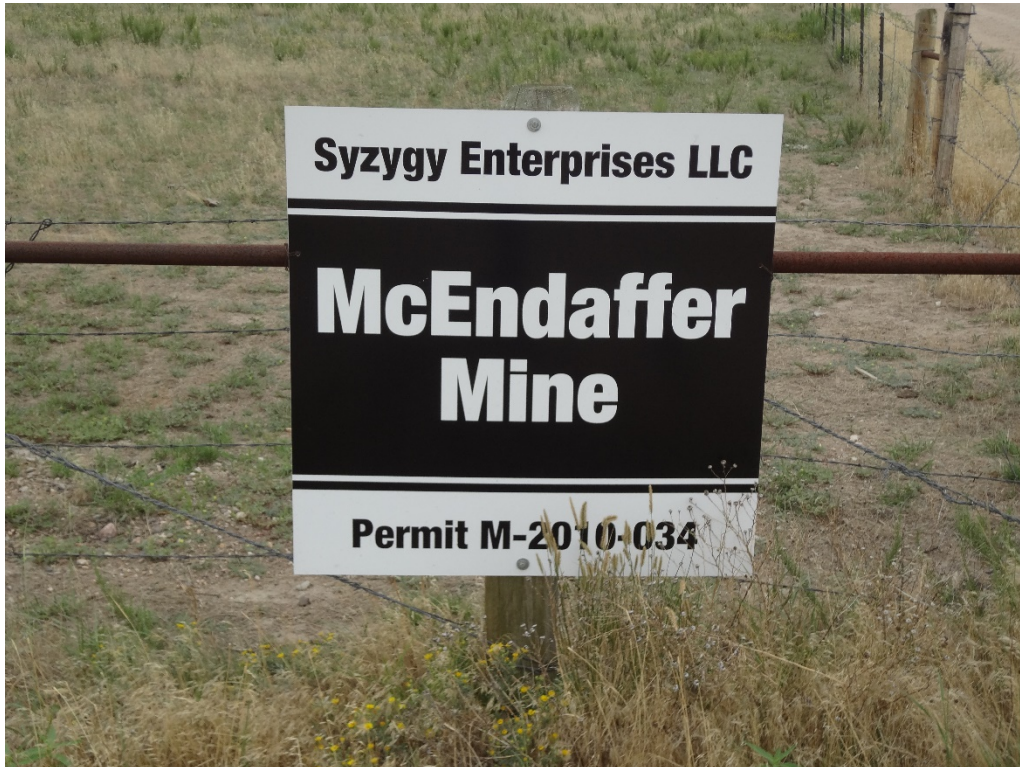
McEndaffer Mine sign

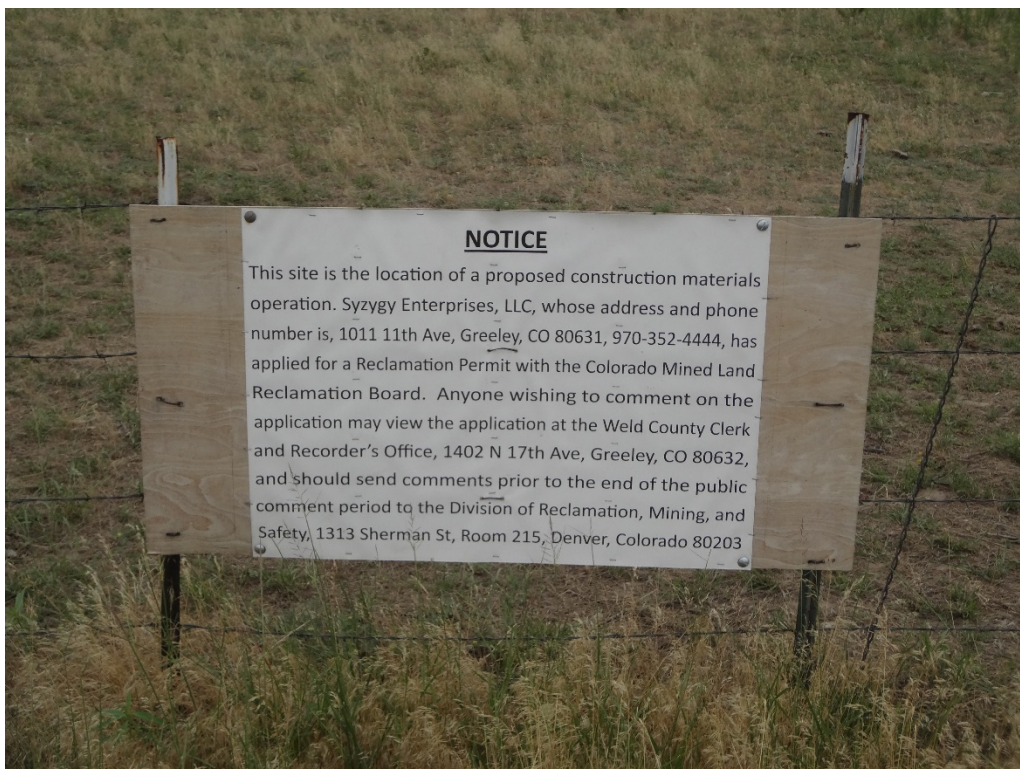
The 110c to 112c construction materials permit application was received by the Division on April 7, 2016. The application was deemed complete on June 21, 2016. The decision due date is September 19, 2016. The Applicant published public notice as required by Rule 1.6.2(d) for four consecutive weeks. The last notice was published on July 16, 2016. The public comment for the application ended on August 5, 2016. No objections were received by the Division during the public comment period. The notice sign was observed during the inspection as required by Rule 1.6.2(b).

Conversion application notice sign

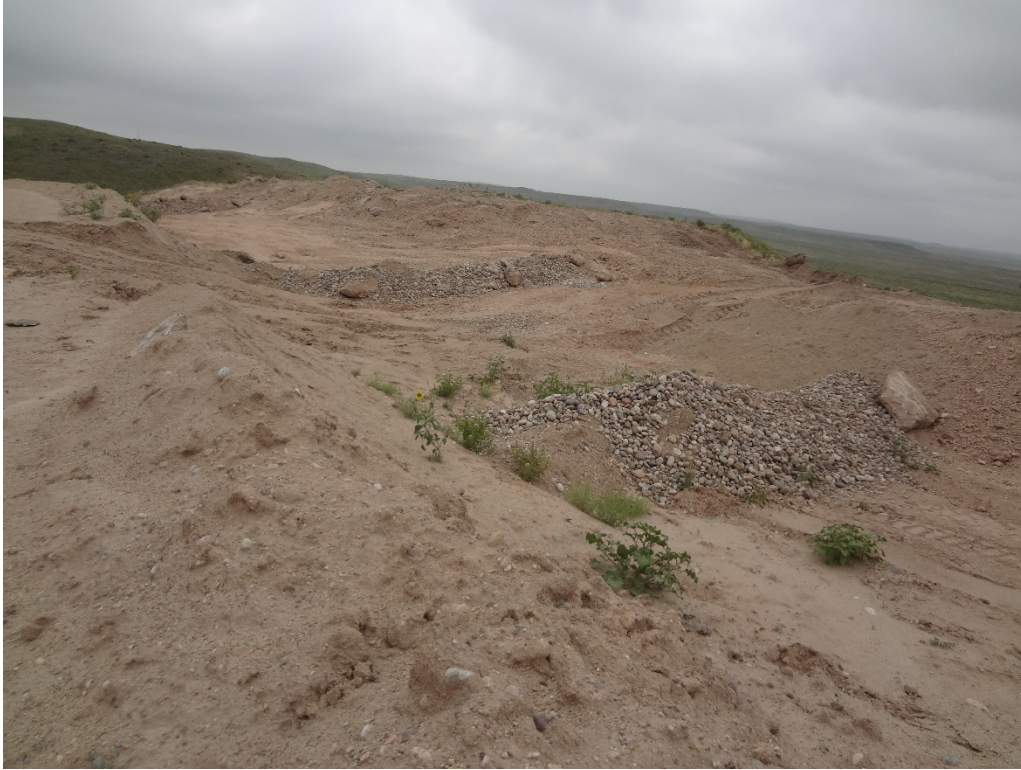
Three problems were cited during the October 1, 2015 inspection for lack of affected area boundary markers, land being affected outside the approved permit boundary by the construction of the scale house and erosion gullies along the east side of the site. The erosion features have been repaired and erosion control structures were constructed by the Operator. All erosion disturbance is contained within the new conversion permit boundary. The Operator has installed new boundary markers for the conversion area and included the scale house disturbance into the conversion application. All three problems will be resolved with the issuance of the conversion application.

Erosion control structures along northeast pit floor

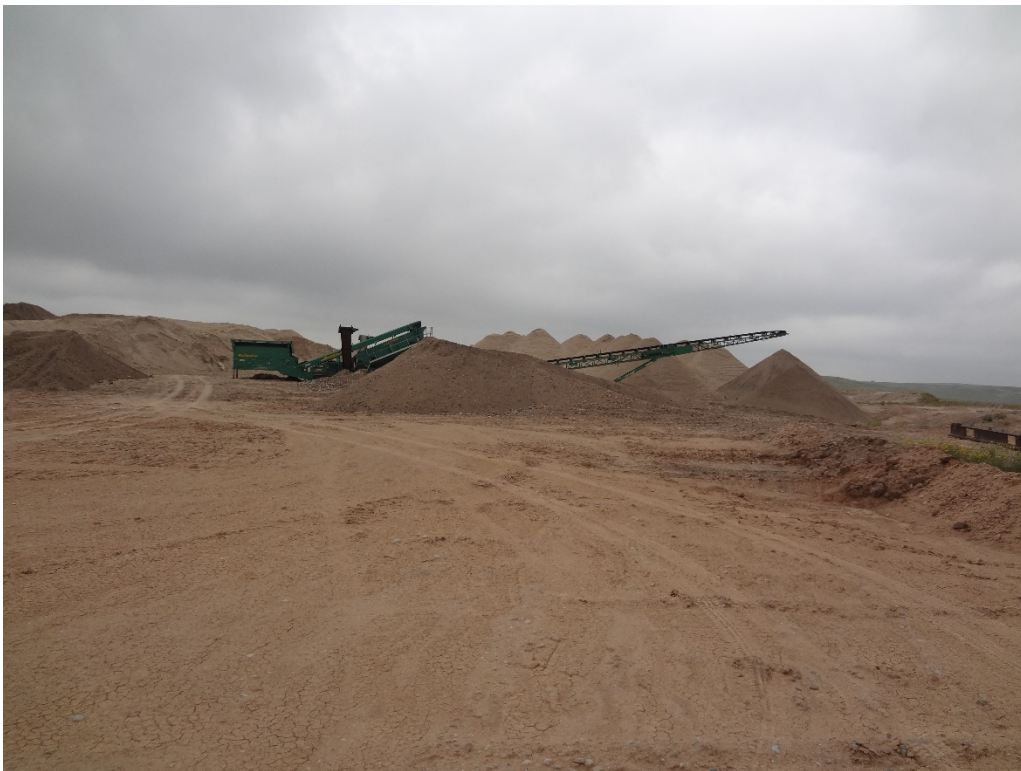
The Operator is screening the current topsoil stockpiles to remove the rock. The Operator estimated 2000 to 2500 tons of material will be screened and stockpiled. The screened topsoil from the current 9.9 acre site will be placed in the southeast corner of the site. The Operator was remind of the requirement to vegetation the stockpile to prevent erosion. The Operator intends to screen the topsoil stripped from the conversion area and stockpile the topsoil in the northwest corner of the pit floor. The south end of the existing mine area has been regraded since the previous inspection. An erosion control berm was constructed around the perimeter of the area. The Operator stated the area would be topsoiled and seeded this fall.

Topsoil screening plant and stockpiles

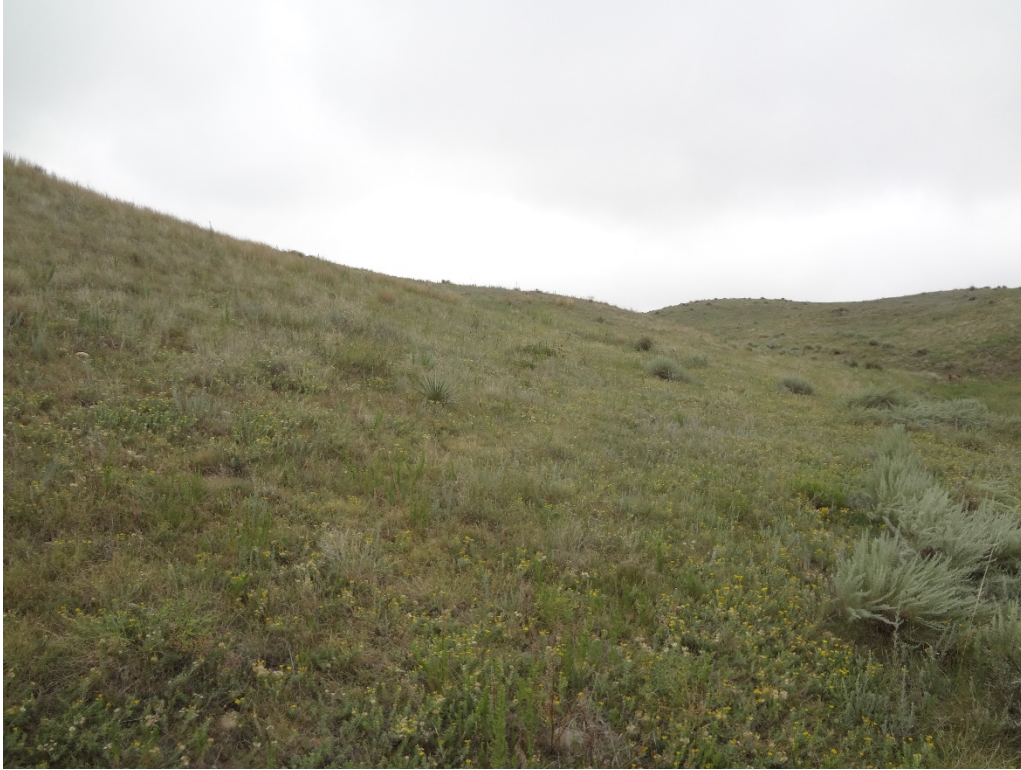
View of rangeland from post north of pit entrance

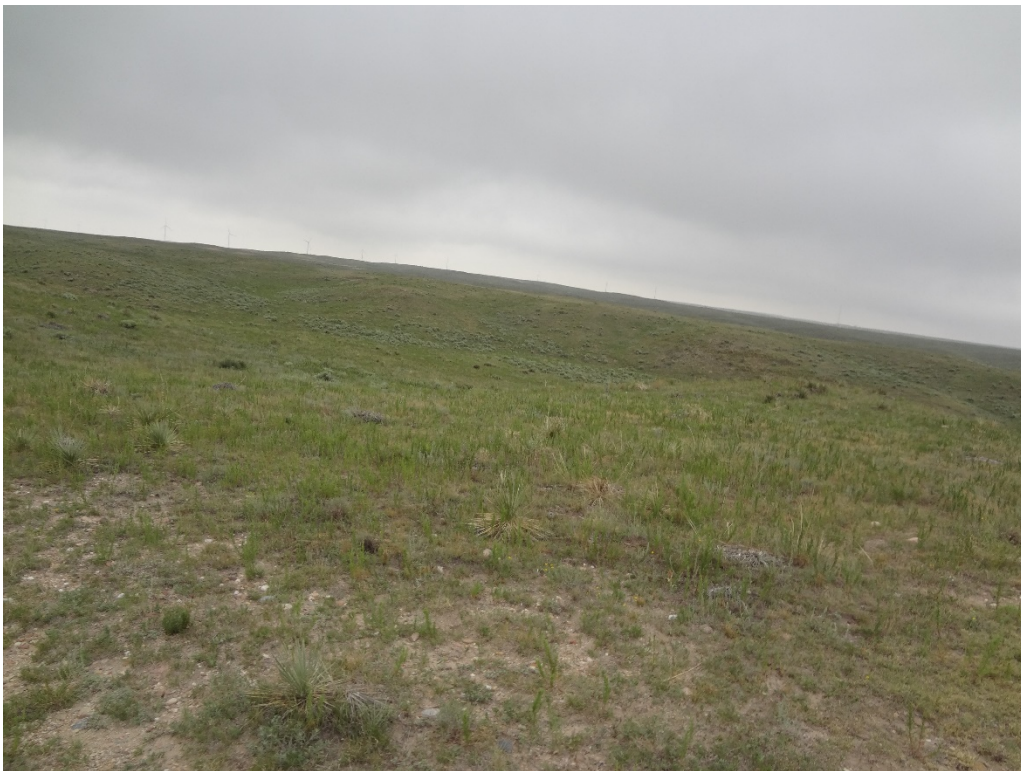
View of rangeland from NW corner looking northeast

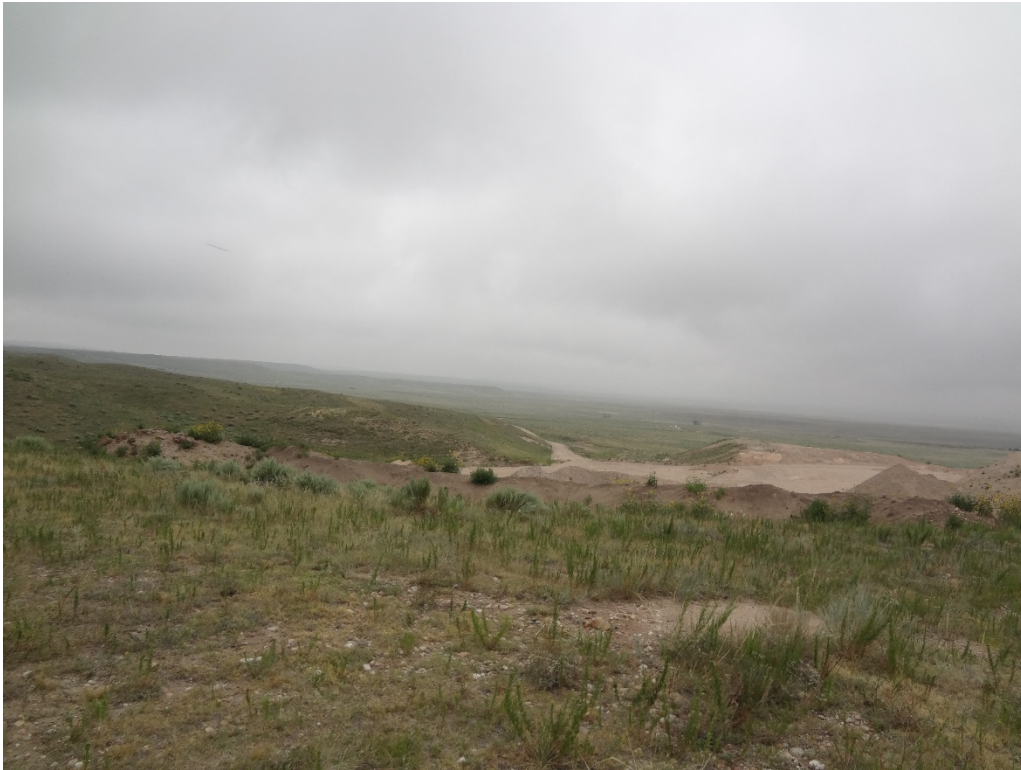
View of rangeland and current mine site from NW corner looking east

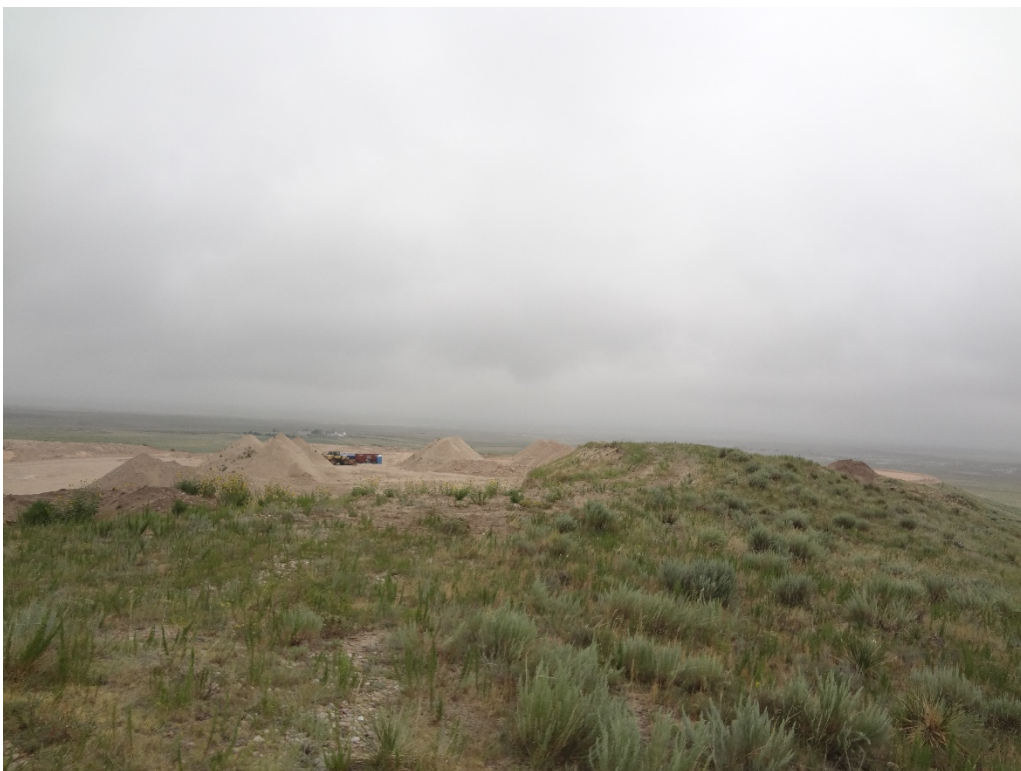
View of rangeland and current mine site from NW corner looking southeast

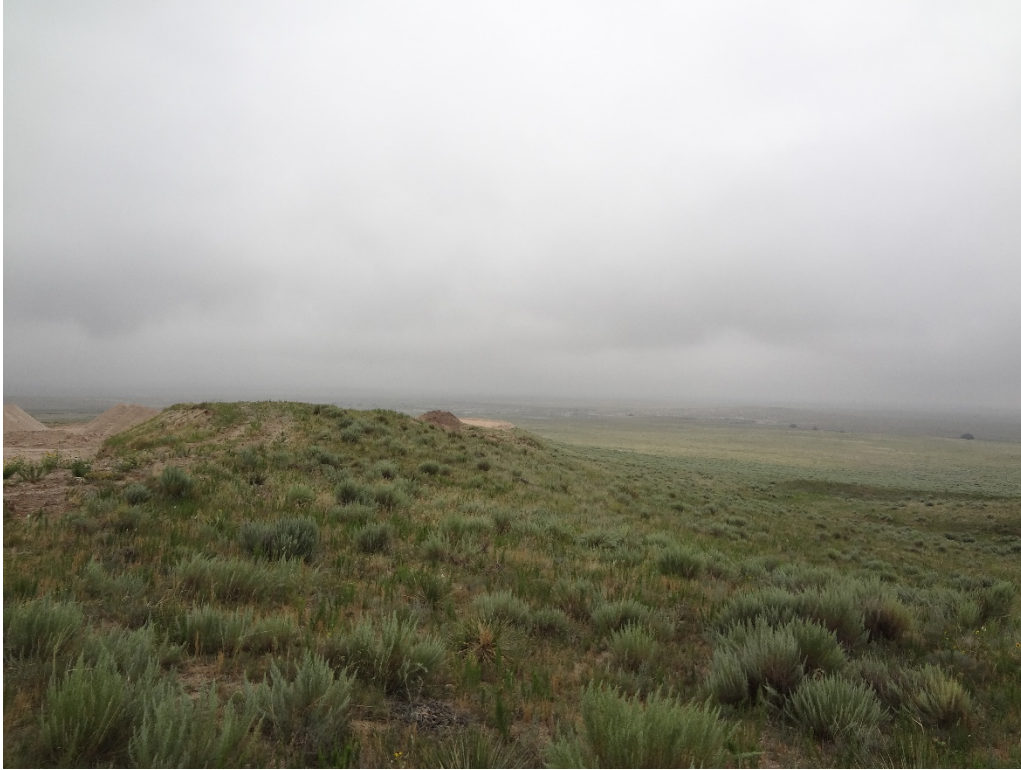
View of rangeland and current mine site from NW corner looking south

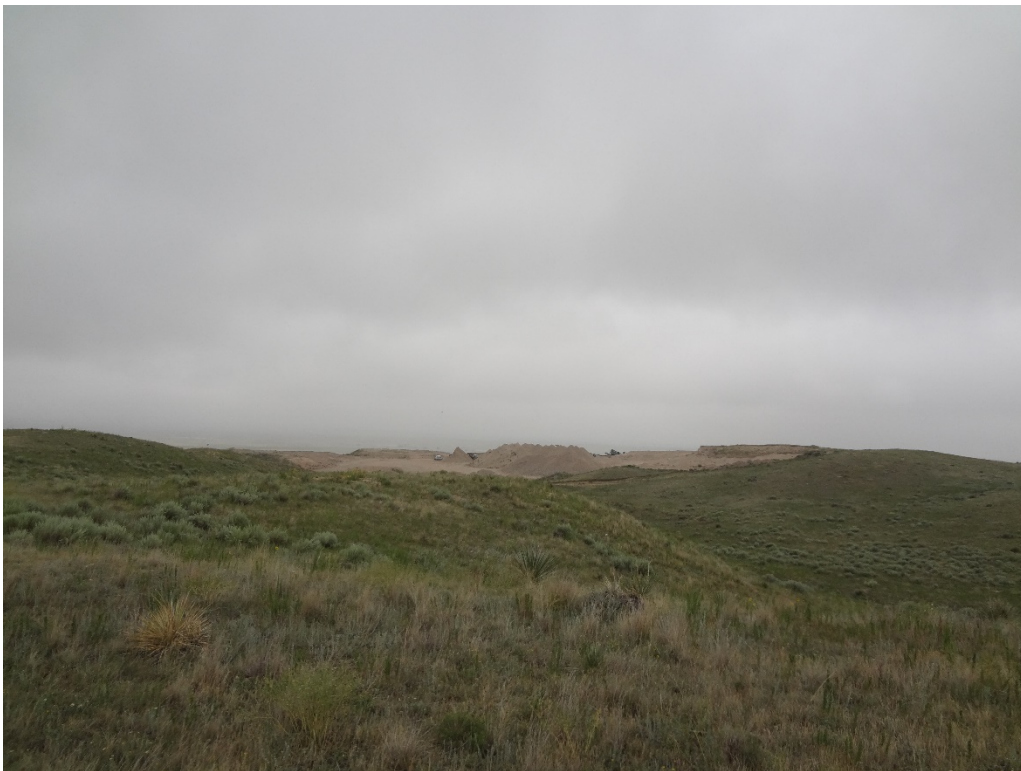
View of rangeland and current mine site from north corner looking south
