MINERALS PROGRAM INSPECTION REPORT

MINE NAME: Skoglund Pit	MINE/PROSPECTING ID#: M-1996-089	MINERAL: Sand and gravel and	COUNTY: Saguache
INSPECTION TYPE: Multi Person Inspection	INSPECTOR(S): Lucas J. West, Amy Yeldell	INSP. DATE: August 11, 2016	INSP. TIME: 09:00
OPERATOR: Skoglund Excavating Inc.	OPERATOR REPRESENTATIVE: Ken Skoglund	TYPE OF OPERATION: 112c - Construction Regular Operation	
REASON FOR INSPECTION: Normal I&E Program	BOND CALCULATION TYPE: Complete Bond	BOND AMOUNT: \$20,000.00	
DATE OF COMPLAINT: NA	POST INSP. CONTACTS: None	JOINT INSP. AGENCY: None	
WEATHER: Clear	INSPECTOR'S SIGNATURE:

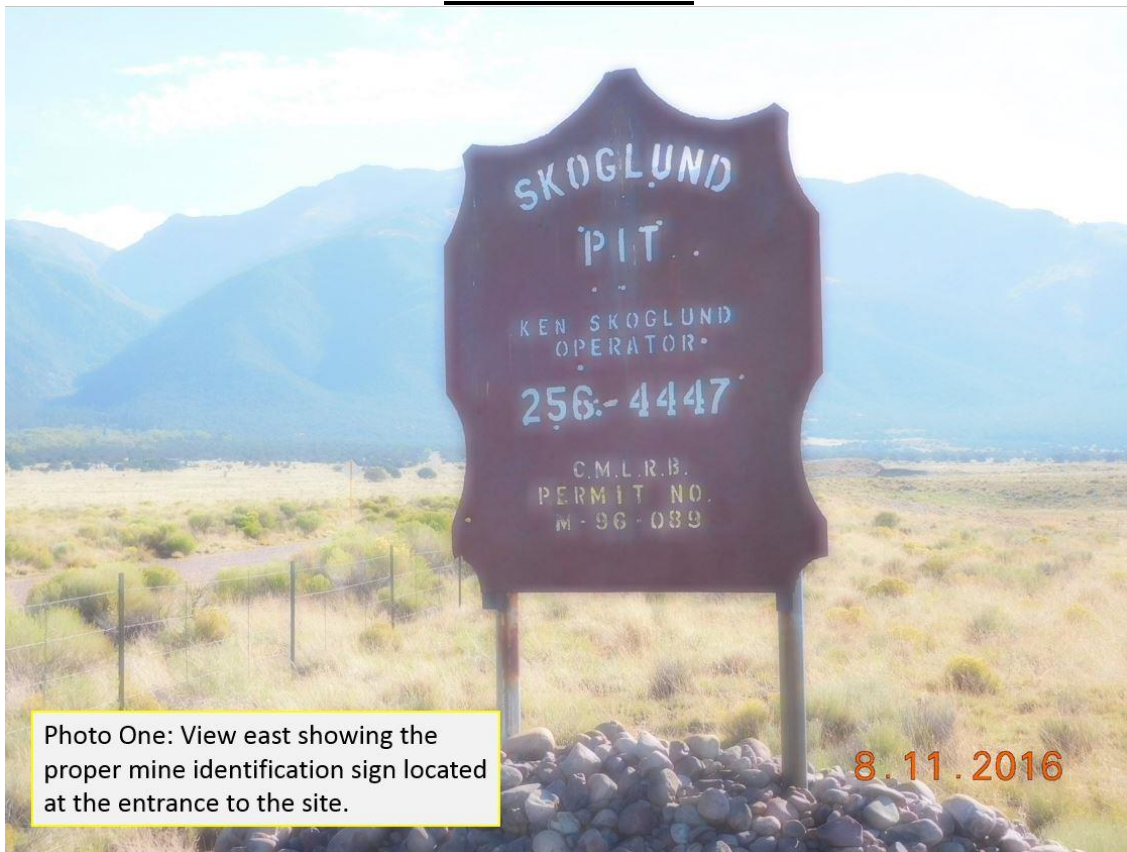
The site was not active during the inspection. Some equipment including a crusher and conveyors were noted on site. Proper mine identification signage was observed at the entrance to the site, shown in Photo One, and the permit boundaries were clearly marked with a fence. All disturbance was contained within the permit boundaries. The operator is conducting contemporaneous reclamation by sloping and revegetating all previously mined areas. Photos Two and Three show areas that have been previously mined, and reclaimed. All areas of reclamation appear to be stable with adequate sloping and young vegetation. Evidence of semi recent drill seeding was noted on the reclaimed areas. The operator has an active weed management plan and evidence of chemical treatment of noxious weeds within the disturbed area was noted.

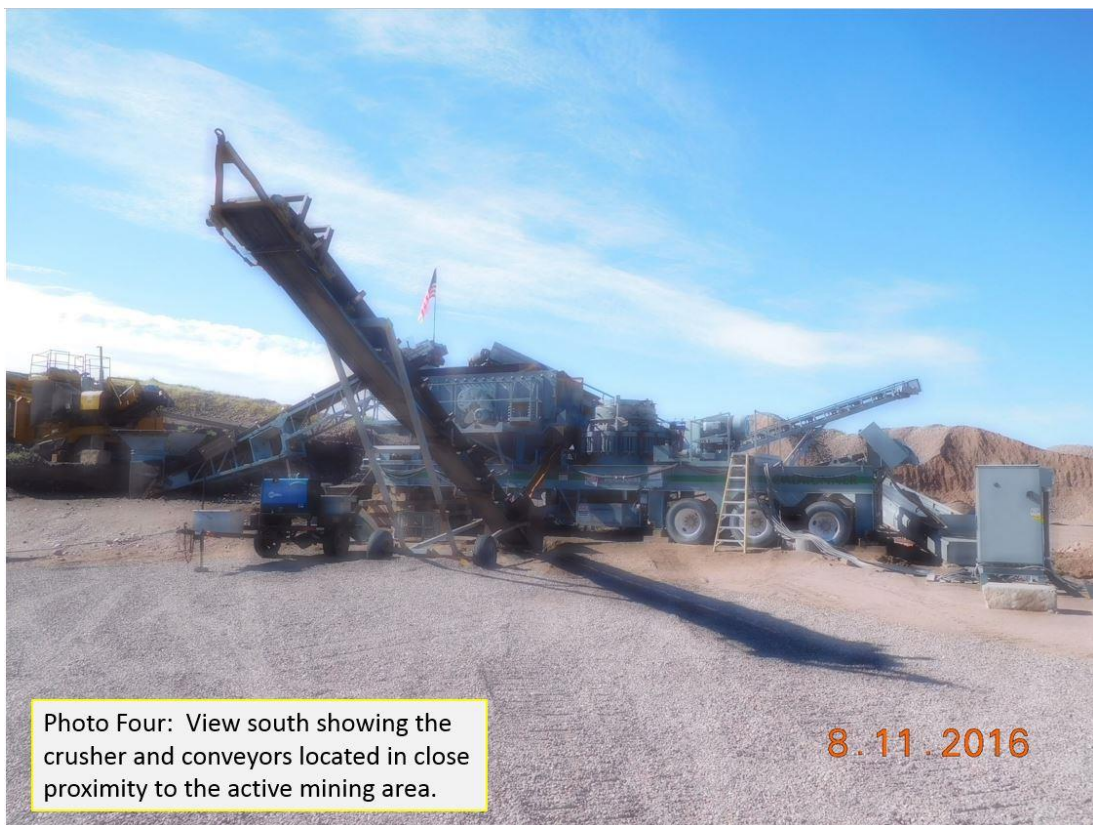
The active mining area consists of a small highwall with an average height of approximately 20 feet. The crusher and conveyors are located in close proximity to active area to minimize the footprint of the site as seen in Photo Four. Several stockpiles of various sized materials were noted on the pit floor, including several small, strategically placed topsoil stockpiles to streamline the reclamation process. All stockpiles located on the pit floor appeared to be stable and in good condition. Photo Five shows an elevated view of the site, showing all of the stockpiles, active mining area and sections of reclaimed area. A small pad area to the south of the pit floor is being used as a lay down area / metal scrap storage. All items being stored in this area are organized and in good order. All fuel containers had proper secondary containers including the tow-behind fuel tank have proper secondary containment devices in place.
