MINERALS PROGRAM INSPECTION REPORT
PHONE: (303) 866-3567

MINE NAME: 5 Mile Pit	MINE/PROSPECTING ID#: M-2016-026	MINERAL: Sand and gravel	COUNTY: Garfield
INSPECTION TYPE: Preoperation Inspection	INSPECTOR(S): Amy C. Yeldell	INSP. DATE: August 3, 2016	INSP. TIME: 08:00
OPERATOR: Elam Construction, Inc.	OPERATOR REPRESENTATIVE: Jon Muller	TYPE OF OPERATION: 112c - Construction Regular Operation	
REASON FOR INSPECTION: Preoperation Inspection	BOND CALCULATION TYPE: None	BOND AMOUNT: No Bond Held	
DATE OF COMPLAINT: NA	POST INSP. CONTACTS:	JOINT INSP. AGENCY: None	
WEATHER: Clear	INSPECTOR'S SIGNATURE:

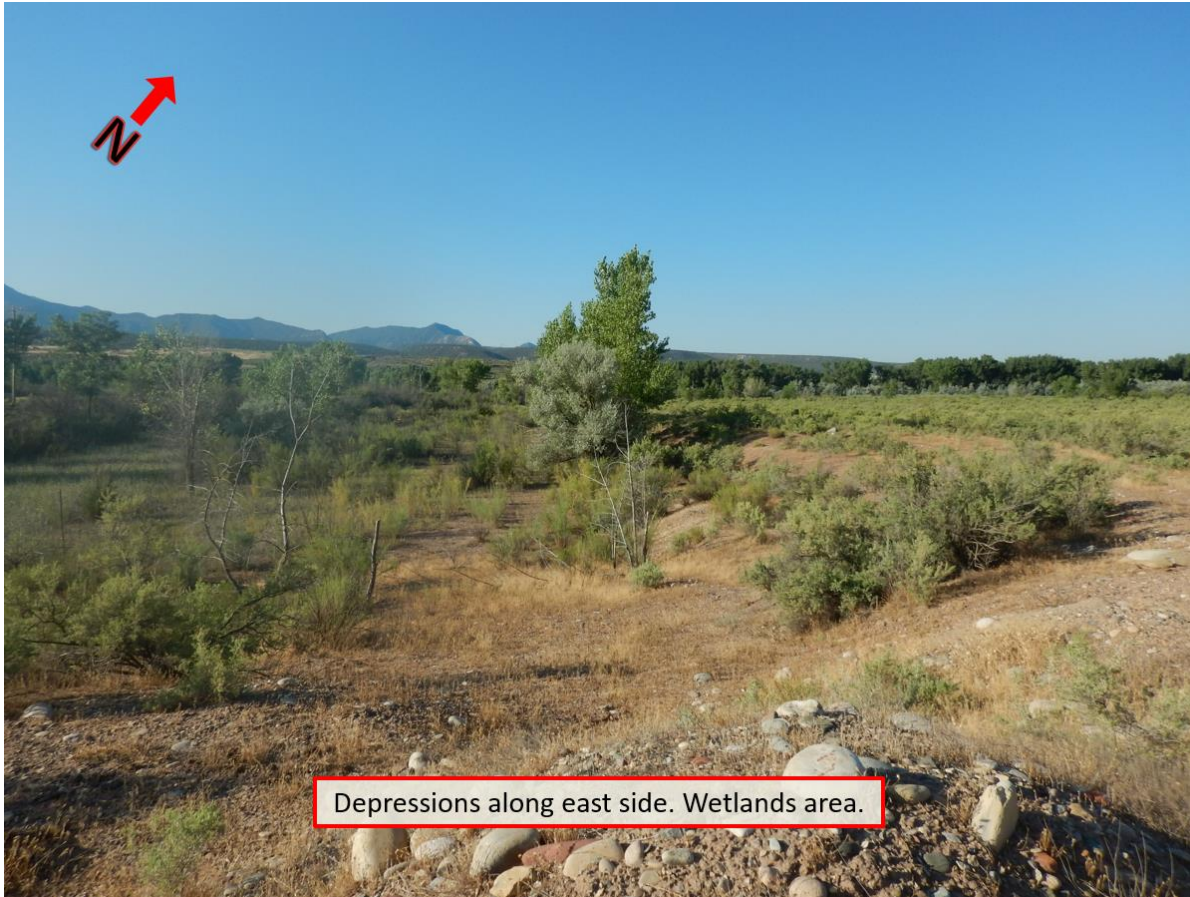
Some of the depressions along the east side are considered to be wetlands. Additional wetlands are located in the southern portion adjacent to the river where there is evidence that the river has overtopped the banks and flooded.

Depressions along east side. Wetlands area.

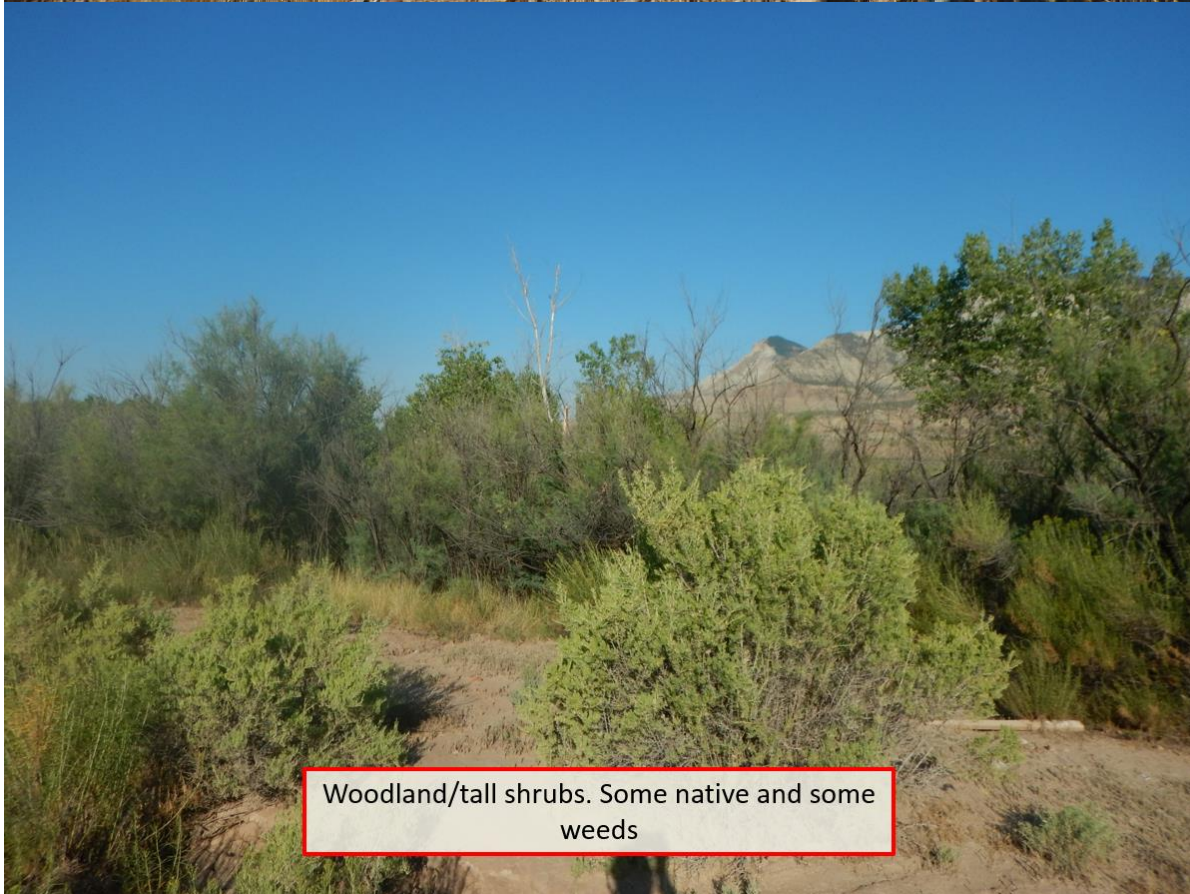
Woodland/tall shrubs. Some native and some weeds
