MINERALS PROGRAM INSPECTION REPORT
PHONE: (303) 866-3567

MINE NAME: Funk & Hooker Pit	MINE/PROSPECTING ID#: M-1979-058	MINERAL: Sand and gravel	COUNTY: Routt
INSPECTION TYPE: Monitoring	INSPECTOR(S): Amy C. Yeldell	INSP. DATE: August 16, 2016	INSP. TIME: 11:00
OPERATOR: Routt County	OPERATOR REPRESENTATIVE: Tanner Carolus & Wes Williams	TYPE OF OPERATION: 112c - Construction Regular Operation	
REASON FOR INSPECTION: Normal I&E Program	BOND CALCULATION TYPE: None	BOND AMOUNT: No Bond Held	
DATE OF COMPLAINT: NA	POST INSP. CONTACTS:	JOINT INSP. AGENCY:	
WEATHER: Clear	INSPECTOR'S SIGNATURE:

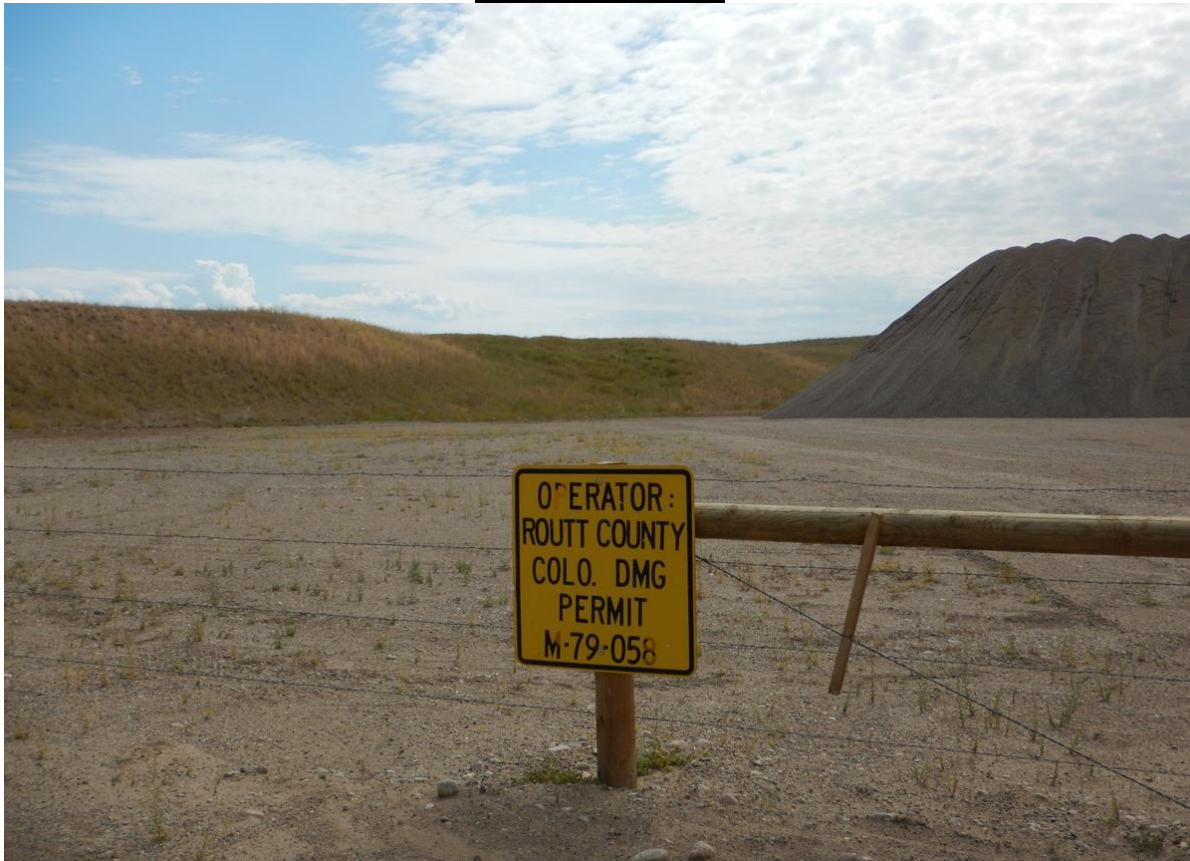
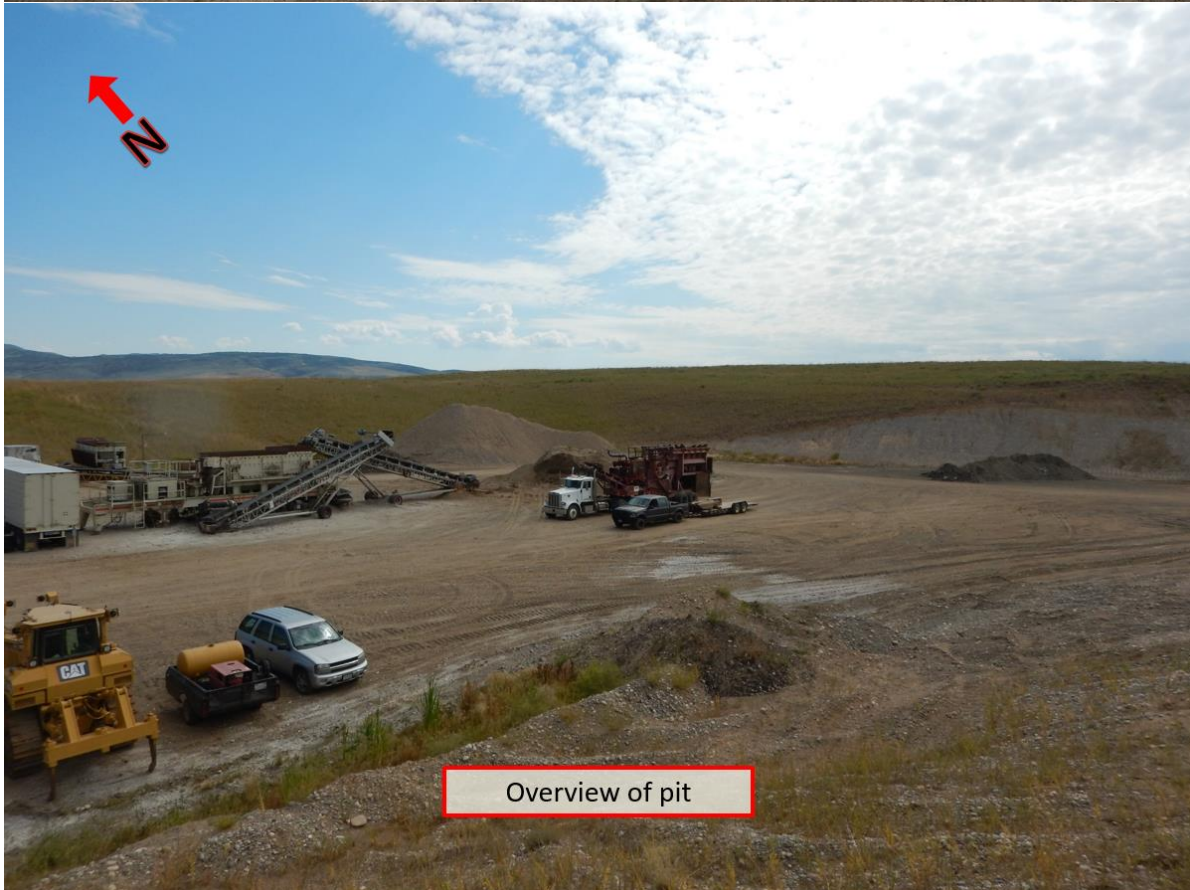
Overview of pit
