MINERALS PROGRAM INSPECTION REPORT
PHONE: (303) 866-3567

MINE NAME: Big Red Park	MINE/PROSPECTING ID#: M-2014-038	MINERAL: Gravel	COUNTY: Routt
INSPECTION TYPE: Monitoring	INSPECTOR(S): Amy C. Yeldell	INSP. DATE: August 16, 2016	INSP. TIME: 12:45
OPERATOR: Routt County	OPERATOR REPRESENTATIVE: Tanner Carolus and Wes Williams	TYPE OF OPERATION: 110c - Construction Limited Impact	
REASON FOR INSPECTION: Normal I&E Program	BOND CALCULATION TYPE: None	BOND AMOUNT: \$0.00	
DATE OF COMPLAINT: NA	POST INSP. CONTACTS:	JOINT INSP. AGENCY: None	
WEATHER: Clear	INSPECTOR'S SIGNATURE:

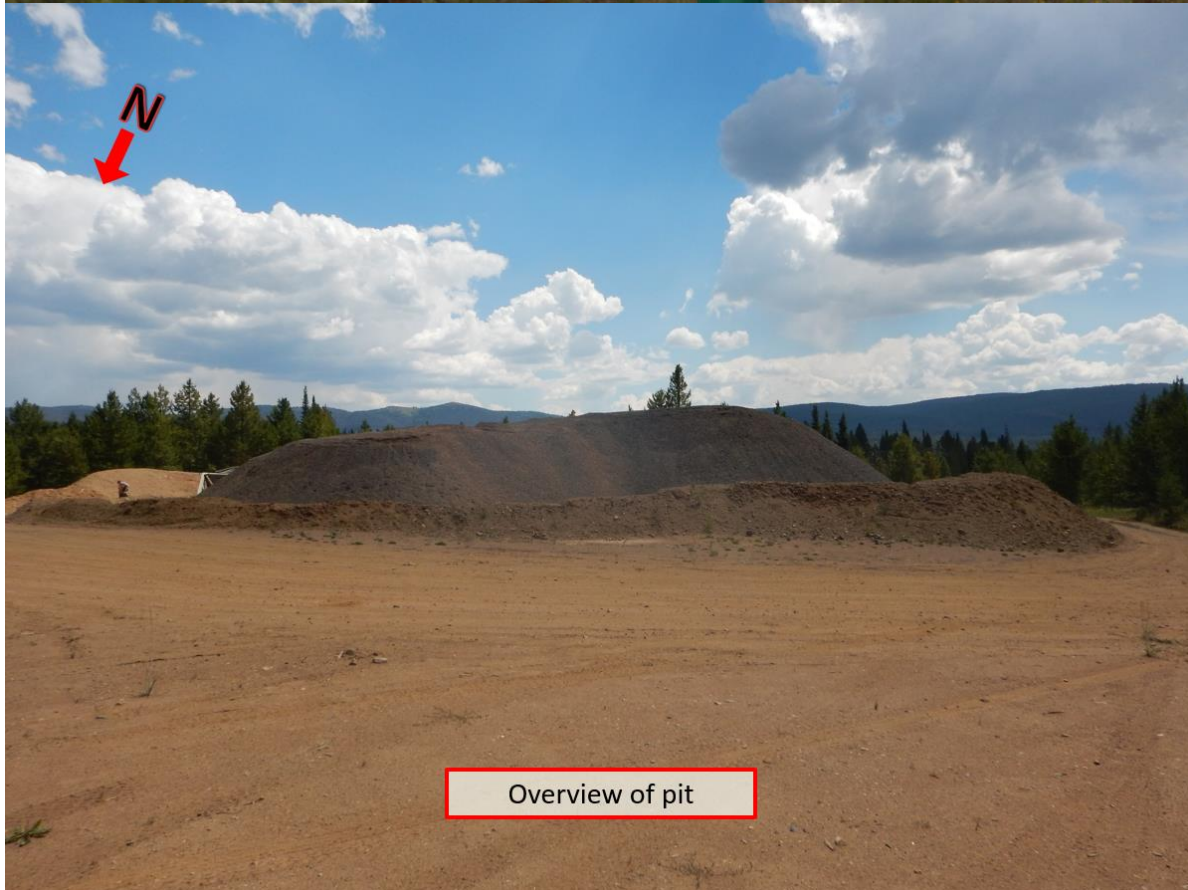
Overview of pit

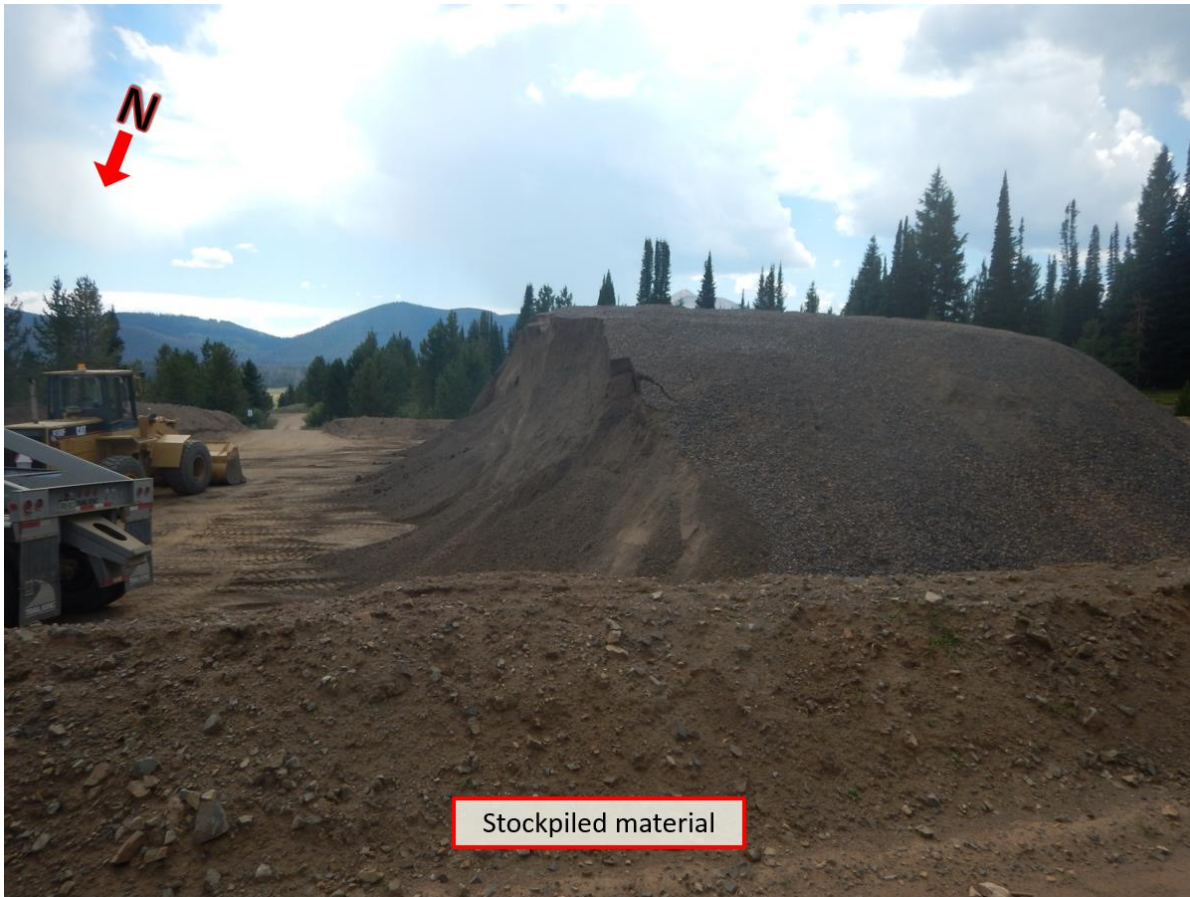
The pit was active at the time of the inspection. A loader and haul trucks were observed. Trucks were actively being loaded during the inspection. There is a large stockpile of crushed material located on the pit floor.

Stockpiled material

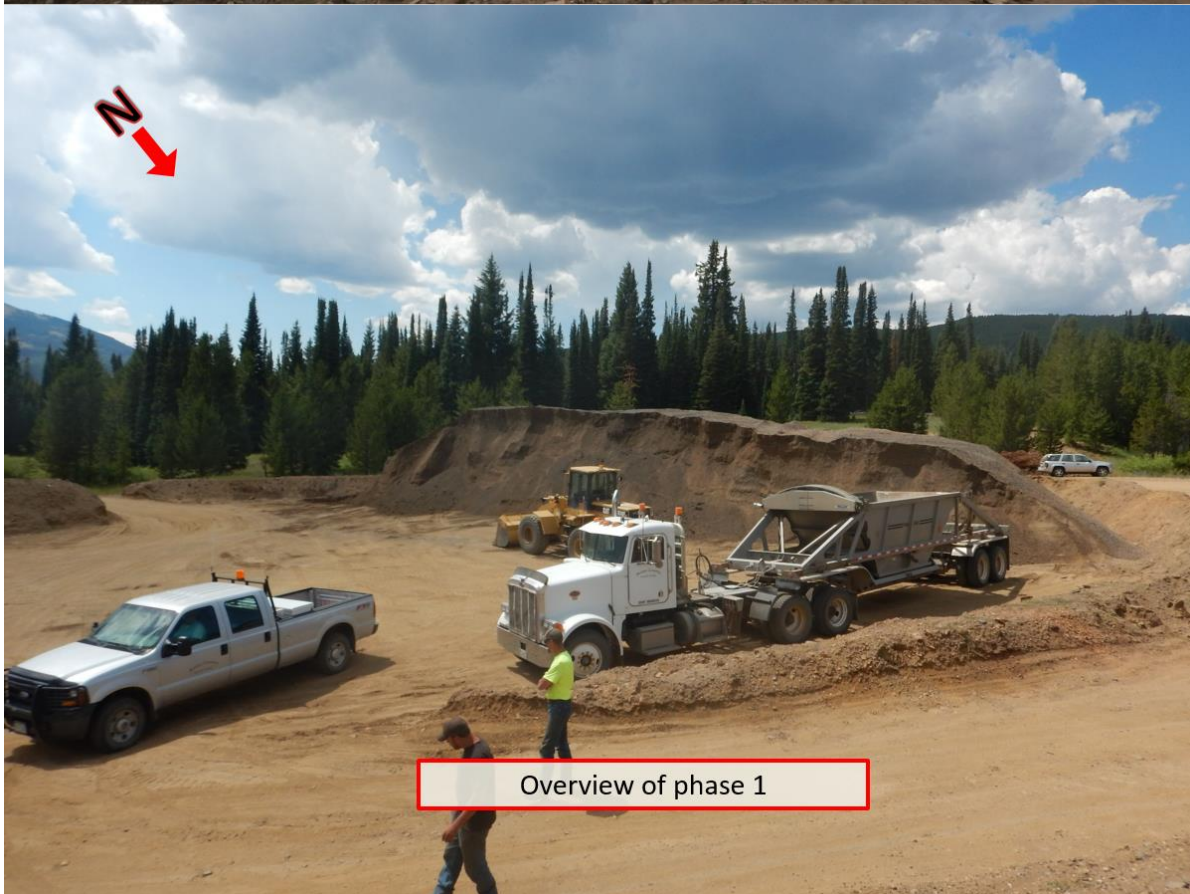
The mine identification sign is in place and in compliance with Rule 3.1.12. The mine sign is located at the main entrance. The phase 1 boundary is delineated by where the trees have been cleared. No actual permit markers were delineated. Prior to moving onto the next phase the permit boundary shall be delineated by markers.

Overview of phase 1
