MINERALS PROGRAM INSPECTION REPORT
PHONE: (303) 866-3567

MINE NAME: Fetcher/Vale Pit	MINE/PROSPECTING ID#: M-2002-119	MINERAL: Sand and gravel	COUNTY: Routt
INSPECTION TYPE: Monitoring	INSPECTOR(S): Amy C. Yeldell	INSP. DATE: August 16, 2016	INSP. TIME: 14:15
OPERATOR: Elam Construction, Inc.	OPERATOR REPRESENTATIVE: Jon Muller	TYPE OF OPERATION: 112c - Construction Regular Operation	
REASON FOR INSPECTION: Normal I&E Program	BOND CALCULATION TYPE: Complete Bond	BOND AMOUNT: \$171,100.00	
DATE OF COMPLAINT: NA	POST INSP. CONTACTS:	JOINT INSP. AGENCY: None	
WEATHER: Cloudy	INSPECTOR'S SIGNATURE:

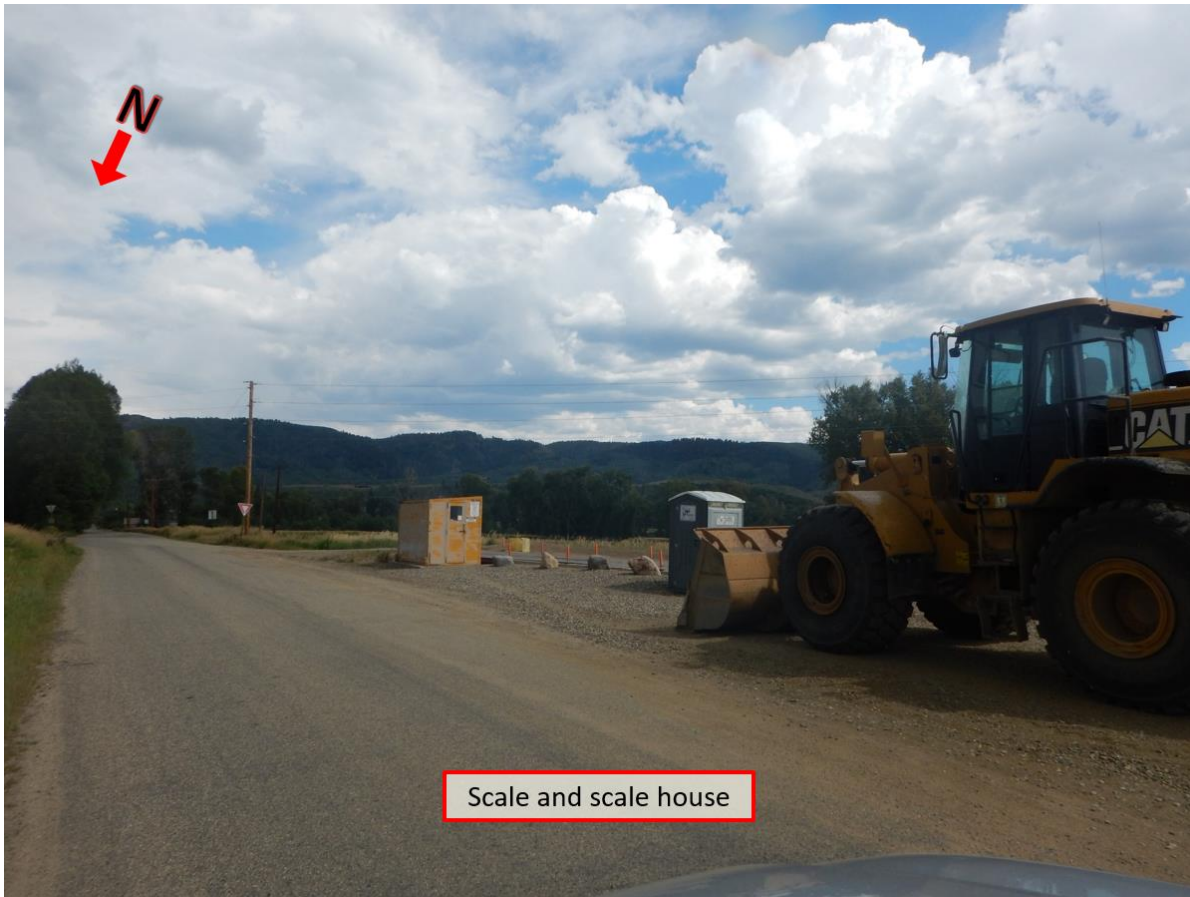
The mine identification sign and affected area boundary markers are in place and in compliance with Rule 3.1.12. The mine sign was located at the main entrance from CR 62. A scale and scale house are located along the access road to the pit

Scale and scale house

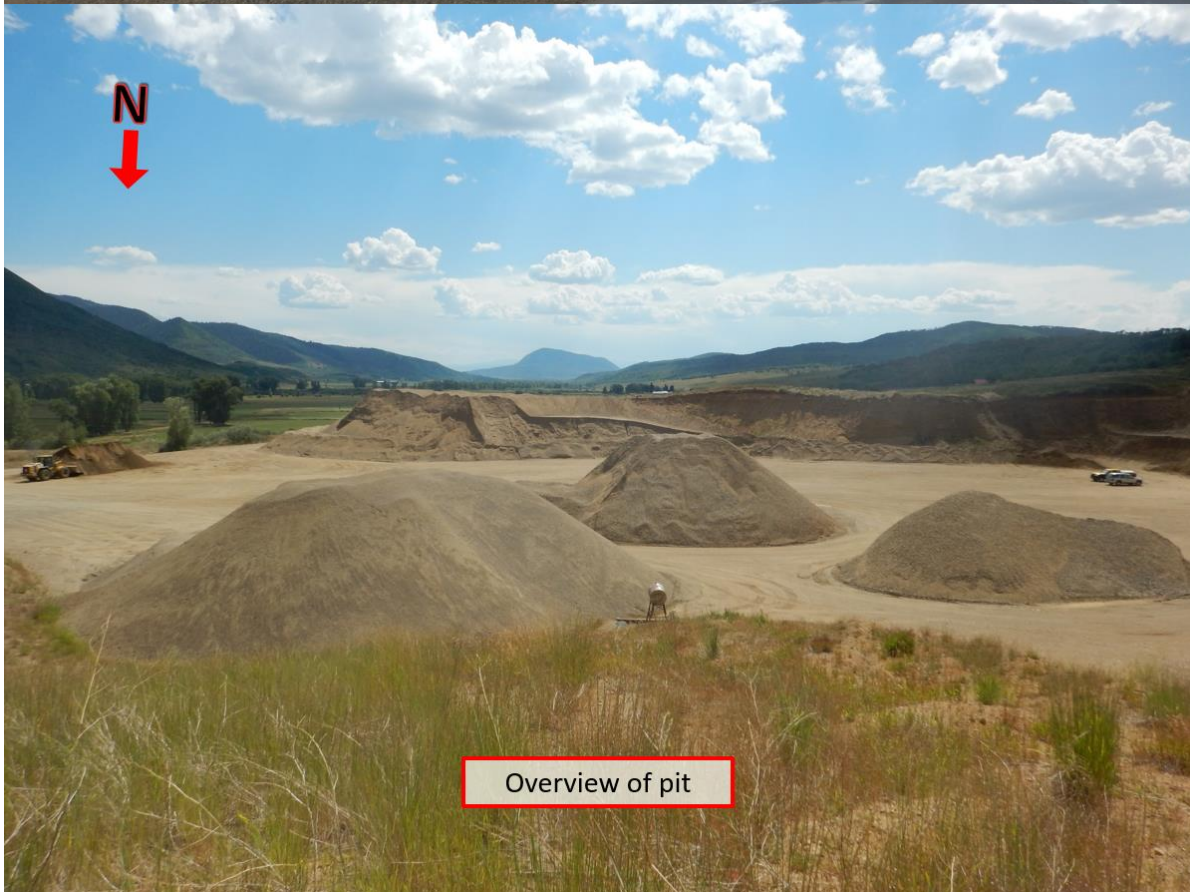
The pit was active at the time of the inspection. A dozer was operating during the inspection. The pit has been excavated to approximately 40' deep. Highwalls range from near vertical to 2:1 sloping. Less than the maximum 1730' of highwall are exposed. Of the currently exposed highwall approximately 600' is adjacent to the permit boundary and will need to be backfilled. There is adequate stockpiled material to be used on site for backfill. The remaining highwalls may be cut and filled. Fuel is in secondary containment.

Overview of pit

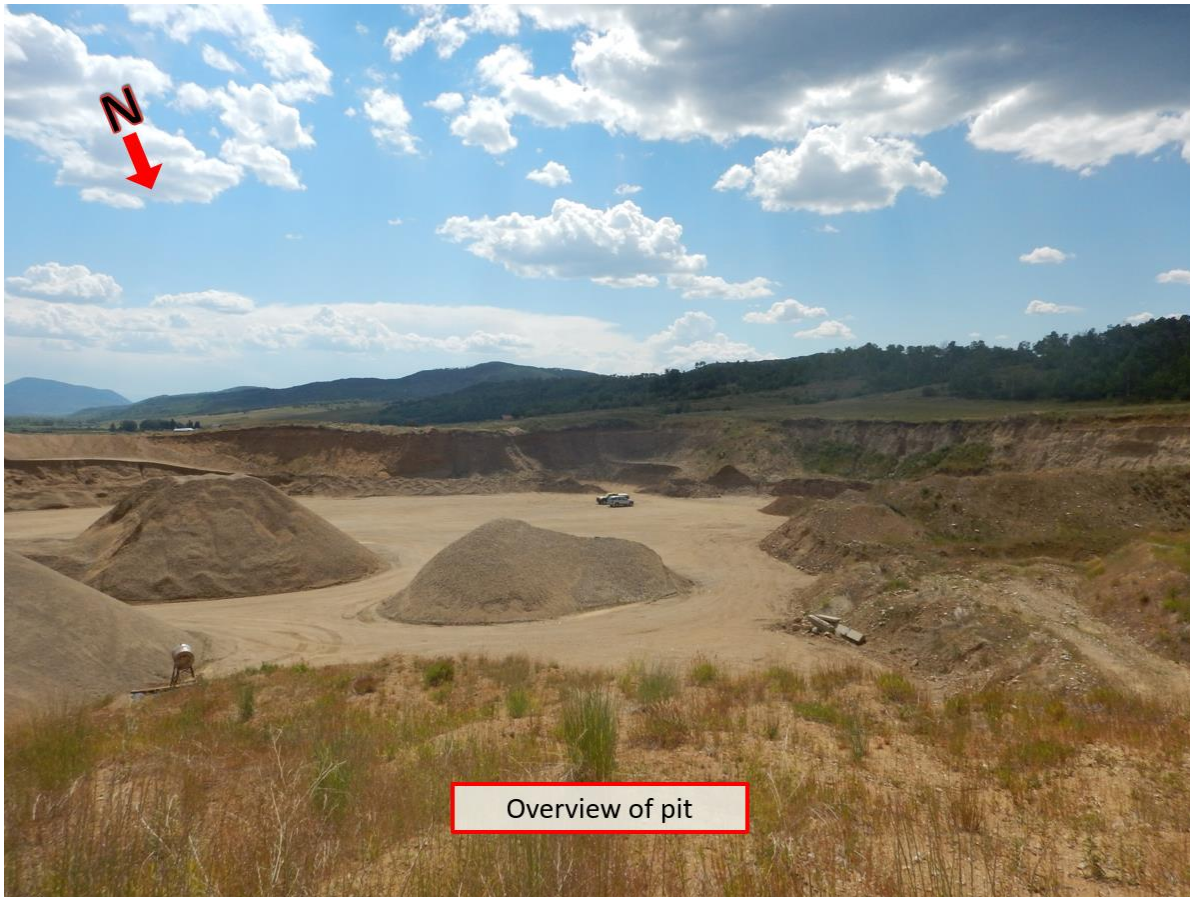
Overview of pit

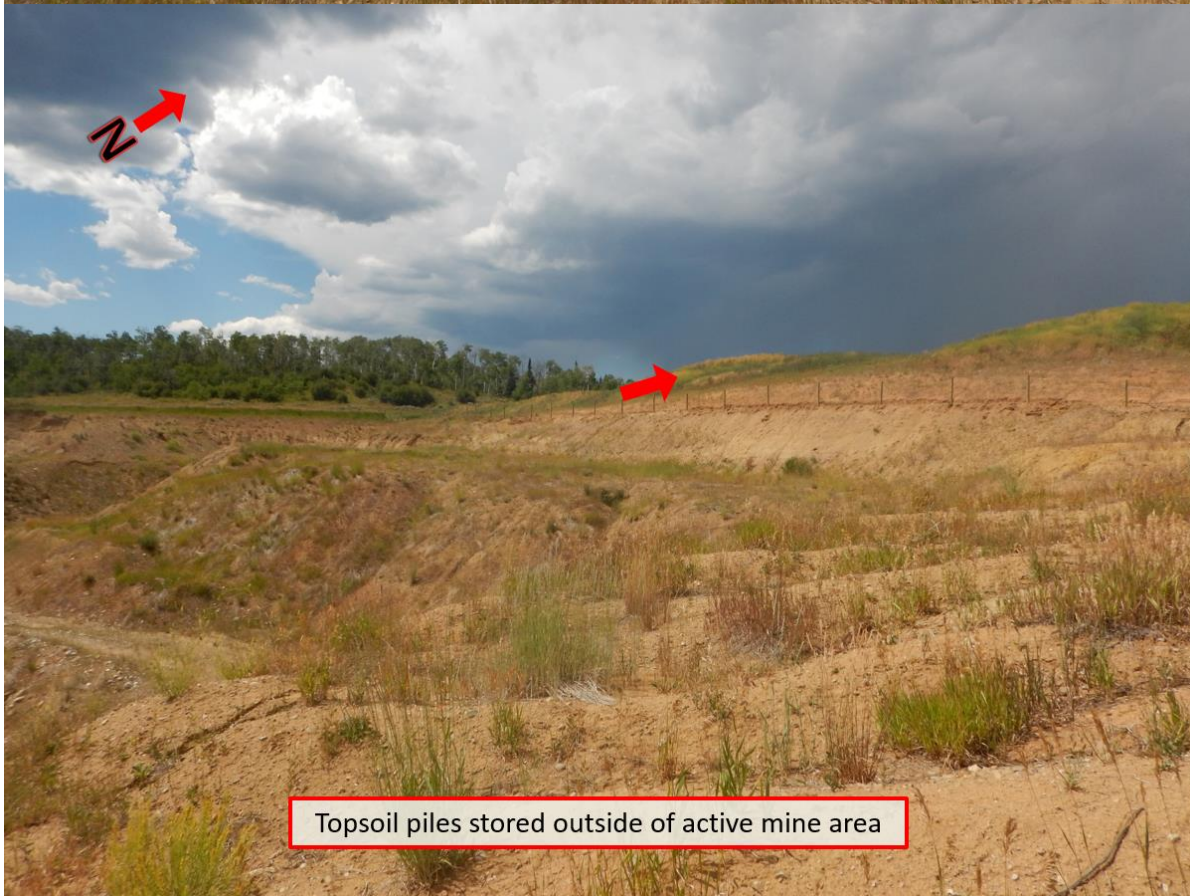
There were several large piles of various stockpiled material. Stockpiles were neatly organized based on size class. All stockpiles were stable, sloped approximately 2:1 and free from any visible erosion. The active mine area is fenced in. The area that topsoil is stockpiled on is located north of the fence within the permit boundary and will not be mined.

Topsoil piles stored outside of active mine area
