MINERALS PROGRAM INSPECTION REPORT
PHONE: (303) 866-3567

MINE NAME: CM-25 Mine	MINE/PROSPECTING ID#: M-1977-307	MINERAL: Uranium and vanadium	COUNTY: Montrose
INSPECTION TYPE: Monitoring	INSPECTOR(S): Dustin M. Czaplá	INSP. DATE: August 30, 2016	INSP. TIME: 11:00
OPERATOR: Cotter Corporation	OPERATOR REPRESENTATIVE: Jim Sheridan	TYPE OF OPERATION: 110d - Designated Limited Impact	
REASON FOR INSPECTION: Normal I&E Program	BOND CALCULATION TYPE: None	BOND AMOUNT: \$100.00	
DATE OF COMPLAINT: NA	POST INSP. CONTACTS: None	JOINT INSP. AGENCY: None	
WEATHER: Clear	INSPECTOR'S SIGNATURE:

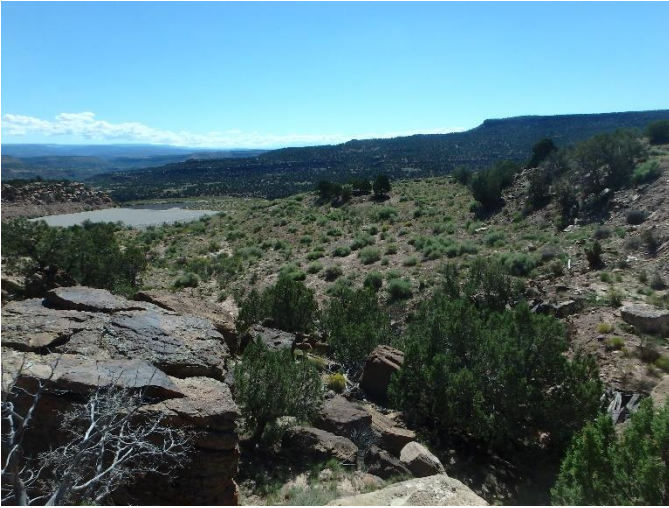
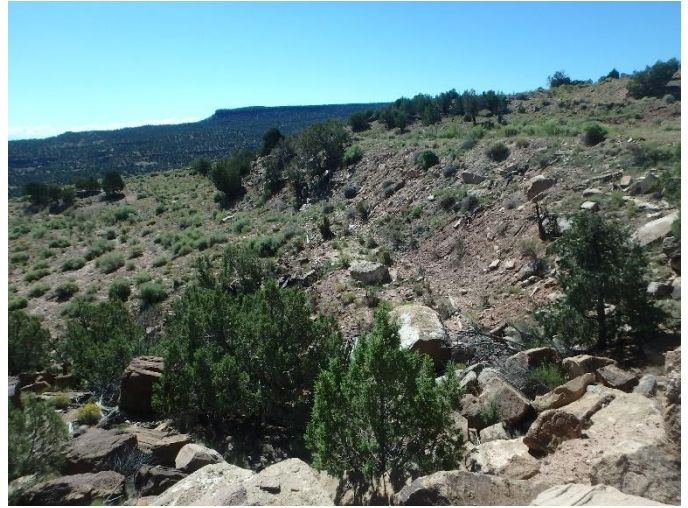
All reclaimed slopes at the site appeared stable. Vegetation was well established over the reclaimed areas.

Adequate mine identification signage was noted at the entrance to the site.
