MINERALS PROGRAM INSPECTION REPORT
PHONE: (303) 866-3567

MINE NAME: C-LP-21	MINE/PROSPECTING ID#: M-1977-305	MINERAL: Uranium and Vanadium	COUNTY: Montrose
INSPECTION TYPE: Monitoring	INSPECTOR(S): Dustin M. Czaplá	INSP. DATE: August 30, 2016	INSP. TIME: 11:30
OPERATOR: Cotter Corporation	OPERATOR REPRESENTATIVE: Jim Sheridan	TYPE OF OPERATION: 112d-1 - Designated Mining Operation	
REASON FOR INSPECTION: Normal I&E Program	BOND CALCULATION TYPE: None	BOND AMOUNT: \$100.00	
DATE OF COMPLAINT: NA	POST INSP. CONTACTS: None	JOINT INSP. AGENCY: None	
WEATHER: Clear	INSPECTOR'S SIGNATURE:

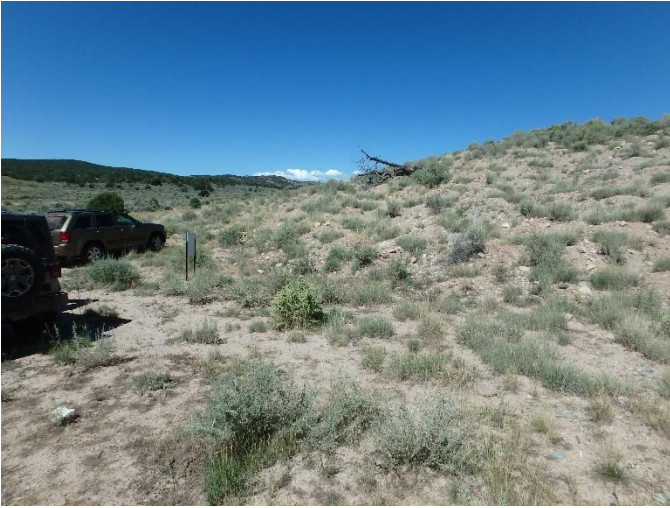
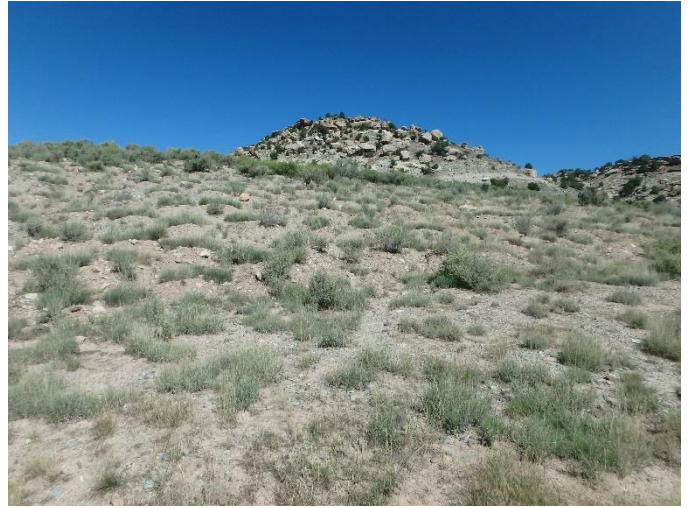
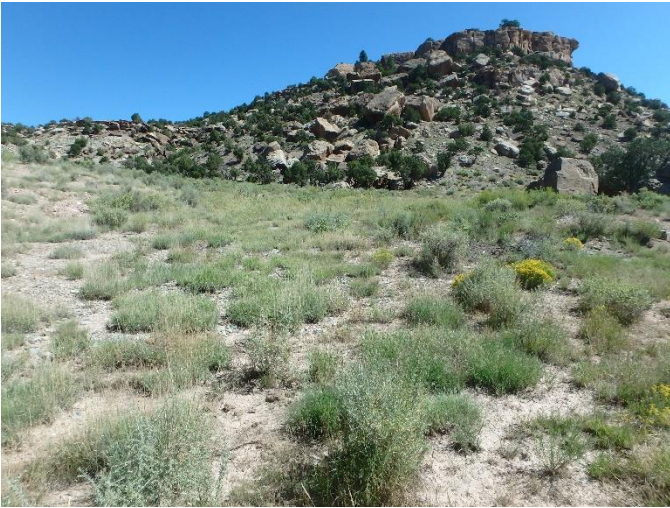
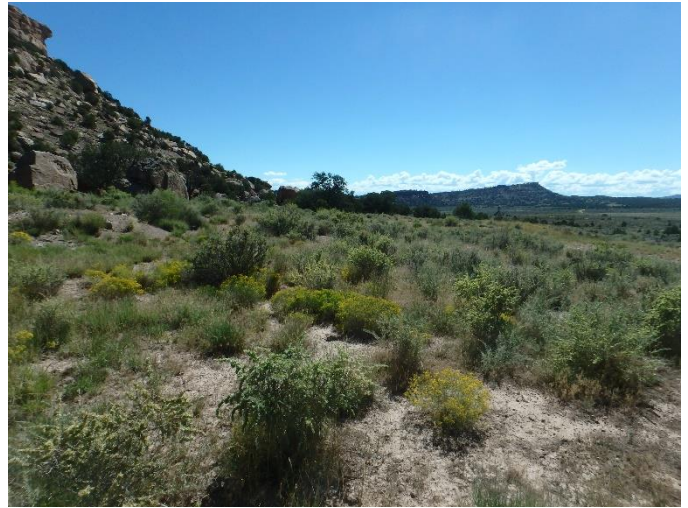
All reclaimed slopes at the site appeared stable. Vegetation is well established over the reclaimed areas.

Adequate mine identification signage was noted at the entrance to the site.
