MINERALS PROGRAM INSPECTION REPORT
PHONE: (303) 866-3567

MINE NAME: JD-6 Mine	MINE/PROSPECTING ID#: M-1977-310	MINERAL: Uranium and vanadium	COUNTY: Montrose
INSPECTION TYPE: Monitoring	INSPECTOR(S): Dustin M. Czapla	INSP. DATE: August 30, 2016	INSP. TIME: 14:00
OPERATOR: Cotter Corporation	OPERATOR REPRESENTATIVE: Jim Sheridan	TYPE OF OPERATION: 110d - Designated Limited Impact	
REASON FOR INSPECTION: Normal I&E Program	BOND CALCULATION TYPE: None	BOND AMOUNT: \$100.00	
DATE OF COMPLAINT: NA	POST INSP. CONTACTS: None	JOINT INSP. AGENCY: None	
WEATHER: Clear	INSPECTOR'S SIGNATURE:

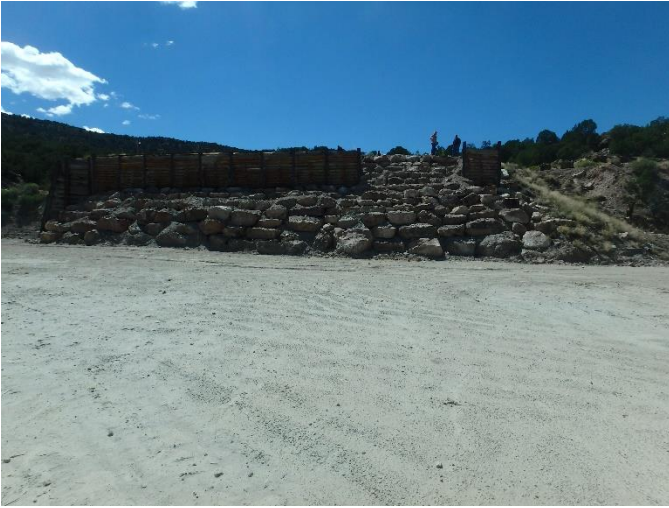
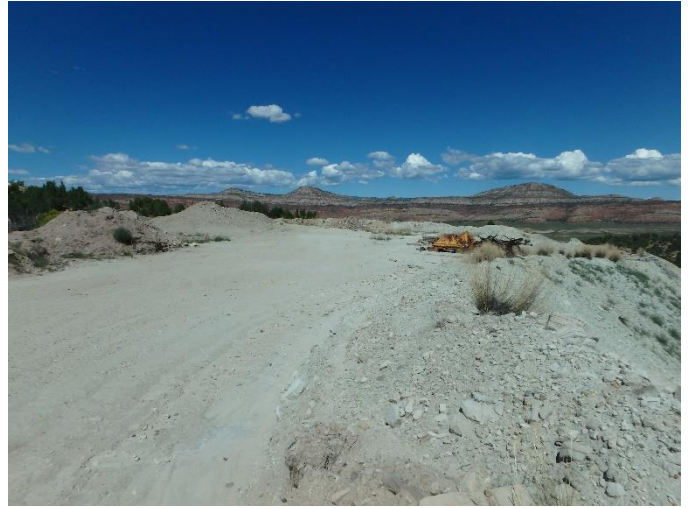
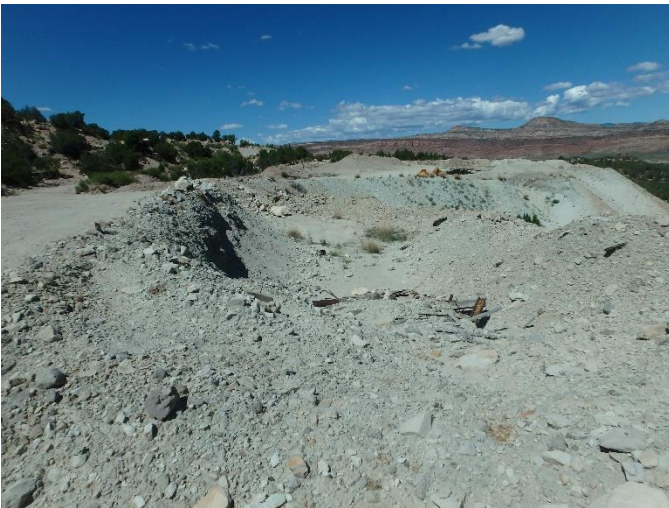
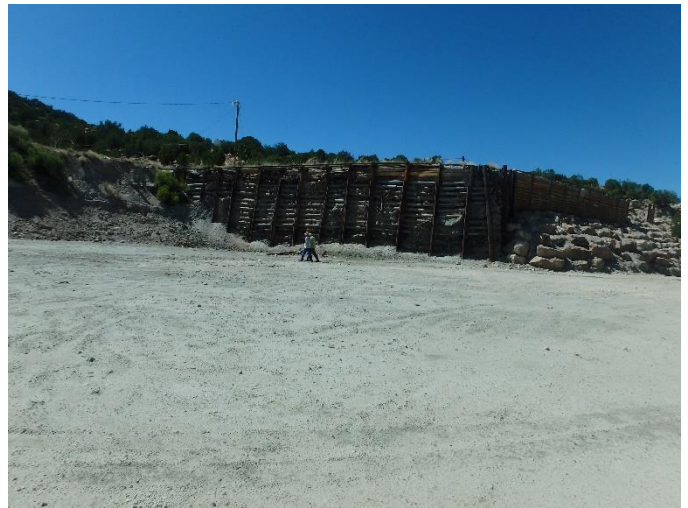
No evidence of recent mining activity was noted during this inspection. The site is currently in Temporary Cessation. A portion of the vertical retaining wall that failed during the spring of this year has been reconstructed and buttressed with large boulders. The repaired slope appeared stable.
