# MINERALS PROGRAM INSPECTION REPORT PHONE: (303) 866-3567

MINE NAME:	MINE/PROSPECTING ID#:	MINERAL:	COUNTY:	
Henderson Mine	M-1977-342	Molybdenum	Clear Creek, Grand	
INSPECTION TYPE:	INSPECTOR(S):	INSP. DATE:	INSP. TIME:	
Monitoring	Peter S. Hays	August 30, 2016	14:00	
OPERATOR:	OPERATOR REPRESENTATIVE:	TYPE OF OPERA	TYPE OF OPERATION:	
Climax Molybdenum Company	Tim Haynes, Alex Ungers, Miguel	112d-3 - Designated	112d-3 - Designated Mining Operation	
	Hamarat			
DE A CON FOR INCRECTION	DOND GALCIII ATRION TOYDE	DOND AMOUNT		
REASON FOR INSPECTION:	BOND CALCULATION TYPE:	BOND AMOUNT:	BOND AMOUNT:	
Normal I&E Program	None	\$35,084,835.00	\$35,084,835.00	
DATE OF COMPLAINT:	POST INSP. CONTACTS:	JOINT INSP. AGE	JOINT INSP. AGENCY:	
NA	None	None	None	
WEATHER:	INSPECTOR'S SIGNATURE:	SIGNATURE DATE:		
Clear	fthe	September 14, 2016

PERMIT #: M-1977-342 INSPECTOR'S INITIALS: PSH INSPECTION DATE: August 30, 2016

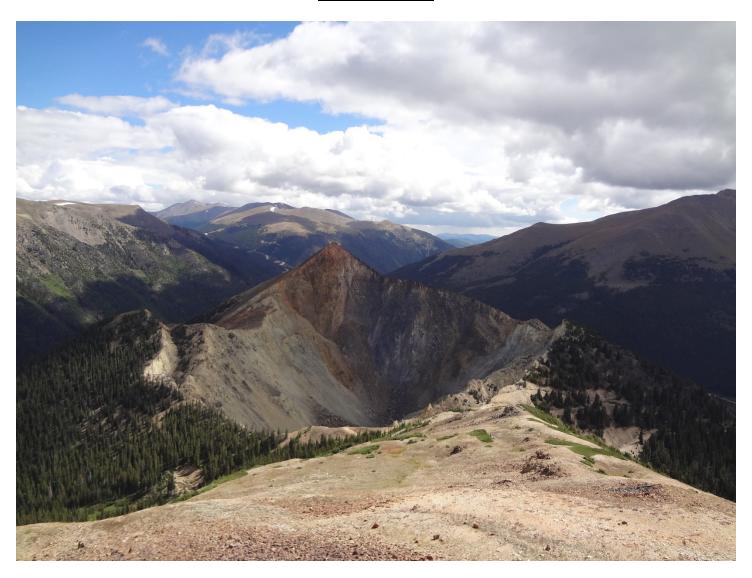
The inspection of the Henderson mine facility included a discussion of the on-going low pH in MNGW-1 and viewing the glory hole in Red Mountain from the Red Mountain NOI drill pad #8.
