MINERALS PROGRAM INSPECTION REPORT
PHONE: (303) 866-3567

MINE NAME: Red Mountain Exploration Drilling	MINE/PROSPECTING ID#: P-2011-014	MINERAL: Molybdenum	COUNTY: Clear Creek
INSPECTION TYPE: Monitoring	INSPECTOR(S): Peter S. Hays	INSP. DATE: August 30, 2016	INSP. TIME: 10:00
OPERATOR: Climax Molybdenum Company	OPERATOR REPRESENTATIVE: Tim Haynes, Alex Ungers	TYPE OF OPERATION: MP - Mineral Prospecting	
REASON FOR INSPECTION: Normal I&E Program	BOND CALCULATION TYPE: None	BOND AMOUNT: \$108,000.00	
DATE OF COMPLAINT: NA	POST INSP. CONTACTS: None	JOINT INSP. AGENCY: None	
WEATHER: Clear	INSPECTOR'S SIGNATURE:

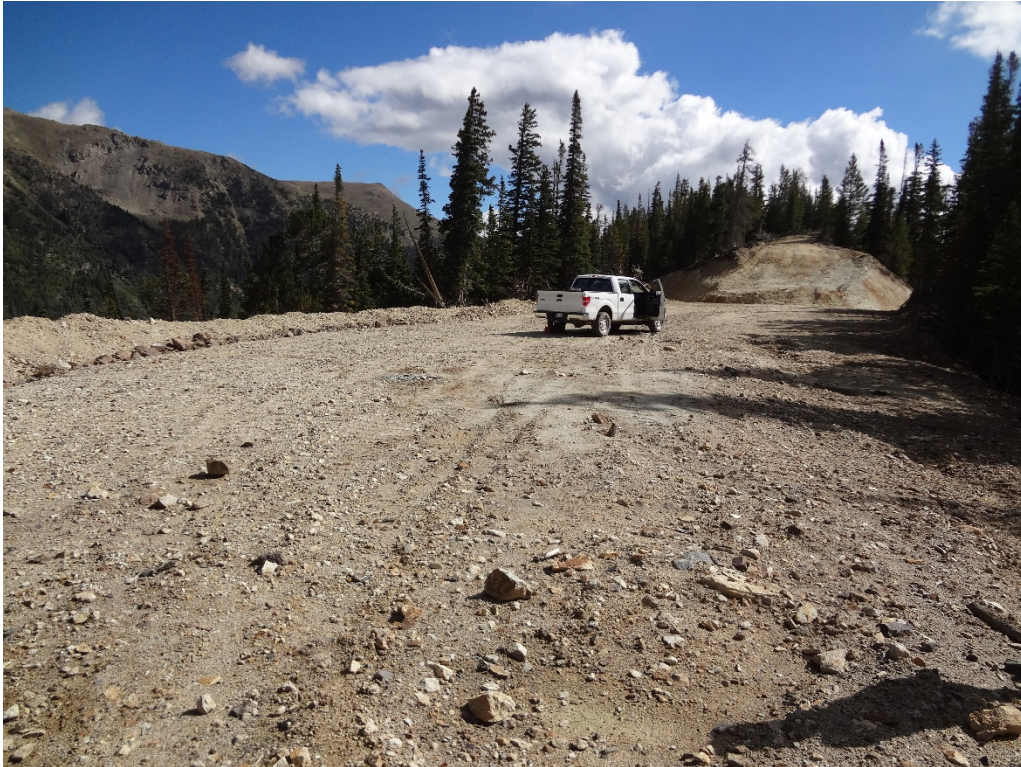
View of drill pad #3 looking northeast

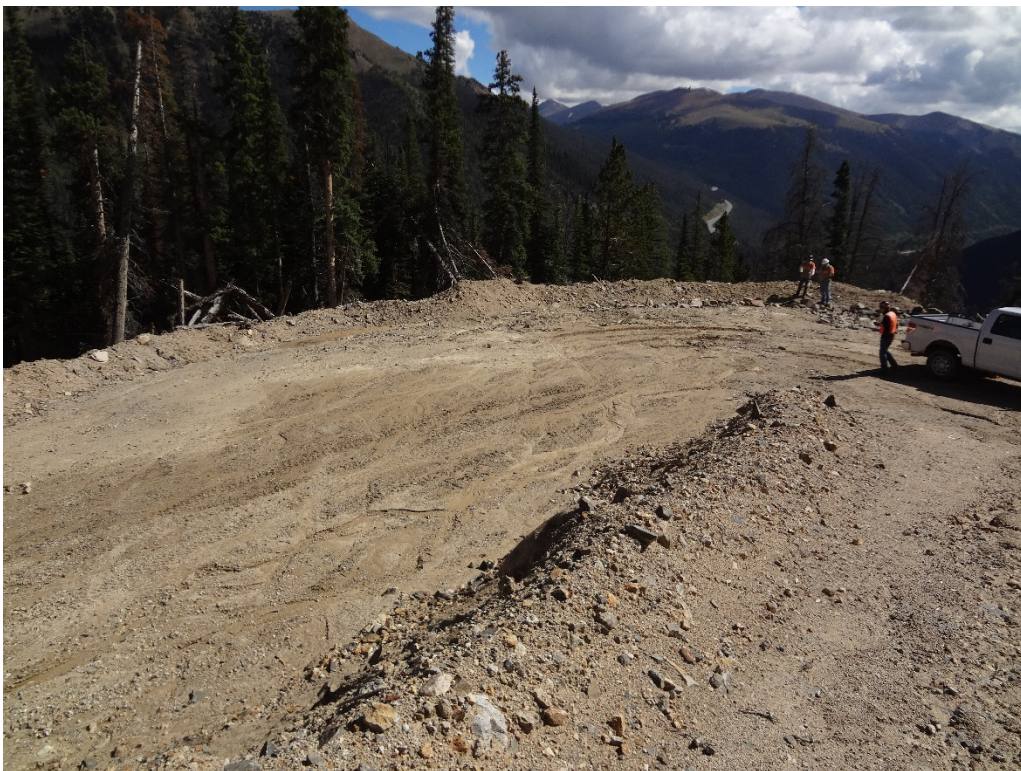
The NOI project was previously inspected by the Division on August 15, 2013. The NOI project appeared unchanged since the last inspection. According to the 2016 annual report, no drilling was done at the project in 2014 or 2015. The drill pads were observed during the inspection. Drill pads #1, #2, and #5 through #8 appeared unchanged since the last inspection. The equipment observed at drill pads #3 and #4 in 2013 has been removed and the sumps have been backfilled. The lower portion of drill pad #4 was covered by material eroded from the upper pad and access road.

View of drill pad #4 looking northeast

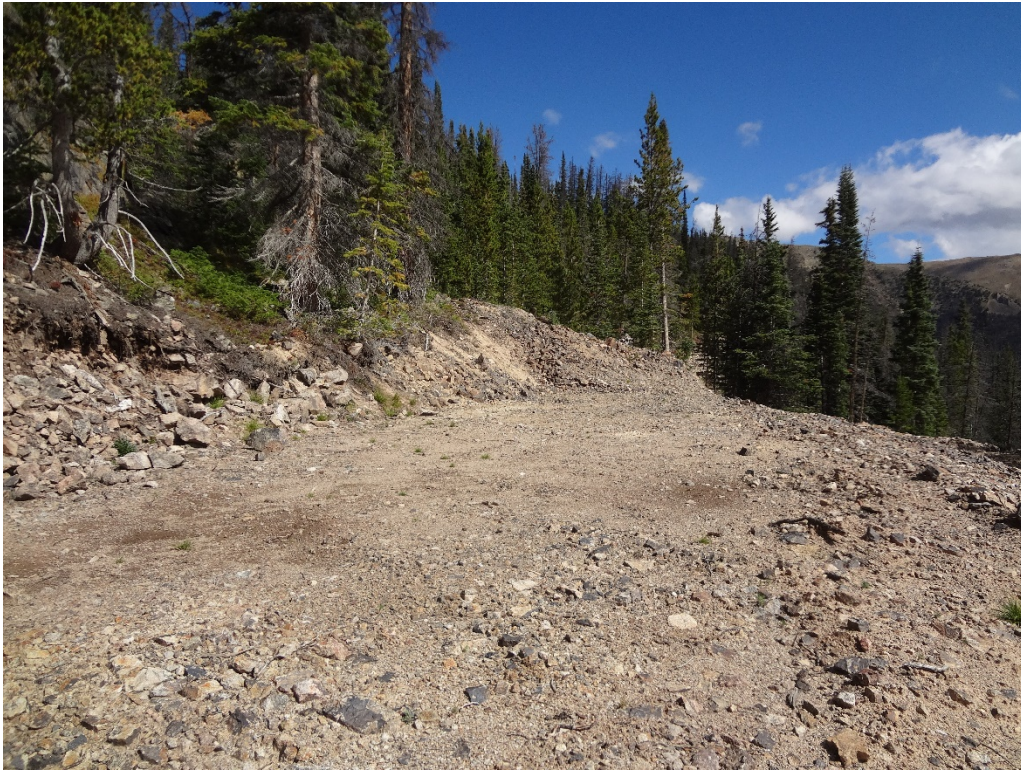
View of upper portion of drill pad #2 looking north

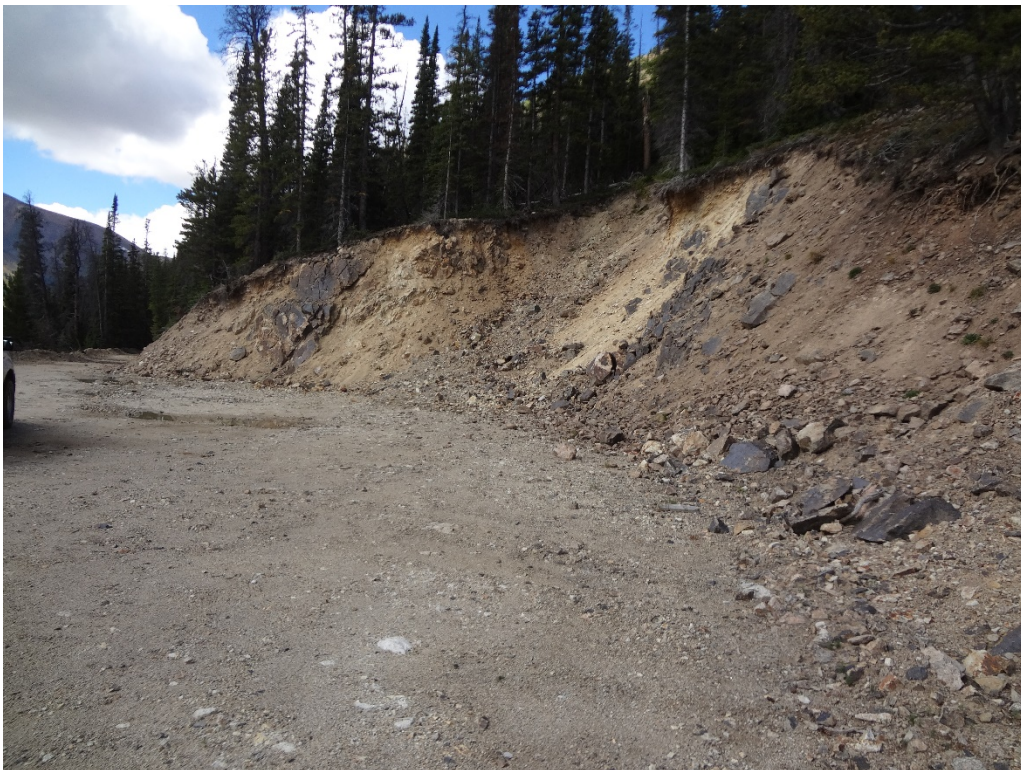
View of lower portion of drill pad #2 looking south (storage area)

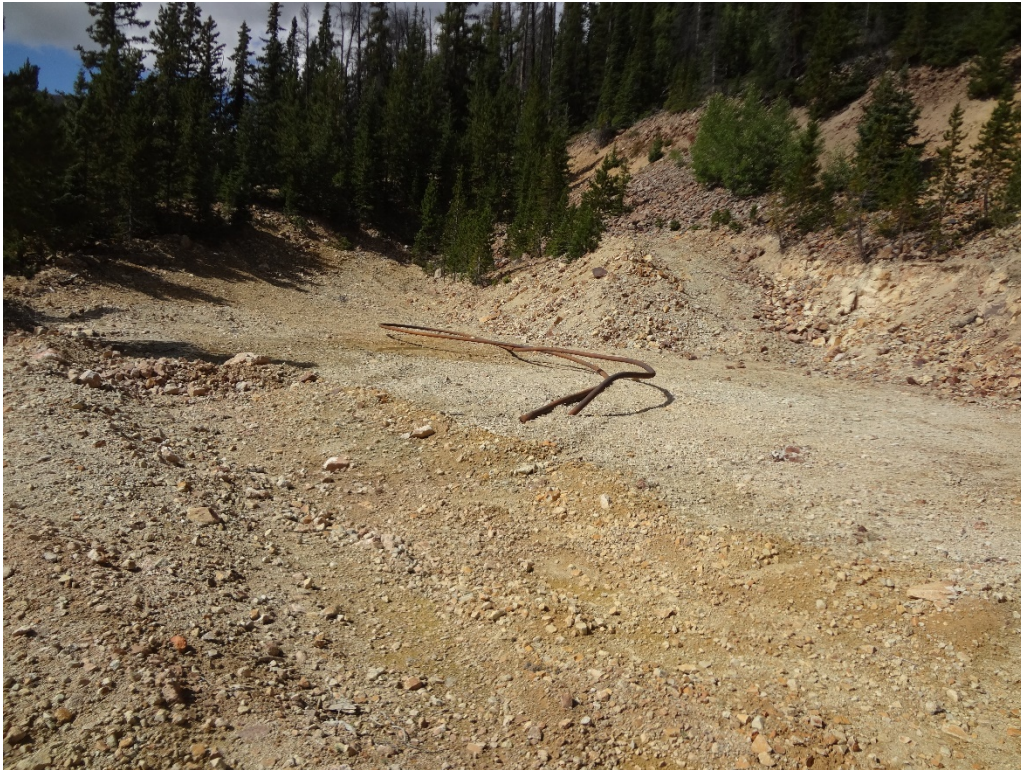
View of drill pad #1 looking southwest

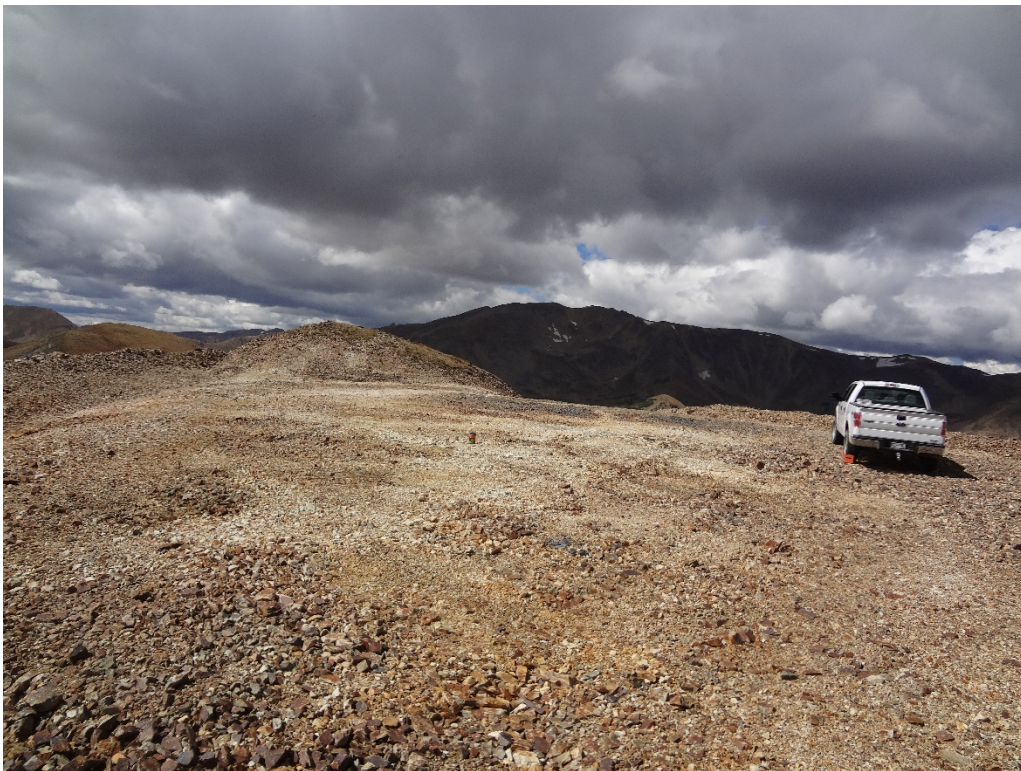
View of drill pad #8 looking northeast
