**MINERALS PROGRAM INSPECTION REPORT**  
**PHONE: (303) 866-3567**

| <b>MINE NAME:</b><br>Toltec No 2 | <b>MINE/PROSPECTING ID#:</b><br>M-1984-039 | <b>MINERAL:</b><br>Silver, gold, copper, | <b>COUNTY:</b><br>San Juan |
| <b>INSPECTION TYPE:</b><br>Surety-Related Inspection | <b>INSPECTOR(S):</b><br>Lucas J. West | <b>INSP. DATE:</b><br>August 24, 2016 | <b>INSP. TIME:</b><br>11:40 |

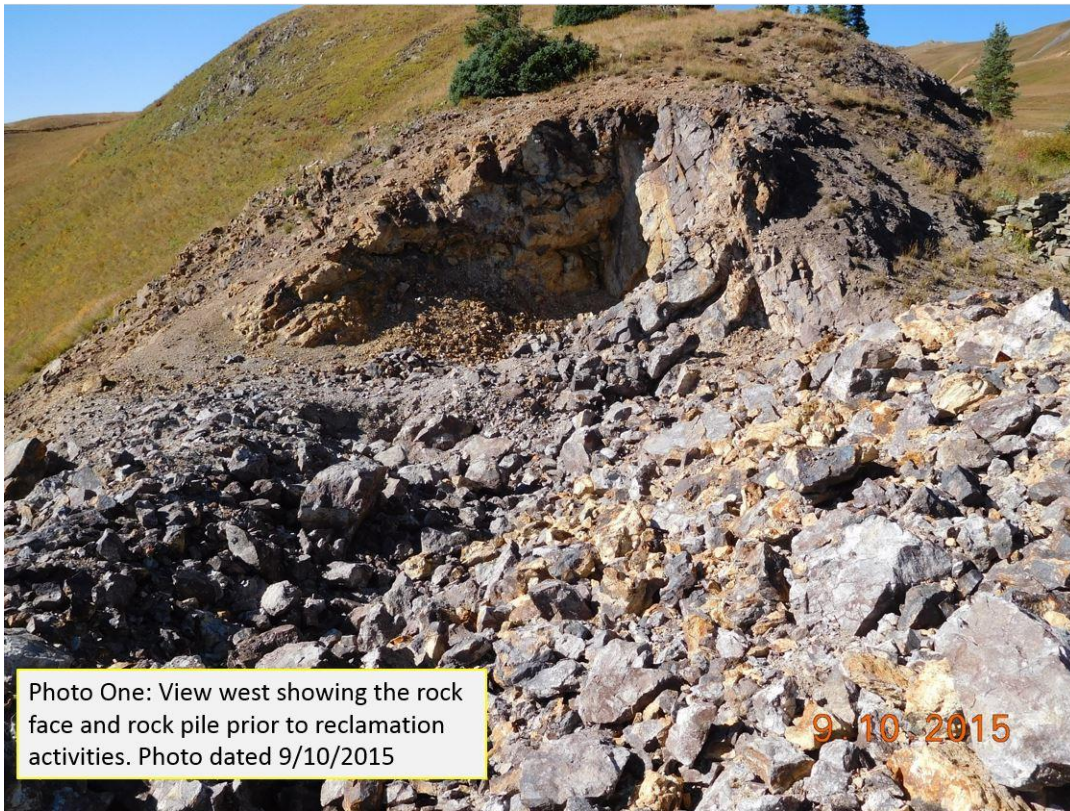
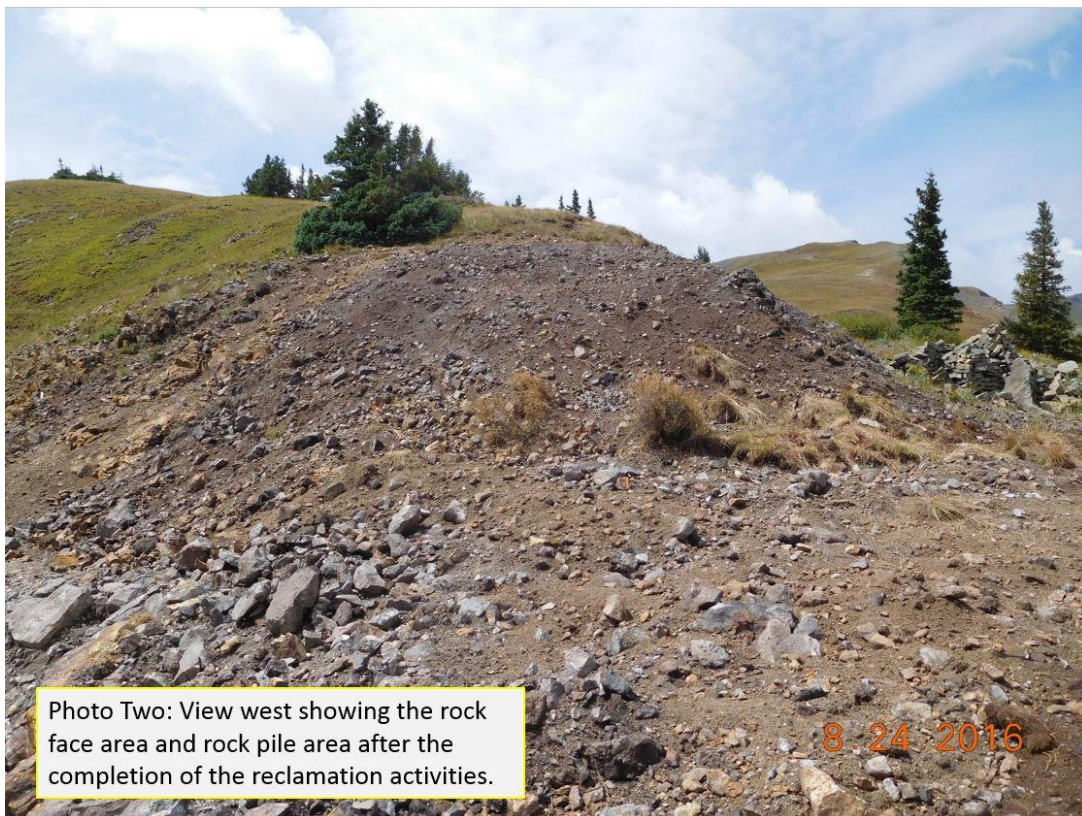
Reclamation activities have taken place on site. The waste rock pile located on site has been blended into the rock face to match the surrounding topography. The backfilling and blending appears to be stable and in good condition. Photos One and Two show the rock face before, and after the completion of this task. The main work area adjacent to the rock face has been graded to ensure positive drainage. Topsoil has been replaced throughout the site, at an average depth of 6 inches. The grading of the topsoil appears to be stable and no erosional issues were noted on site. Photo Three shows the main work area with the topsoil replaced. All earthwork and grading has been completed according to the approved reclamation plan that was recently modified through TR-02. Photos Four and Five show other views of the reclamation work that has been completed. Revegetation is the only remaining task to achieve final reclamation of the site.
