MINERALS PROGRAM INSPECTION REPORT
PHONE: (303) 866-3567

MINE NAME: Marvel Pit	MINE/PROSPECTING ID#: M-1977-575	MINERAL: Sand and gravel	COUNTY: La Plata
INSPECTION TYPE: Monitoring	INSPECTOR(S): Lucas J. West	INSP. DATE: September 14, 2016	INSP. TIME: 12:20
OPERATOR: LaPlata County	OPERATOR REPRESENTATIVE: Leslie Jakoby	TYPE OF OPERATION: 110c - Construction Limited Impact	
REASON FOR INSPECTION: Normal I&E Program	BOND CALCULATION TYPE: None	BOND AMOUNT: \$0.00	
DATE OF COMPLAINT: NA	POST INSP. CONTACTS: None	JOINT INSP. AGENCY: None	
WEATHER: Clear	INSPECTOR'S SIGNATURE:

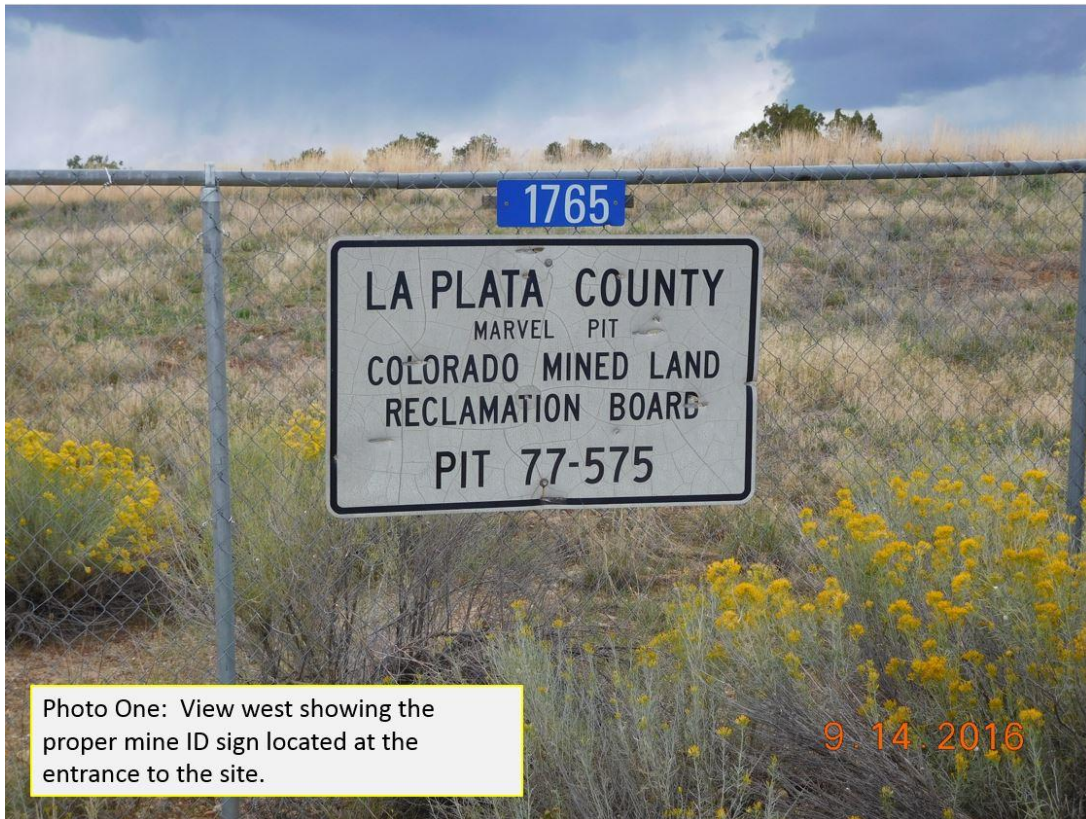
Proper mine identification signage was posted at the entrance to the site, as shown in Photo One. The permit boundaries were clearly marked with fences and earthen berms. Of the 6 permitted acres approximately three acres have been disturbed. All disturbances are within the permitted boundaries. The site was not active during the inspection and no equipment was on site. The site is operated on an as needed basis. Various small stockpiled material was observed on the pit floor. All stockpiles are small and appear to be stable. The topsoil and overburden stockpiles are located in the Southwest corner of the permitted area and are well vegetated and appear to be stable as well. Photo Two shows the overburden stockpile and Photo Three shows the topsoil. The active mining area, shown in Photo Four, consists of a highwall approximately 15 feet tall and 100 feet in length and appears to be stable.

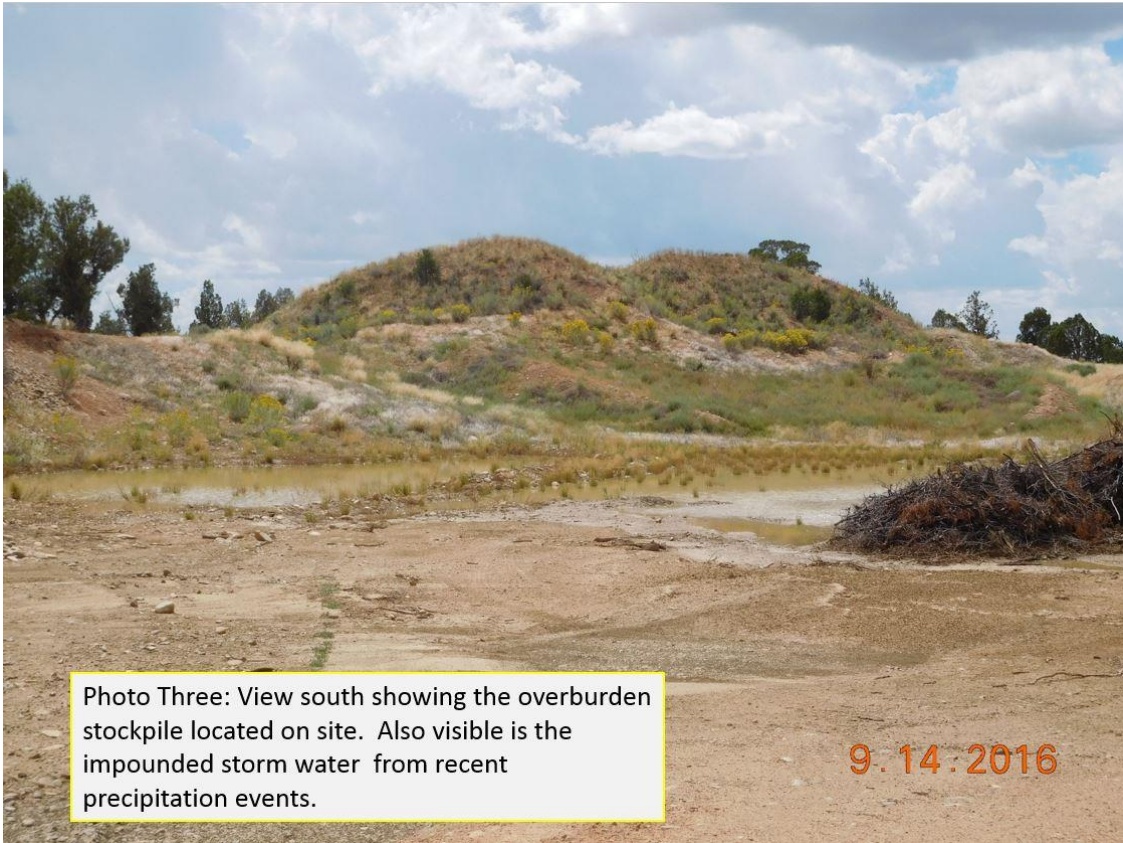
No erosional features were noted on site. Impounded storm water was observed in the southern end of the pit floor in response to recent precipitation events. No state listed noxious weeds were noted on site, the operator expressed that ongoing weed management happens at all county pits with the assistance of the County Weed Department.

Photo Three: View south showing the overburden stockpile located on site. Also visible is the impounded storm water from recent precipitation events.

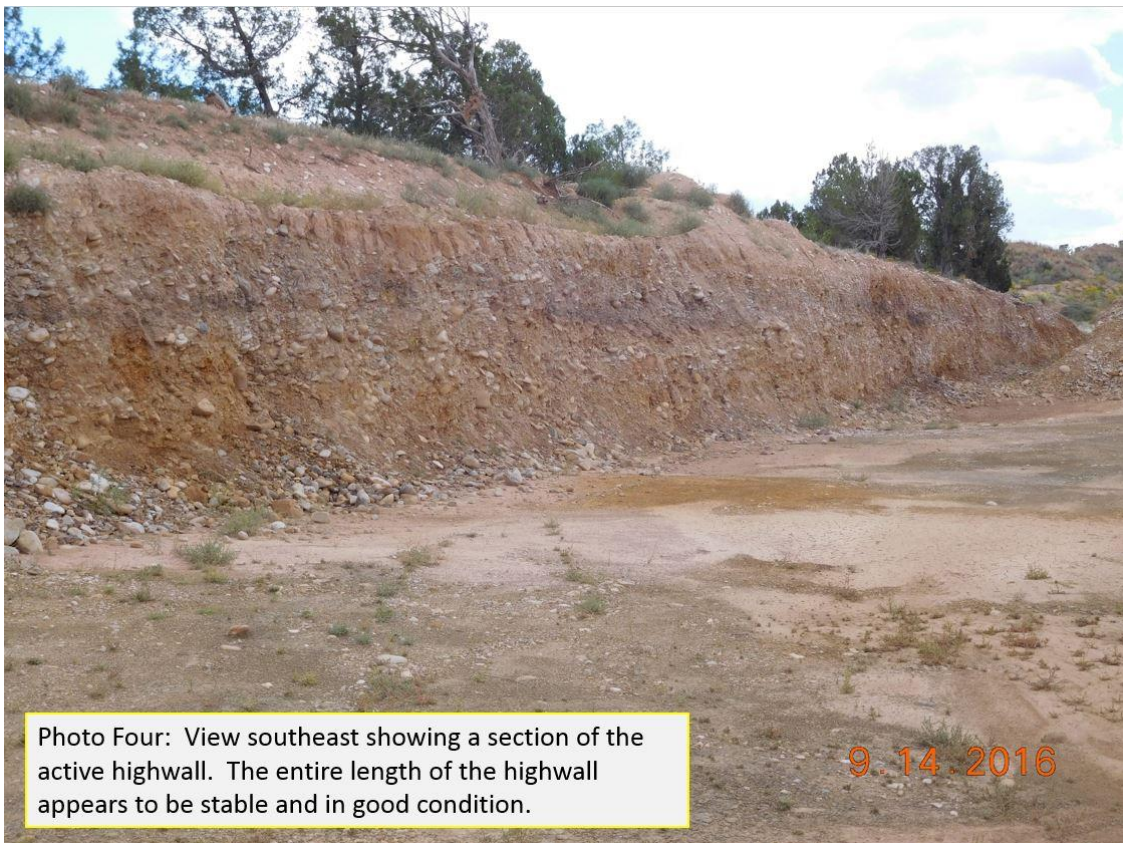
Photo Four: View southeast showing a section of the active highwall. The entire length of the highwall appears to be stable and in good condition.

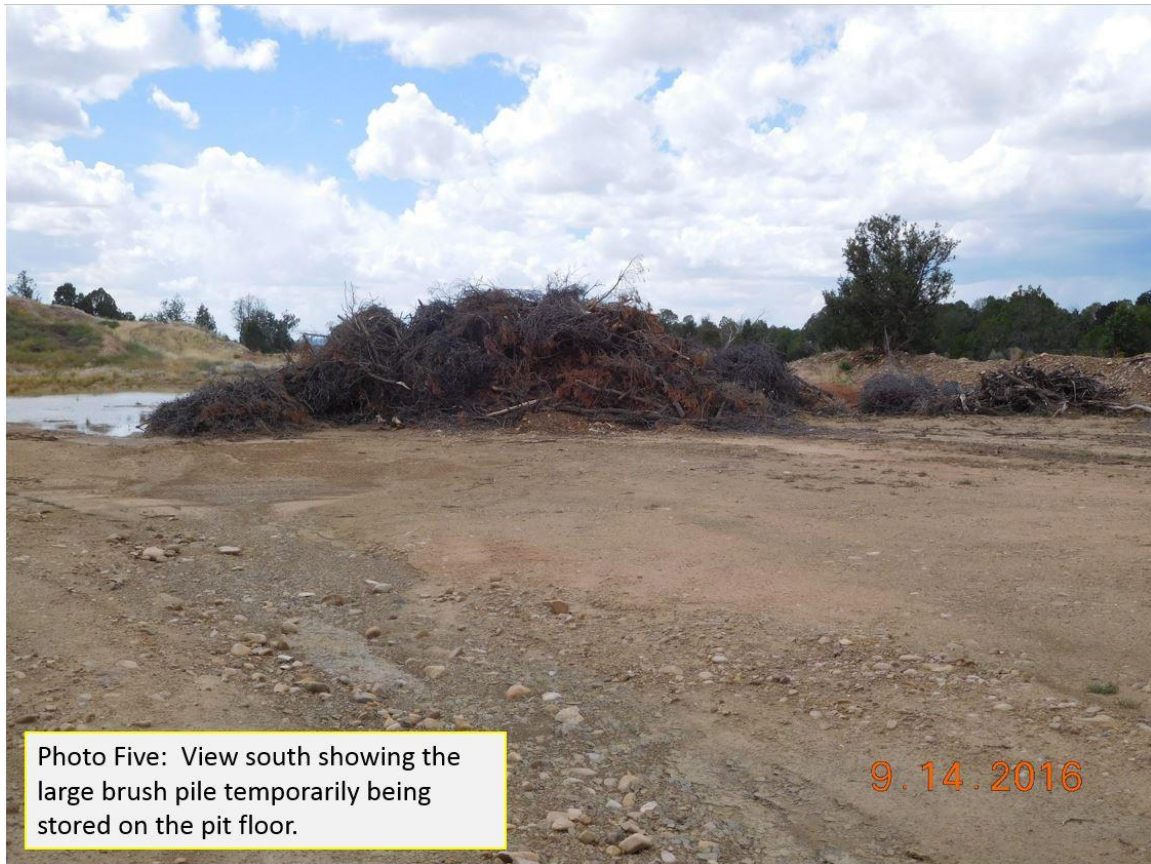
The pit floor is relatively flat and appears to be stable. A large pile of brush and other deleterious material is located on the pit floor. The operator expressed that they temporarily store brush here until the chipping crew can process and remove the material. Photo Five shows the brush pile. A small area of the pit floor is being used as a storage area, items being stored there include scrap fencing, Jersey Barriers, a large fuel tank and other miscellaneous items. The items shown in Photo Six are stored in neat and orderly fashion and are not considered a problem at this time. The operator expressed that all items are stored there temporarily.

Photo Five: View south showing the large brush pile temporarily being stored on the pit floor.

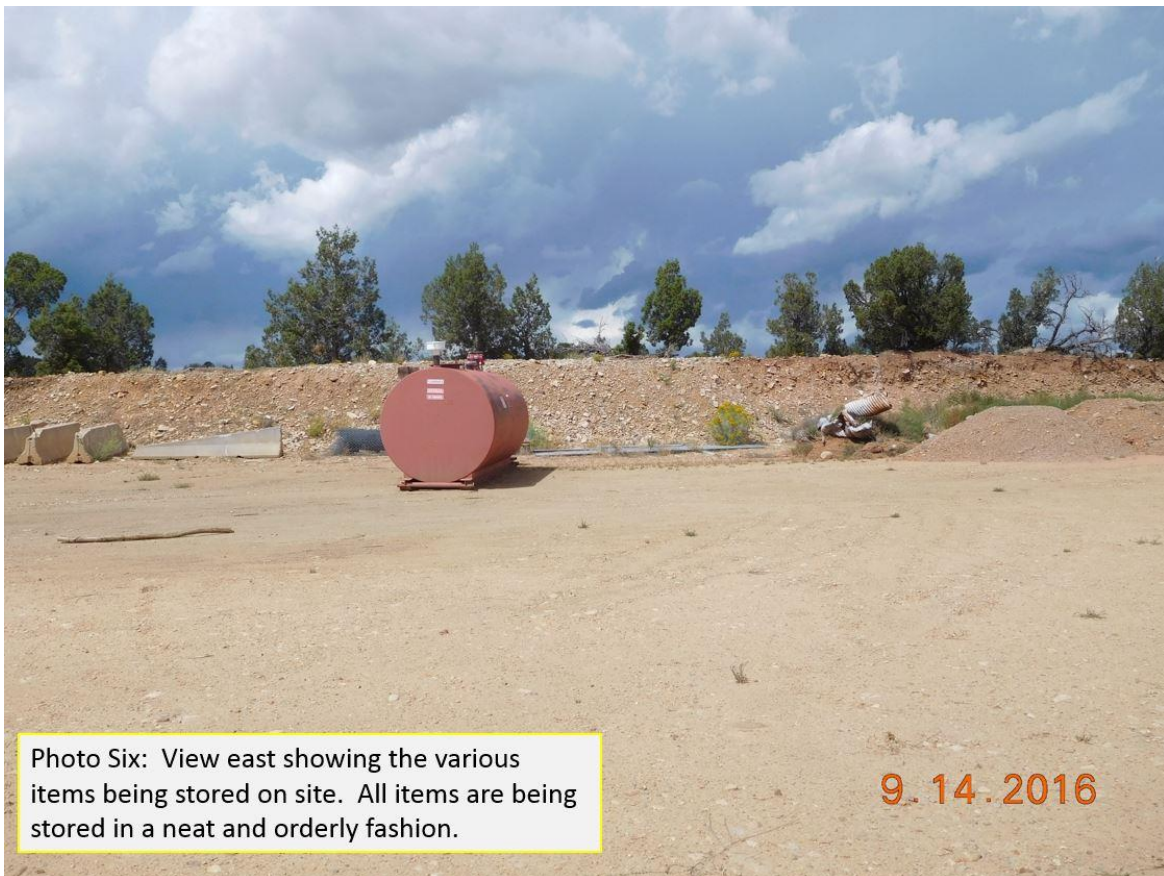
Photo Six: View east showing the various items being stored on site. All items are being stored in a neat and orderly fashion.
