**MINERALS PROGRAM INSPECTION REPORT**  
**PHONE: (303) 866-3567**

<b>MINE NAME:</b> Hubbs Pit	<b>MINE/PROSPECTING ID#:</b> M-1987-088	<b>MINERAL:</b> Sand and gravel	<b>COUNTY:</b> La Plata
<b>INSPECTION TYPE:</b> Monitoring	<b>INSPECTOR(S):</b> Lucas J. West	<b>INSP. DATE:</b> September 14, 2016	<b>INSP. TIME:</b> 03:09
<b>OPERATOR:</b> Hubbs III, LLC	<b>OPERATOR REPRESENTATIVE:</b> Leslie Jakoby, Gerard Gurule	<b>TYPE OF OPERATION:</b> 112c - Construction Regular Operation	
<b>REASON FOR INSPECTION:</b> Normal I&E Program	<b>BOND CALCULATION TYPE:</b> None	<b>BOND AMOUNT:</b> \$59,905.00	
<b>DATE OF COMPLAINT:</b> NA	<b>POST INSP. CONTACTS:</b> None	<b>JOINT INSP. AGENCY:</b> None	
<b>WEATHER:</b> Clear	<b>INSPECTOR'S SIGNATURE:</b>

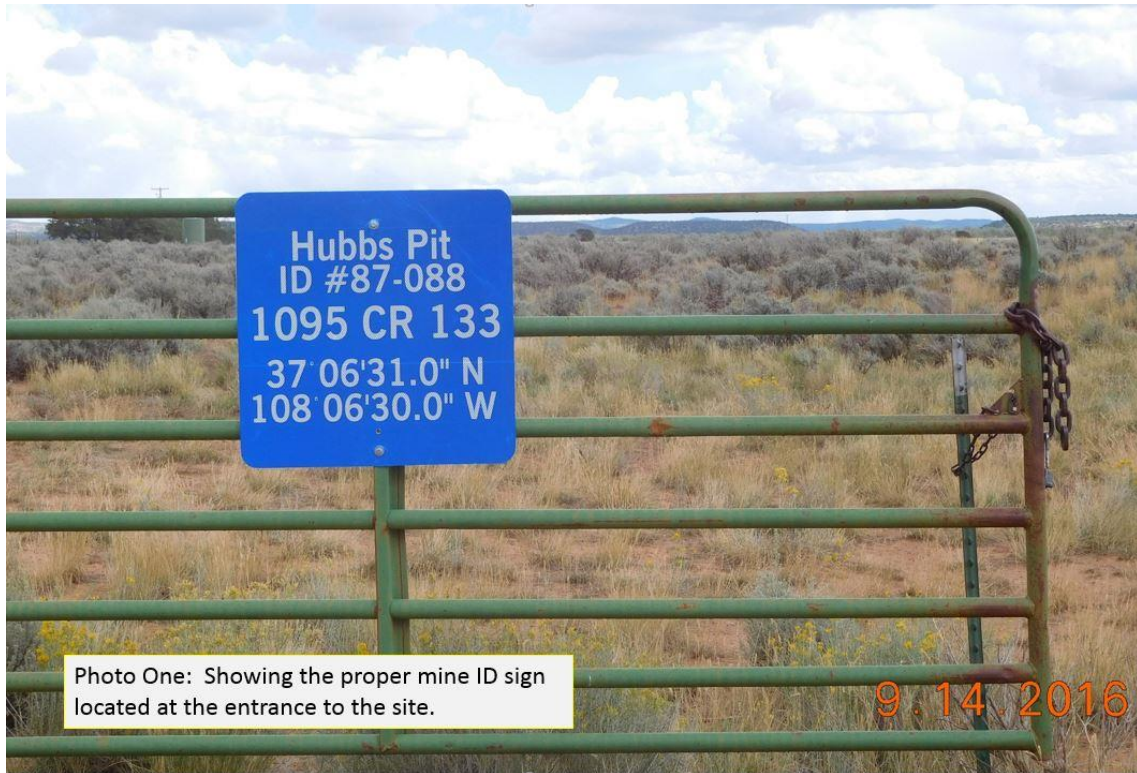
Proper mine identification signage was posted at the entrance to the site and is shown in Photo One. The permitted area was clearly outlined with a barbed wire fence encompassing the entire site. The site consists of two permitted sections, one ten acre section located just north of County Road 133 is completely undisturbed and was not inspected at this time, and the other section approximately 28 acres in size is located just south of the County Road. All disturbances were confined within the permitted boundaries. The southern permitted area is split up into three phases of mining. Phases one, two and part of three have been mined out with the majority of the mining activity taking place in the northern section of phase three. Photo two shows the active mining area of phase three which consists of a highwall approximately 20 feet tall on average and stretching an estimated 300 linear feet. The highwall appears to be stable and is in good condition. Several stockpiles were located on the pit floor including a reject fines, overburden and topsoil stockpiles. Examples of the stockpiles are shown in Photos Three and Four. All stockpiles observed appeared to be stable and in good condition. The site was active at the time of the inspection.

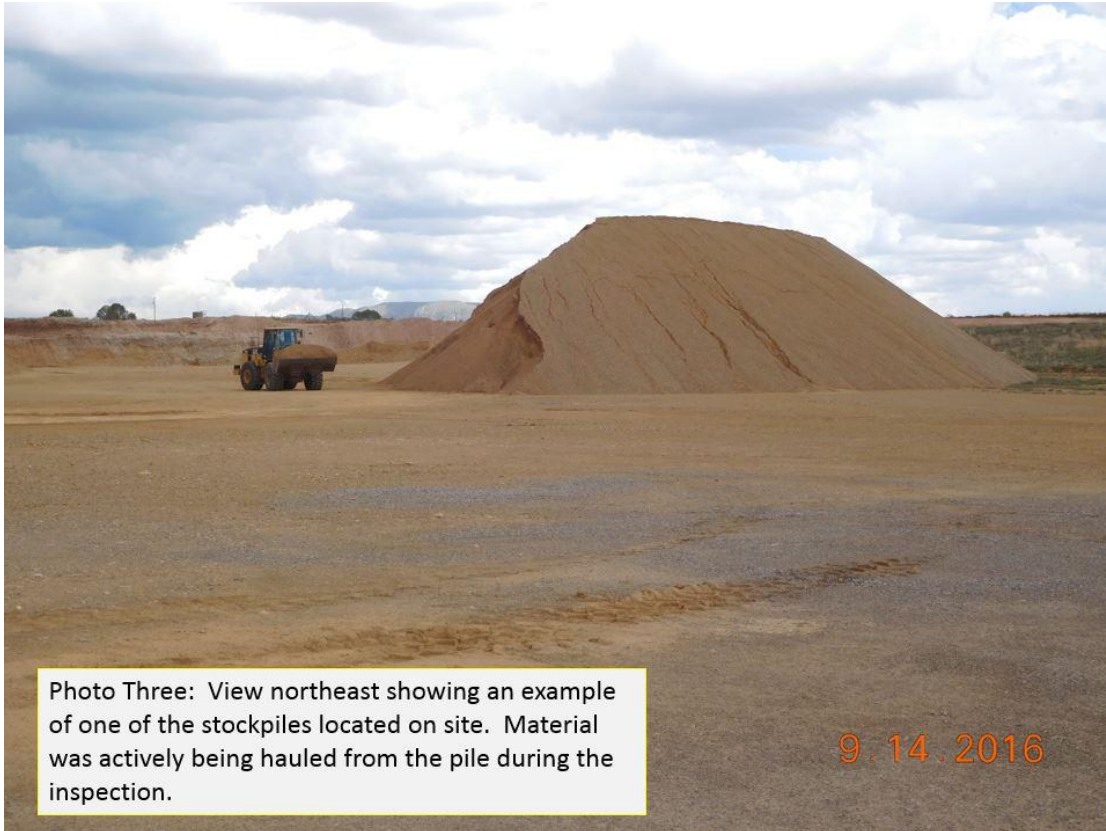
Photo Three: View northeast showing an example of one of the stockpiles located on site. Material was actively being hauled from the pile during the inspection.

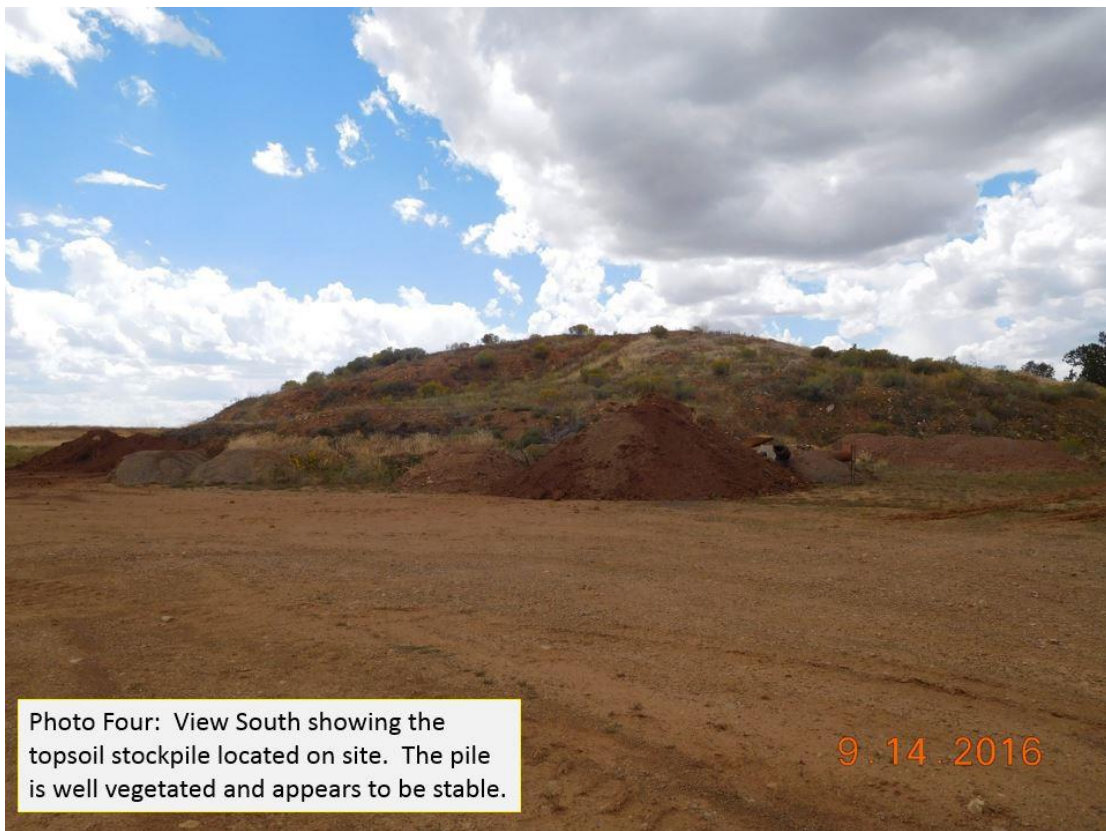
Photo Four: View South showing the topsoil stockpile located on site. The pile is well vegetated and appears to be stable.
