Bureau of Land Management Colorado River Valley Field Office Minerals Inspection Report

General Information	
Date	9/1/2016
Project Name	Eagle-Gypsum Mine
Operator	American Gypsum Company, LLC
Serial Number	COC-072973
Project Classification	Plan of Operations
Project Location	T4S R85W Sections 28, 29, 32 and 33; Eagle County
Inspection Purpose	Regular site inspection (per 43 CFR 3809.600 (a))
Time Period Onsite	3 hours
Attendees	Jessica Lopez Pearce, BLM Geologist
	Jared Rhea, American Gypsum Co. Mine Manager
	Brian Bloess, American Gypsum Co. EHS and HR Manager
	Travis Marshall, DRMS Environmental Protection Specialist

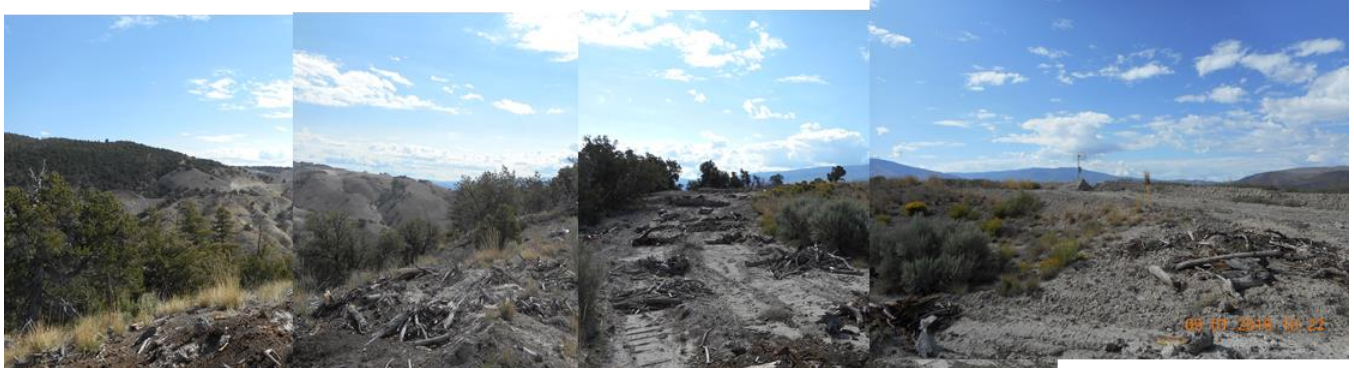
We started our site visit at the mine office and equipment yard area. There is an established photopoint on the east side of the mine office (Photo 1). The equipment storage area that was located to the southeast of the mine office has been reclaimed and all structures have been removed. The area has been ripped and seeded (Photo 2). A rough two-track to the mine radio antenna is still present in this reclaimed area and the antenna cable is located under this road. Jared stated that they plan to remove the cable and antenna this winter. The noxious weed Halogeton is present along the old pit highwall berm and in other surface disturbance in this area. Jared stated that he would address this and contact a weed control contractor soon.

Photo 1. Mine office and equipment yard photopoint panorama, looking east and south.

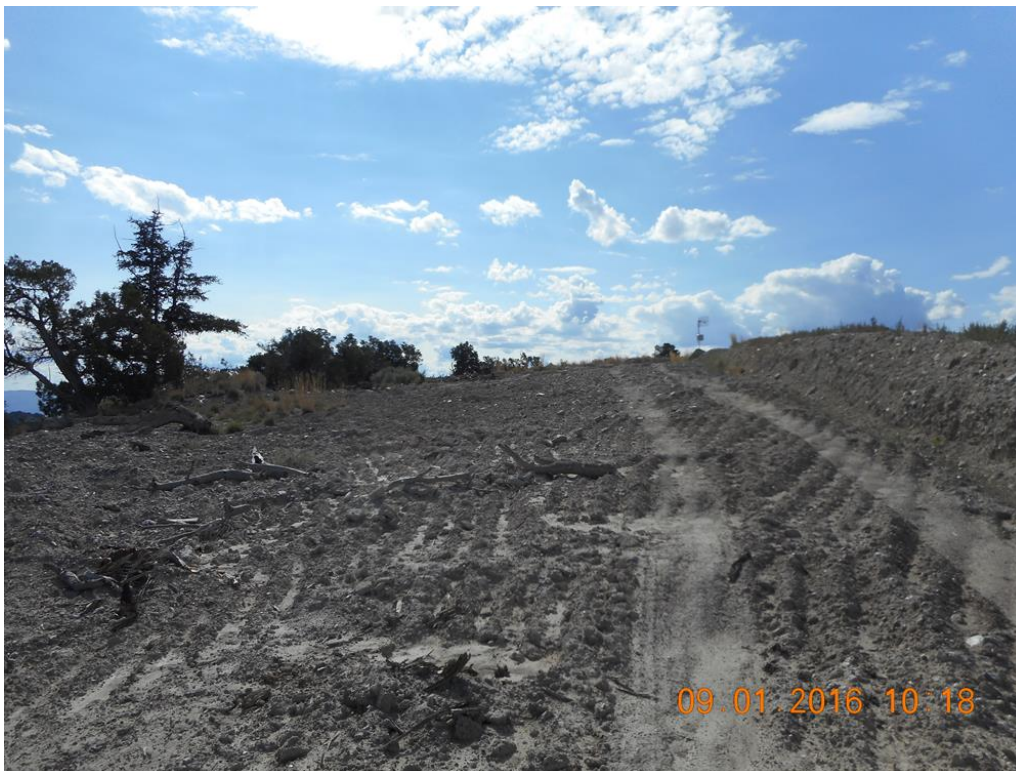
Photo 2. Looking southeast at reclaimed area southeast of the mine office.

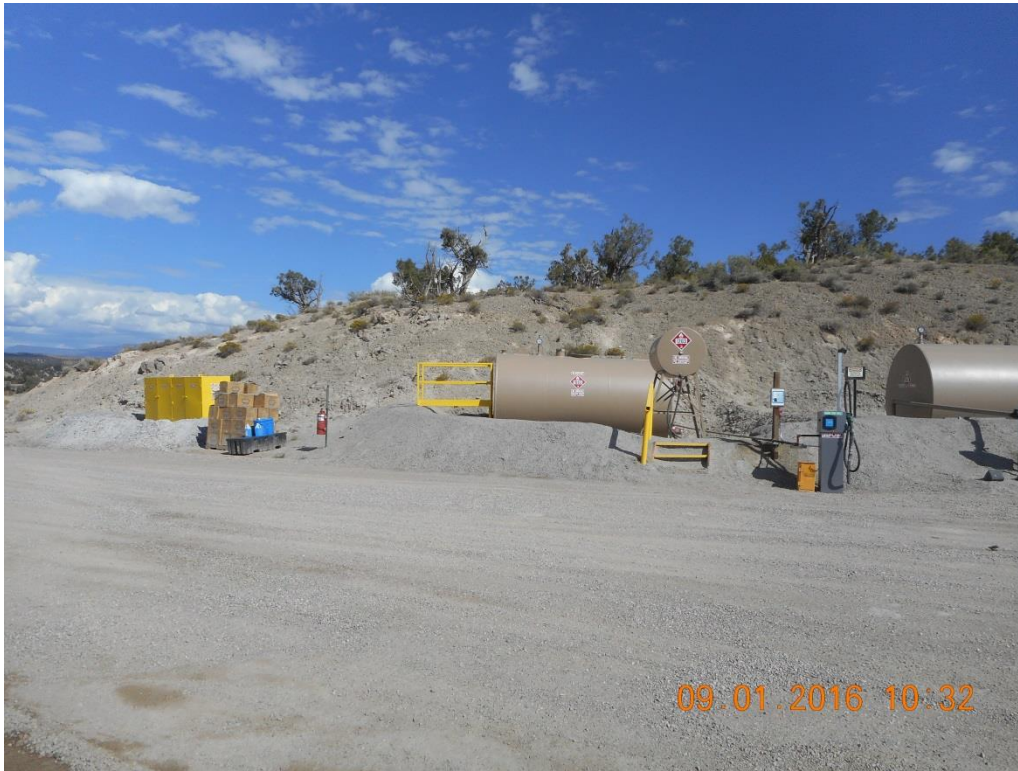
Fluid containment within the equipment yard area appears adequate. The berms around fuel tanks are adequate and there is no evidence of leaks. I observed a 10,000-gallon diesel tank, a 300-gallon gasoline tank, and a 4,000-gallon diesel tank within a 2-foot-tall earthen berm. The 55-gallon antifreeze tank that was leaking upon my last inspection was not present. The single 55-gallon barrel of windshield washer fluid on secondary

containment was replaced by multiple boxes containing 1-gallon jugs of windshield washer fluid on secondary containment (Photo 3). Metal sheds with double-wall containment and an earthen berm contains used oil and lubricants. The mine office and shop displayed good housekeeping practices. American Gypsum recently updated its SPCC Plan.

Photo 3. Looking north at fluid containment in equipment yard area.

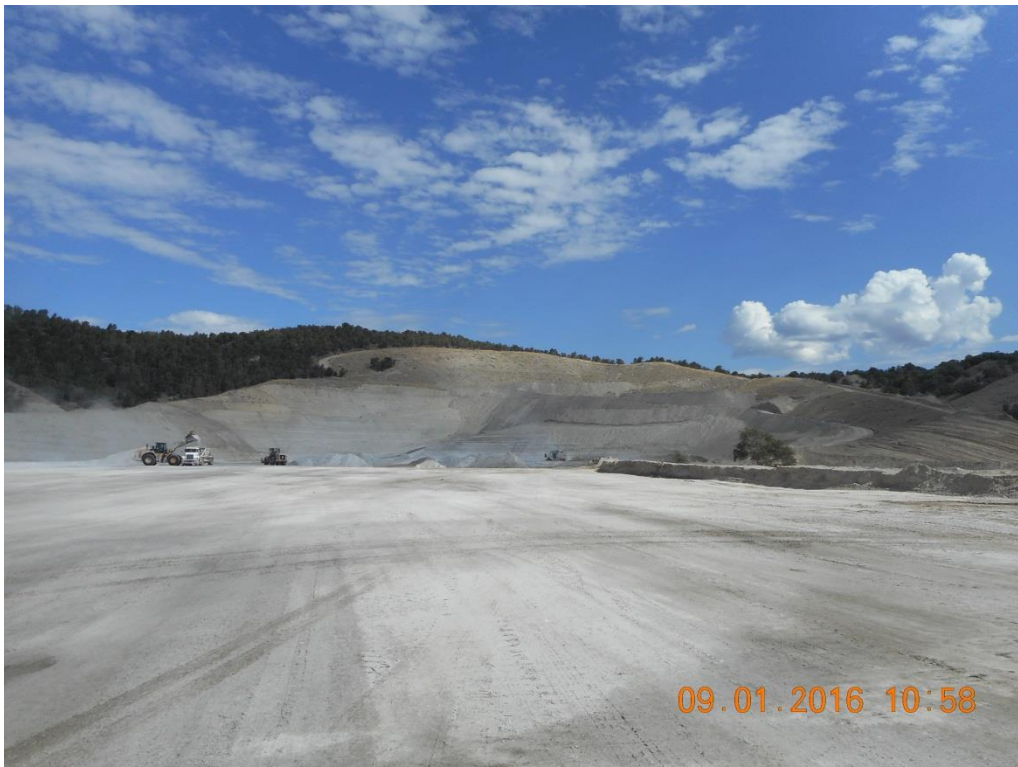
After visiting the old pit located on patented mining claims, we entered the new eastern pit. Mining is progressing to the south and downsection with activity also occurring in a small area on the north-central side. There is a highwall on the northern side of the active operation that is approximately 100 feet tall (Photo 4). Two rotomills were operating during my visit, as were two loaders and multiple haul trucks. A dozer was working in the concurrent reclamation area. American Gypsum plans to bring in a third rotomill with different attachments to work in the small north-central area. Operations occur 6 am to 5 pm, Monday through Friday. Mining operations are occurring according to the 2002 approved Plan of Operations.

Photo 4. Looking north at active mining operations.

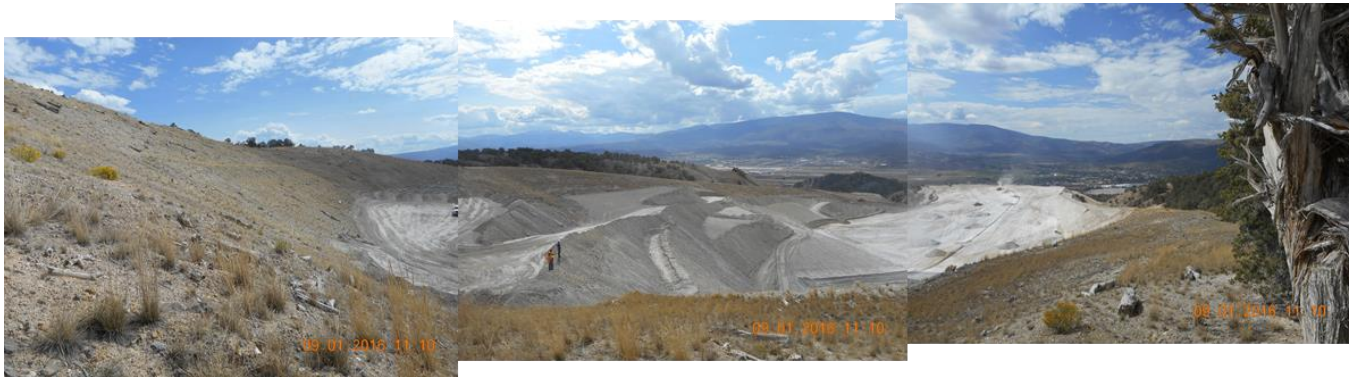
Concurrent reclamation is ongoing on the northern side of the active pit. The upper and central portion of the backfilled and reclaimed slope is steep. Grasses, small shrubs, and evidence of wildlife are present on this slope. Small shrubs and pinon and juniper seedlings are located along the top ridge of reclamation. I took photos at the north-central established photopoint and created a new photopoint on the northwest side of the reclamation (Photos 5 and 6, respectively). Future reclamation will be at a lower angle, closer to 3:1, so that equipment may safely operate up and down the slope. Future reclamation may utilize a pocking technique to establish vegetation. Concurrent reclamation will progress southward as mining continues. The reclamation plan within the 2002 approved Plan of Operations states: "Backfill material in all reclaimed slope areas will be compacted and sloped at a 2.5:1 ratio to allow for attainment of revegetation on reclaimed slopes." According to the BLM Solid Minerals Reclamation Handbook 3042-1: "Where practical, consider shaping the disturbance to a 3:1 slope (H:V) or flatter to enhance the success of revegetation" (BLM H-3042-1 Solid Mineral Reclamation Handbook, Chapter 11, Section B. Shaping, Grading, and Erosion Control).

Photo 5. Looking south at active mine and east to concurrent reclamation from northwestern photopoint.

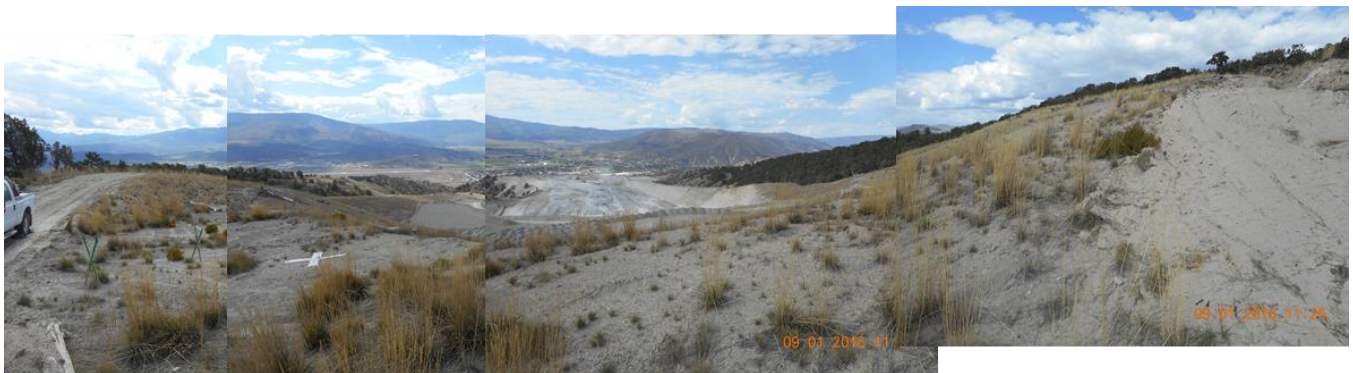
Photo 6. Looking south at active mine and concurrent reclamation from northern photopoint.

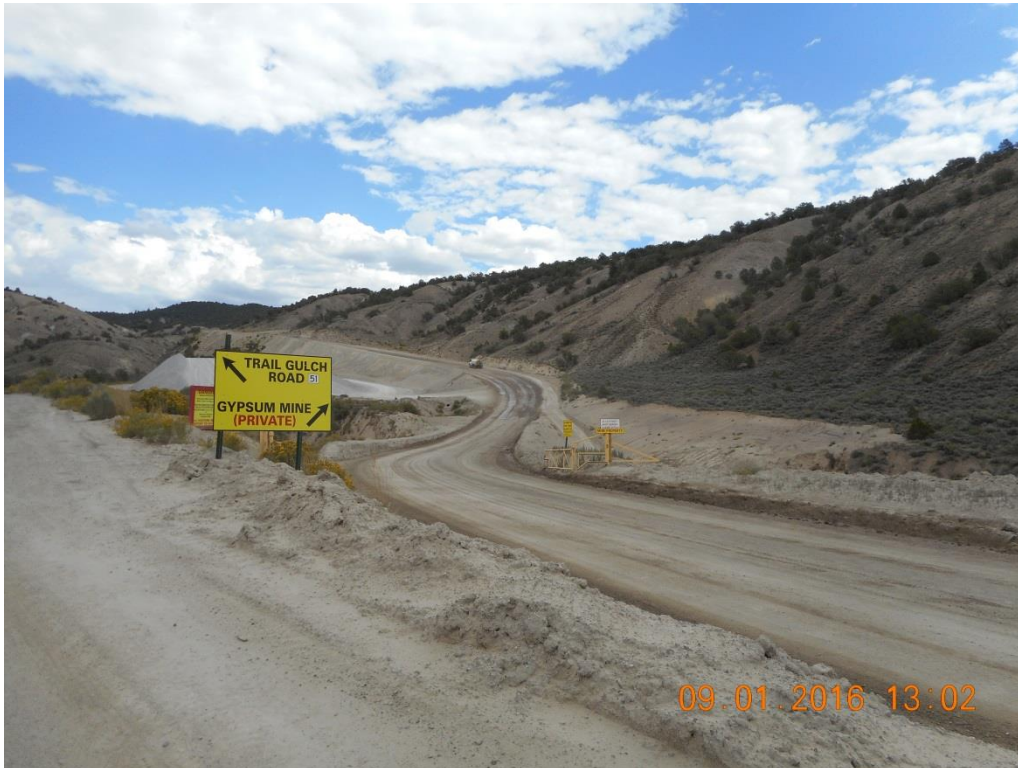
The haul road had large berms with good crowning and drainage ditches. Dust abatement was ongoing. I observed a water truck spraying the roads during my visit (Photo 7).

A gypsum ore stockpile is located directly east of the mine entrance gate and held approximately 65,000 tons at the time of my visit. The stockpile area was designed to hold a maximum of 100,000 tons of ore. This stockpile area was approved under the 1990 Record of Decision and constructed as insurance in case the mine and haul road is inaccessible due to adverse weather or road conditions.

There was adequate signage and a gate at the entrance to the operation. For safety purposes, American Gypsum closes this gate when the mine is not in operation. The BLM provided American Gypsum with 3715 occupancy concurrence for the gate, signage, mine office, and equipment yard on August 9, 2016.

Photo 7. Looking east at mine signage, stockpile located behind the signs, and haul road. Note water truck performing dust abatement on the haul road.
