Bureau of Land Management Colorado River Valley Field Office Minerals Inspection Report

General Information	
Date	9/1/2016
Project Name	Dotsero Quarry
Operator	Mayne Block & Stone
Serial Number	COC-066169
Project Classification	Mineral Materials Contract (expired 10/9/2011)
Project Location	T4S R 86W Sec 34 NWNW, Eagle County
Inspection Purpose	Annual site inspection (per BLM Handbook H-3600-1, Chapter VII, Sections B and C)
Time Period Onsite	1 hours
Attendees	Jessica Lopez Pearce, BLM Geologist
	Travis Marshall, DRMS Environmental Protection Specialist

Summary

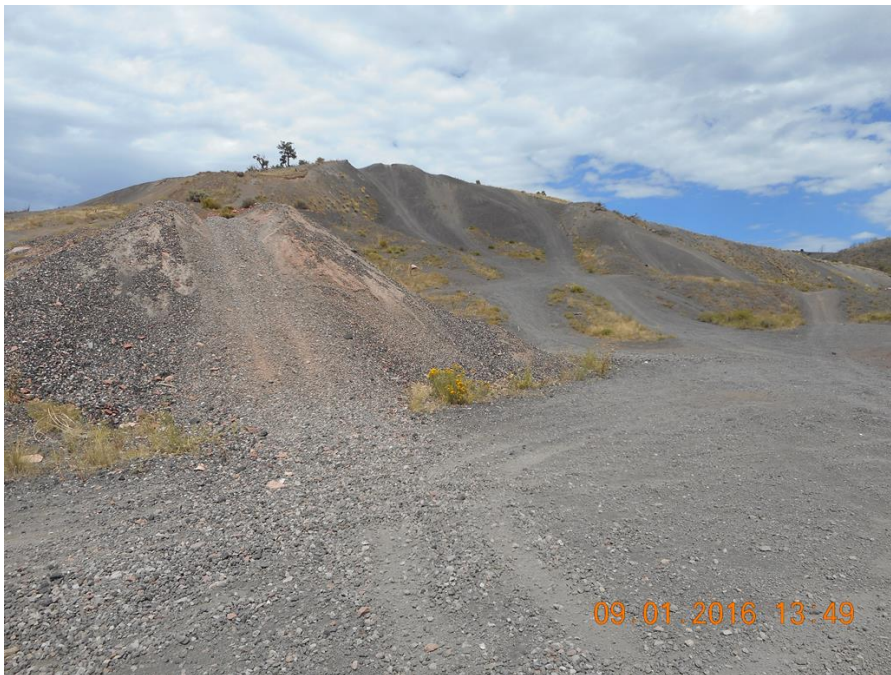
The quarry is currently inactive. Extensive surface disturbance has occurred on approximately 10 acres within the 65-acre permit area from commercial operations under a mineral materials contract. There are stockpiles of topsoil and screened material within the permit boundary. Mined slopes are approximately 2:1. There was no mining equipment observed on site. Heavy OHV use has created additional disturbance on the quarry highwall and throughout the site. A small amount of litter was observed.

Photo 1. Looking northeast at the quarry highwall. Note extensive OHV use throughout the area.

- The operator must conduct final reclamation activities.

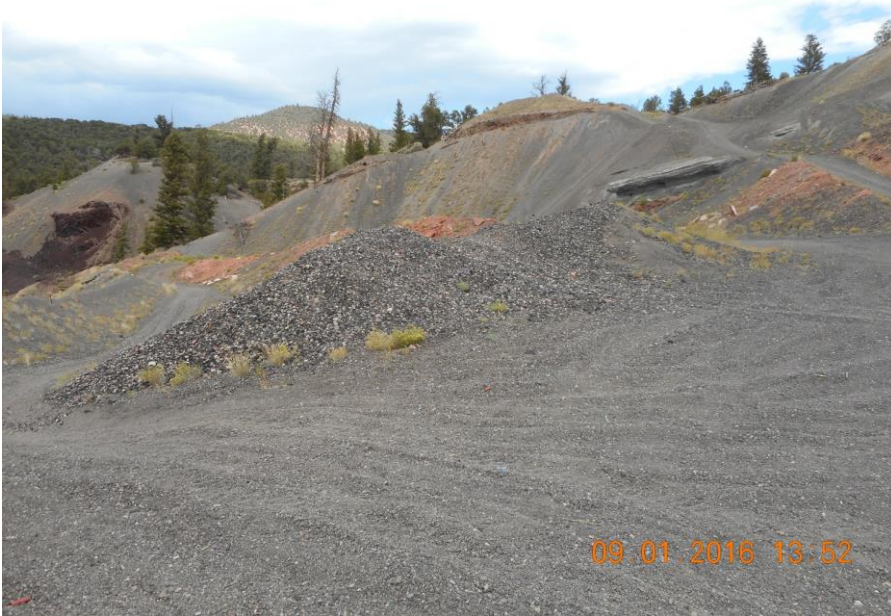
Photo 2. Looking northwest at northwestern portion of the quarry area. Screened stockpile in foreground.

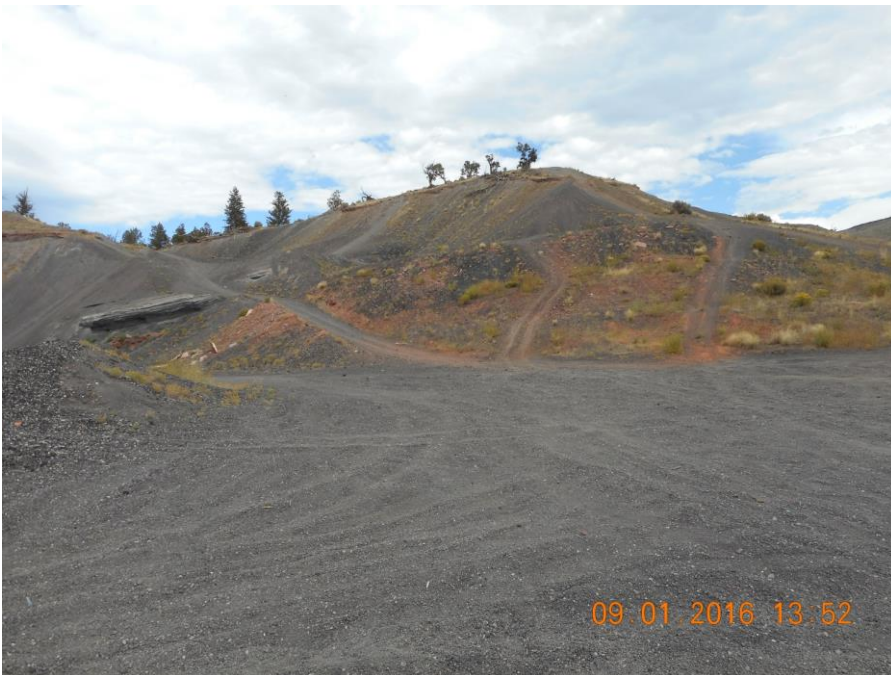
Photo 3. Looking north at quarry highwalls, access routes within the site, and extensive OHV use.

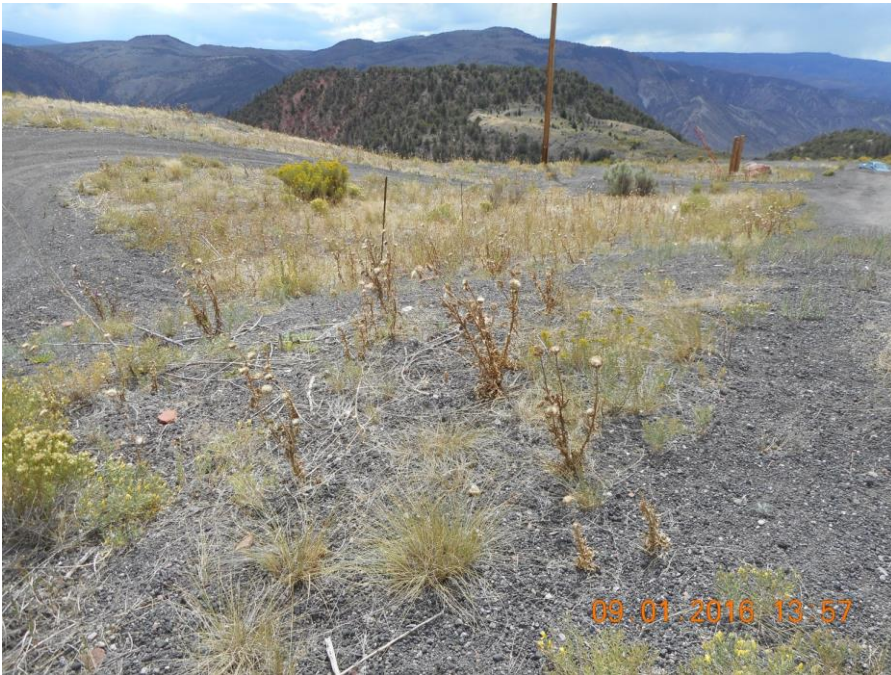
Some of the disturbed areas were covered in grasses, rabbitbrush, and sage. Invasive thistle was prevalent.

Photo 4. Looking south, noxious thistle in foreground.

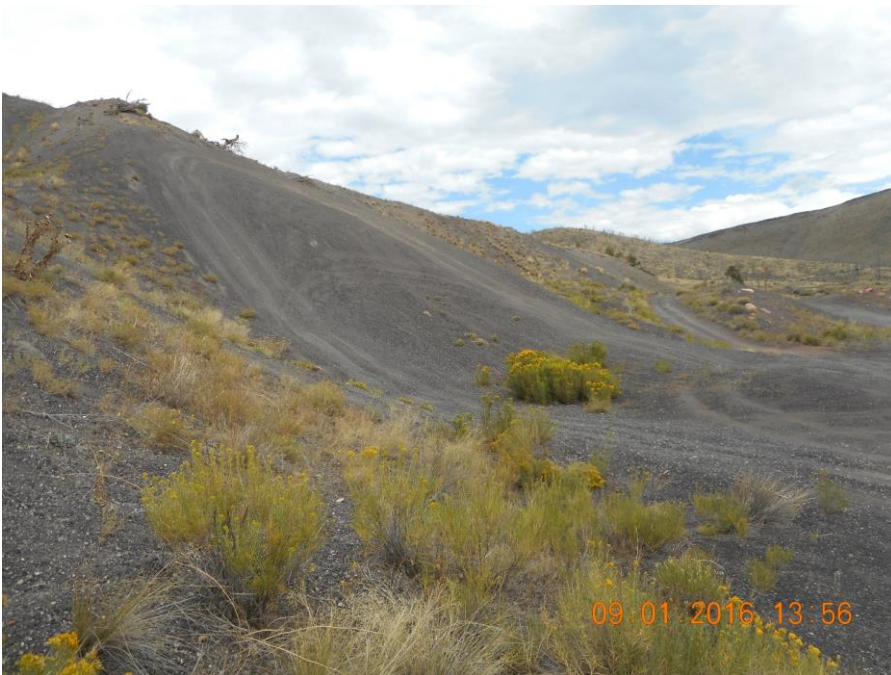
Photo 5. Looking east at highwall with OHV tracks.

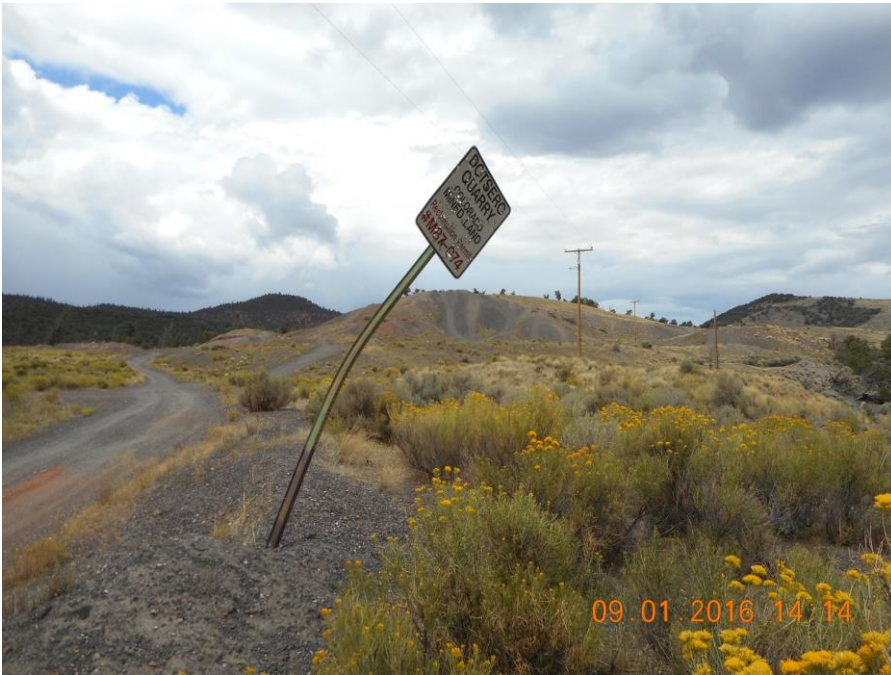
The quarry is accessible by travelling eastbound from Dotsero on Highway 6 and taking a left (north) on BLM 8460. This BLM route travels through several parcels of private land before heading uphill approximately 2 miles to Dotsero Crater. The Dotsero Quarry permit boundary is located on the eastern edge of Dotsero Crater. There was a partially destroyed DRMS sign present at the quarry entrance, but no BLM signage present. The site is unfenced.

Photo 6. Looking north at quarry area and DRMS sign.
