MINERALS PROGRAM INSPECTION REPORT
PHONE: (303) 866-3567

MINE NAME: Dotsero Quarry	MINE/PROSPECTING ID#: M-1987-074	MINERAL: Volcanic materials (a	COUNTY: Eagle
INSPECTION TYPE: Monitoring	INSPECTOR(S): Travis Marshall	INSP. DATE: September 1, 2016	INSP. TIME: 13:00
OPERATOR: Mayne Block & Stone Company	OPERATOR REPRESENTATIVE:	TYPE OF OPERATION: 112c - Construction Regular Operation	
REASON FOR INSPECTION: Normal I&E Program	BOND CALCULATION TYPE: Complete Bond	BOND AMOUNT: \$100.00	
DATE OF COMPLAINT: NA	POST INSP. CONTACTS: U.S.BLM	JOINT INSP. AGENCY: U.S.BLM	
WEATHER: Cloudy	INSPECTOR'S SIGNATURE:

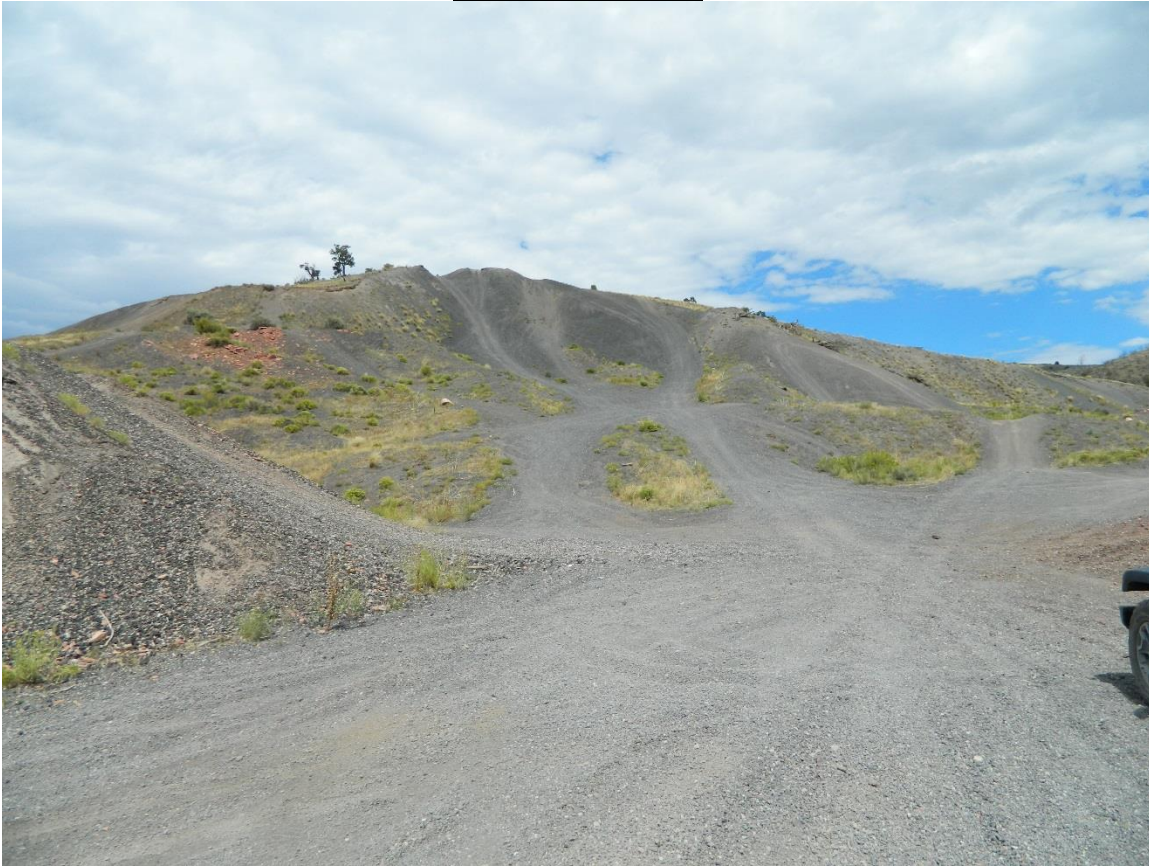
The reclaimed slopes appear to be at or near the approved 2H:1V. Many slopes in the mine site still require additional regrading and seed application. Vegetation on the reclaimed slopes consisted of a variety of grasses and shrubs. The area is heavily used by OHV's which have created tracks and trails that go up and down the mined slopes. Slopes that have heavy use by OHV's are void of vegetation and slopes not disturbed by OHV have adequate vegetation. The permit area is on public land with a public road going through the middle of the mined area. The operator should work closely with the land manager to develop a plan that minimizes public access allowing reclamation to be successfully completed at the site.

Evidence of heavy OHV use within permit boundary.

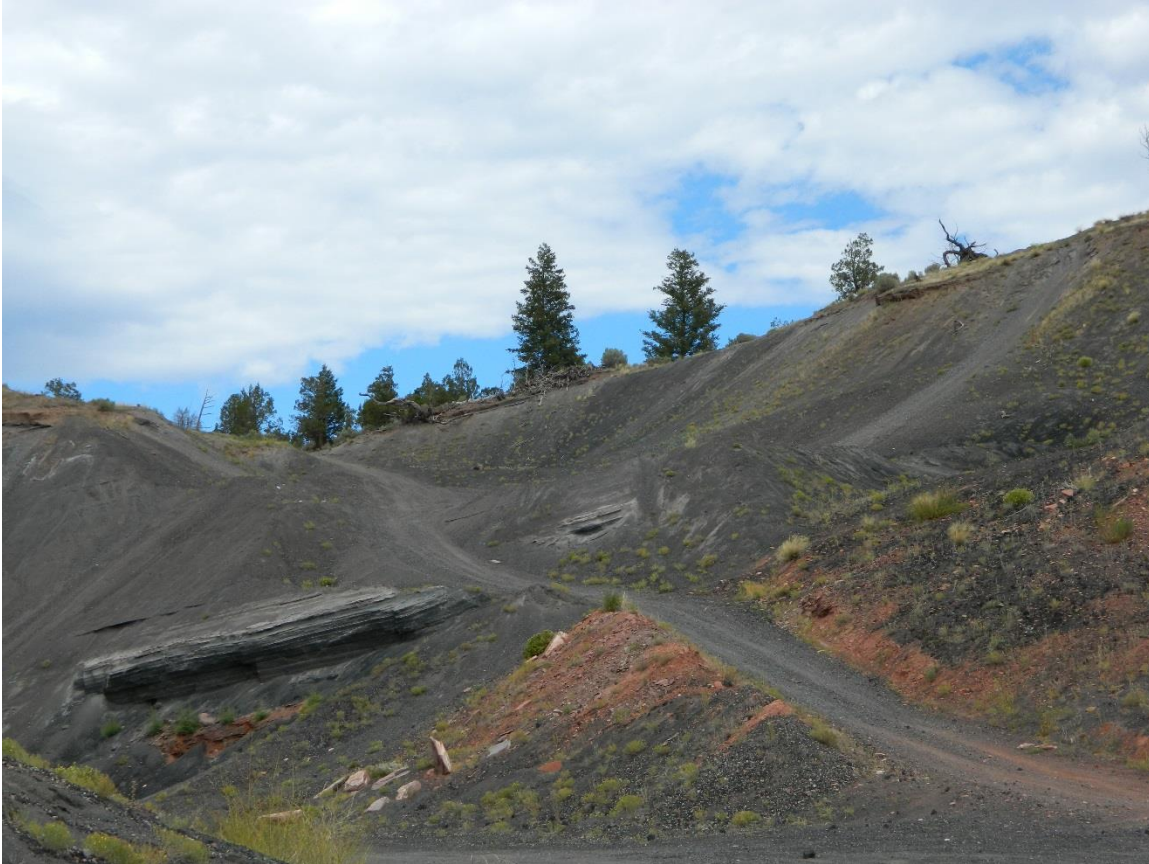
Mined area that needs regrading. Note OHV use within permit area.

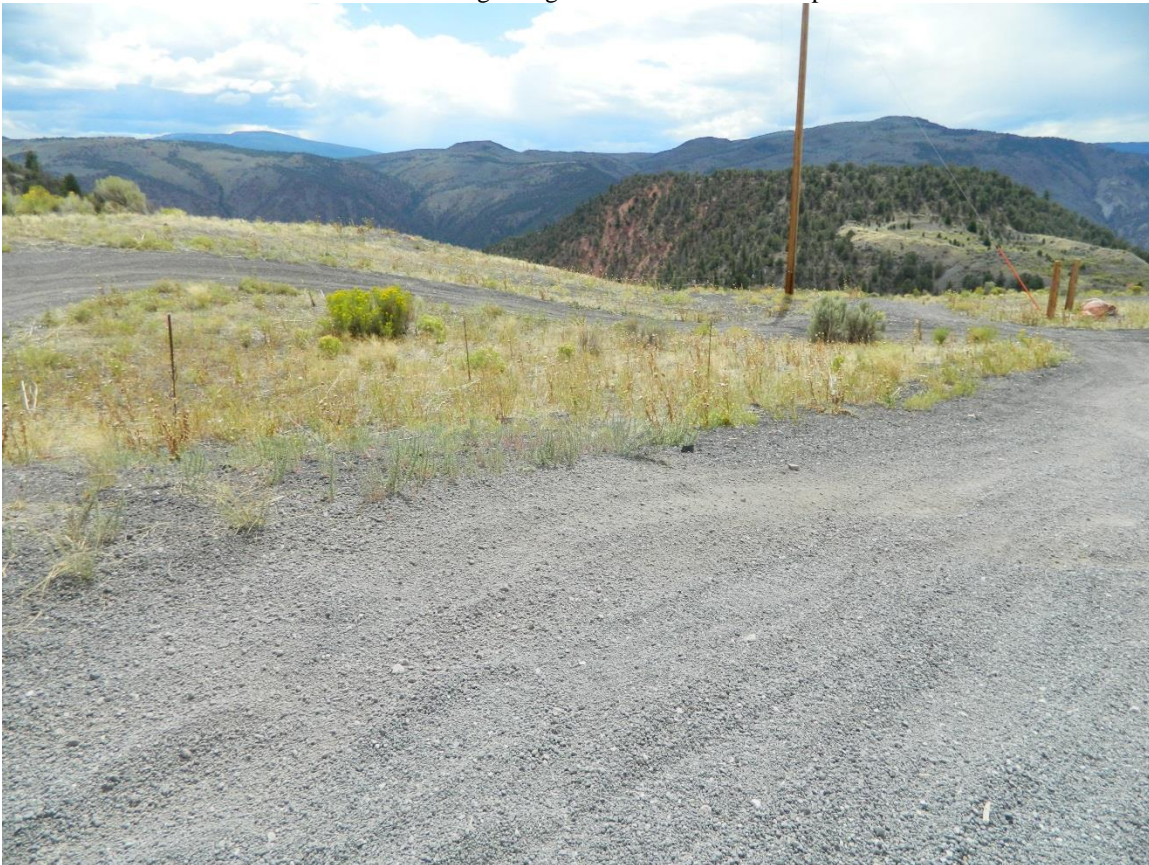
A variety of weeds were observed within the permit area but none appeared to be noxious. A few thistles were observed in the eastern portion of the disturbed area. Based on the leaf structure the species present appears to be Flodman's Thistle which is a native thistle to Colorado. It is recommended that the thistle be treated in future growing seasons to prevent a large infestation and promotion of more desirable vegetation.

Area with thistle that appears to not have been treated.

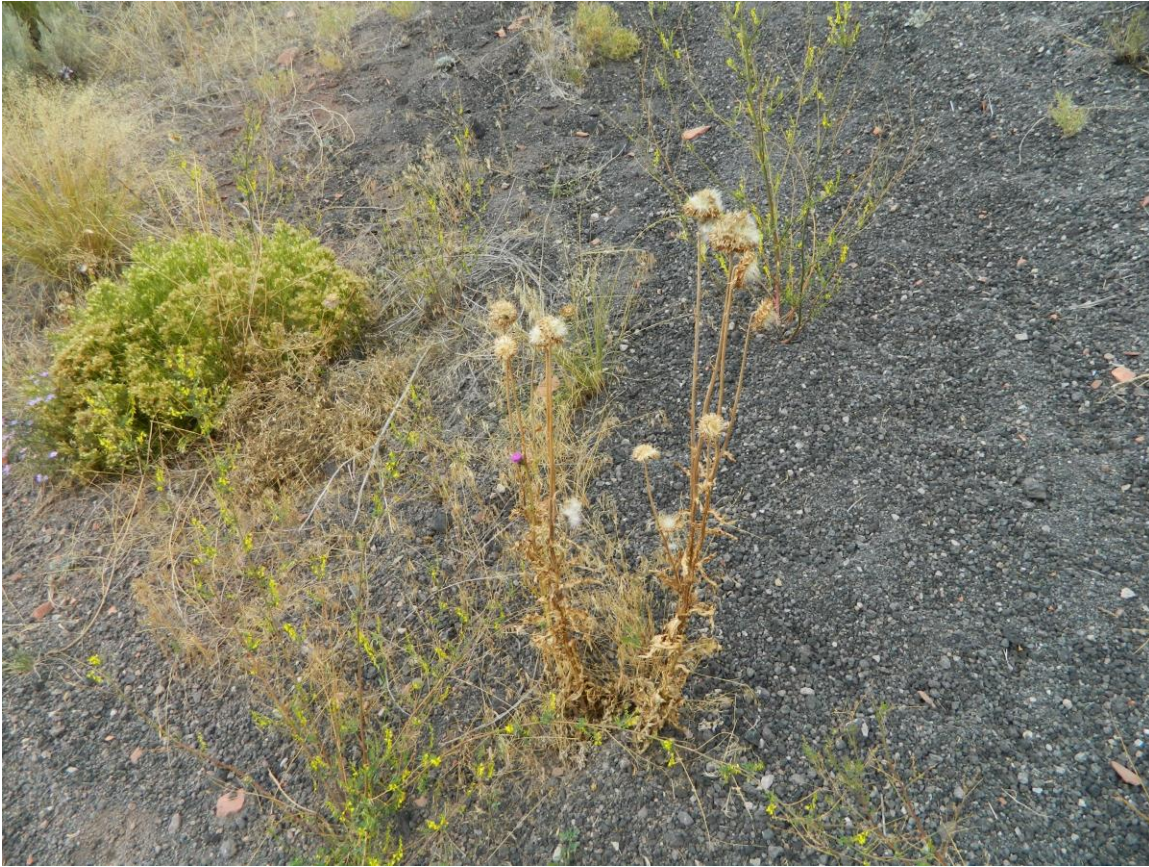
Flodman's Thistle

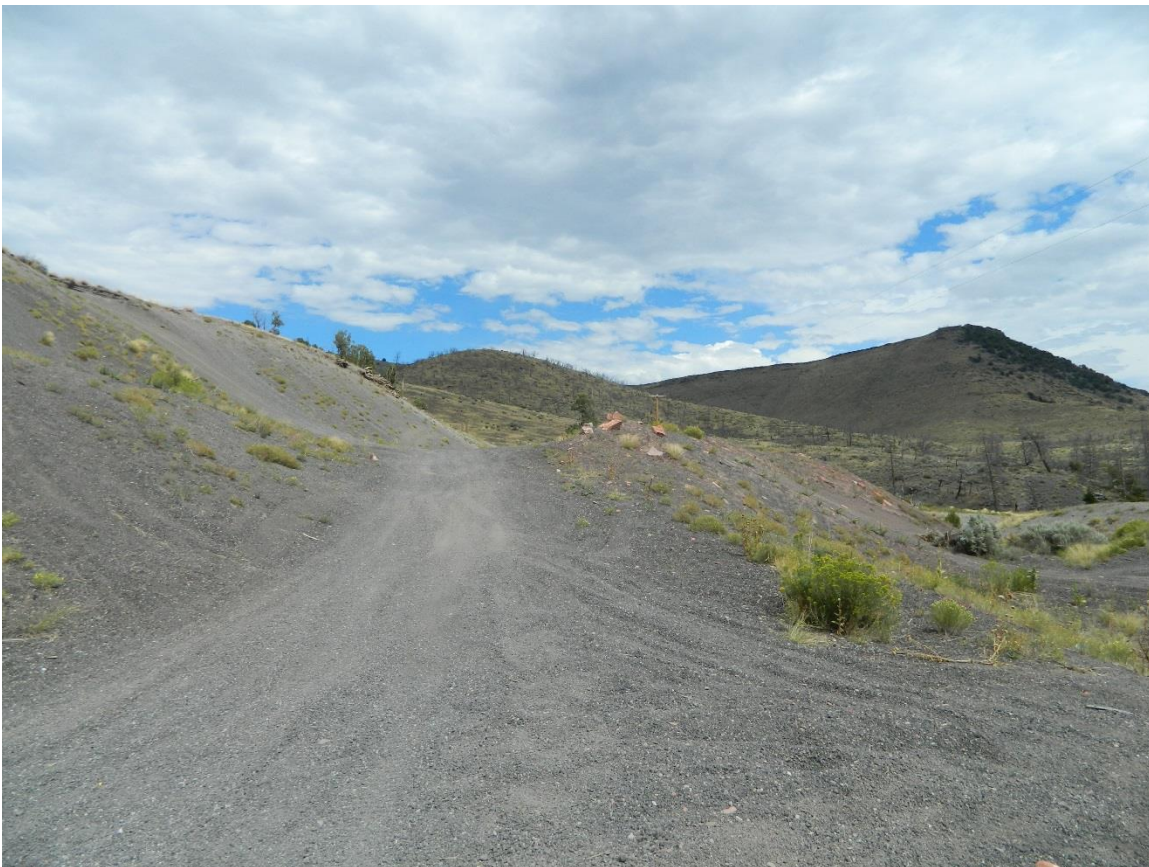
Public road through permit area.

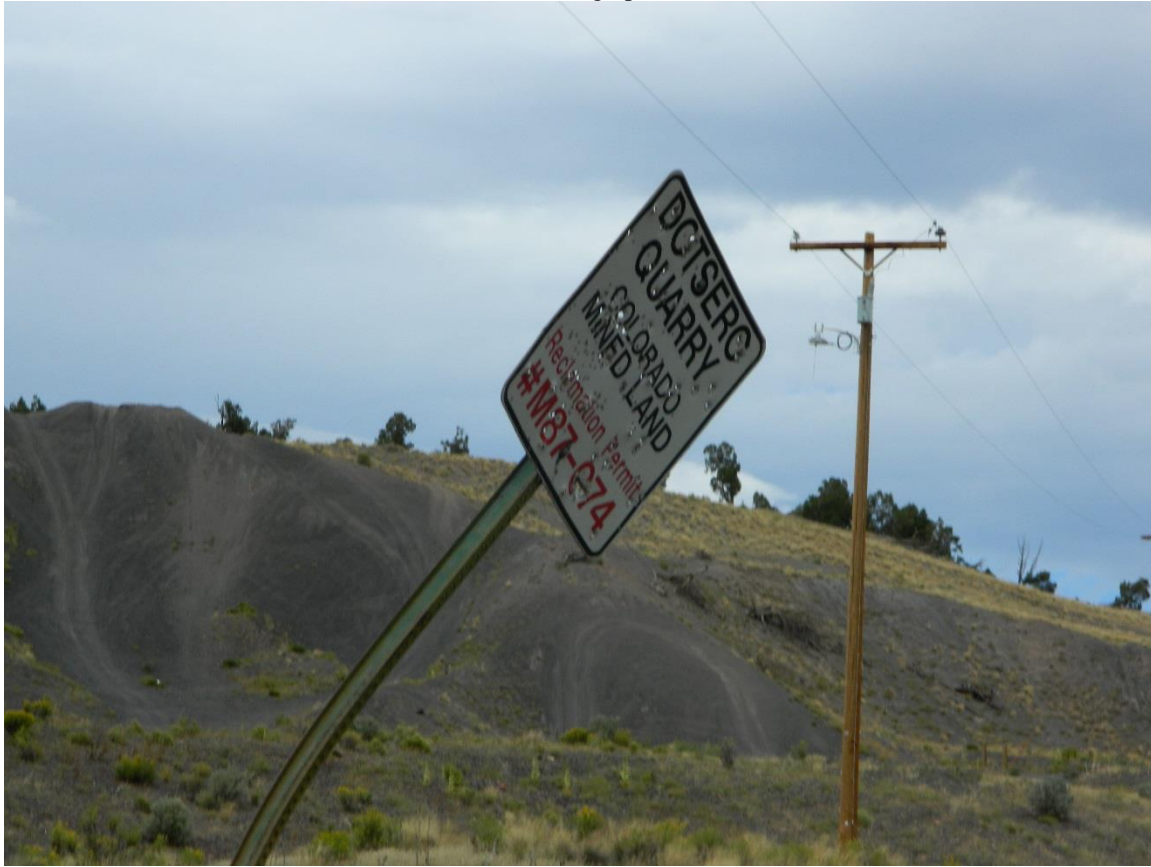
The mine identification sign and permit boundary markers were in place and in compliance with Rule 3.1.12. The sign appeared to have been vandalized.

Vandalized sign at mine entrance.
