**MINERALS PROGRAM INSPECTION REPORT**  
**PHONE: (303) 866-3567**

<b>MINE NAME:</b> Crader Gravel Pit	<b>MINE/PROSPECTING ID#:</b> M-1981-114	<b>MINERAL:</b> Sand and gravel	<b>COUNTY:</b> La Plata
<b>INSPECTION TYPE:</b> Monitoring	<b>INSPECTOR(S):</b> Lucas J. West	<b>INSP. DATE:</b> September 15, 2016	<b>INSP. TIME:</b> 08:00
<b>OPERATOR:</b> La Plata County	<b>OPERATOR REPRESENTATIVE:</b> Leslie Jakoby, Gereard Gurule	<b>TYPE OF OPERATION:</b> 112c - Construction Regular Operation	
<b>REASON FOR INSPECTION:</b> Normal I&E Program	<b>BOND CALCULATION TYPE:</b> None	<b>BOND AMOUNT:</b> \$0.00	
<b>DATE OF COMPLAINT:</b> NA	<b>POST INSP. CONTACTS:</b> None	<b>JOINT INSP. AGENCY:</b> None	
<b>WEATHER:</b> Clear	<b>INSPECTOR'S SIGNATURE:</b>

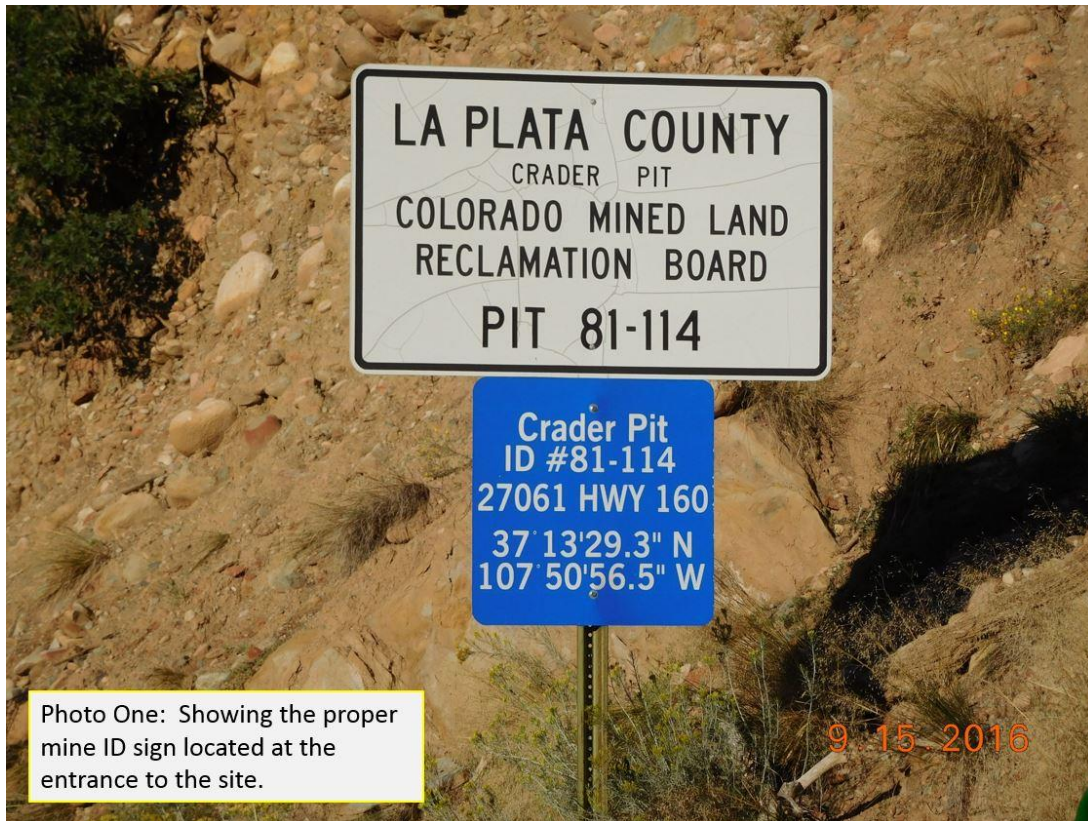
Proper mine identification signage was posted at the entrance to site and is shown in Photo One. The permit boundaries are clearly marked with signs and earthen berms around the site. The site was not active during the inspection and the only equipment noted on site was a track hoe. The mining activity is being carried out in phases with all of the active mining being located in Phase One. The active highwall is approximately 40 feet tall on average and stretches between 100 and 150 linear feet. The highwall is in good condition and appears to be stable as seen in Photo Two. The highwall also serves as the boundary between the Crader pit and the adjacent Montoya pit operated by C & J Gravel. The mining plan outlines for the removal of the material making up the highwall which will daylight the Crader Pit to the Montoya Pit. On site discussions with the operator indicate that the highwall will not be removed for a few years and will be done in conjunction with C & J Gravel.

Photo One: Showing the proper mine ID sign located at the entrance to the site.

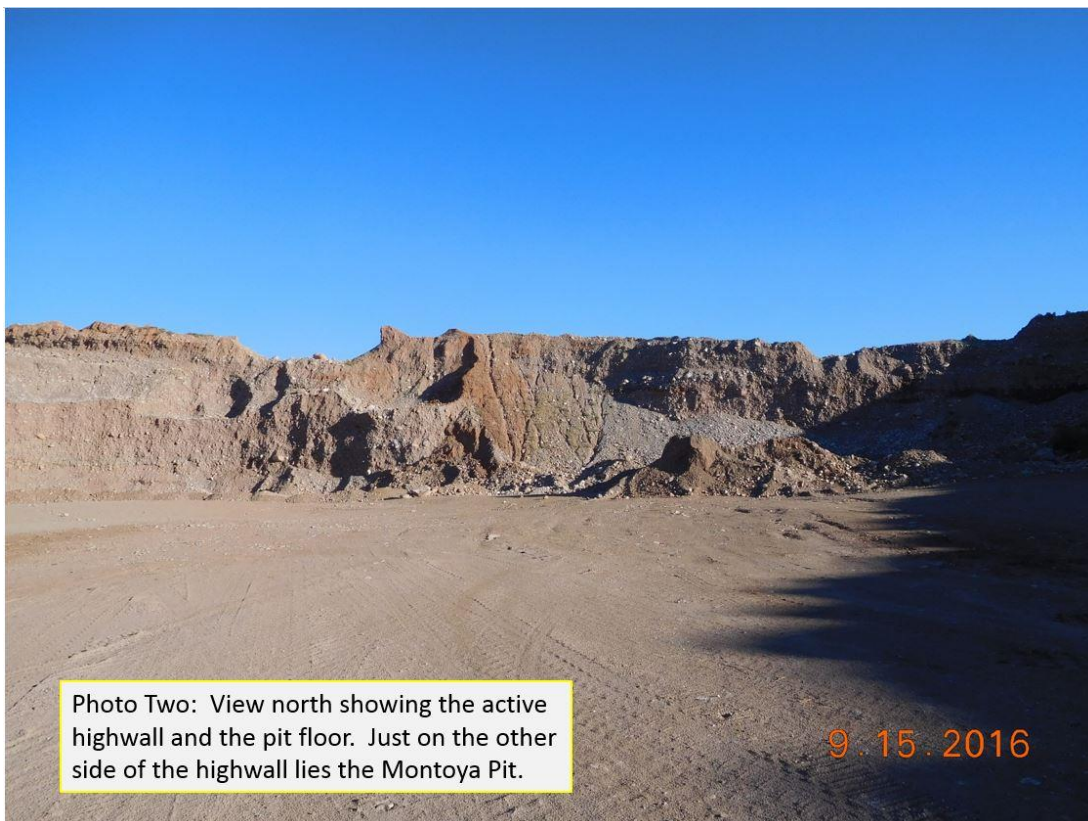
Photo Two: View north showing the active highwall and the pit floor. Just on the other side of the highwall lies the Montoya Pit.

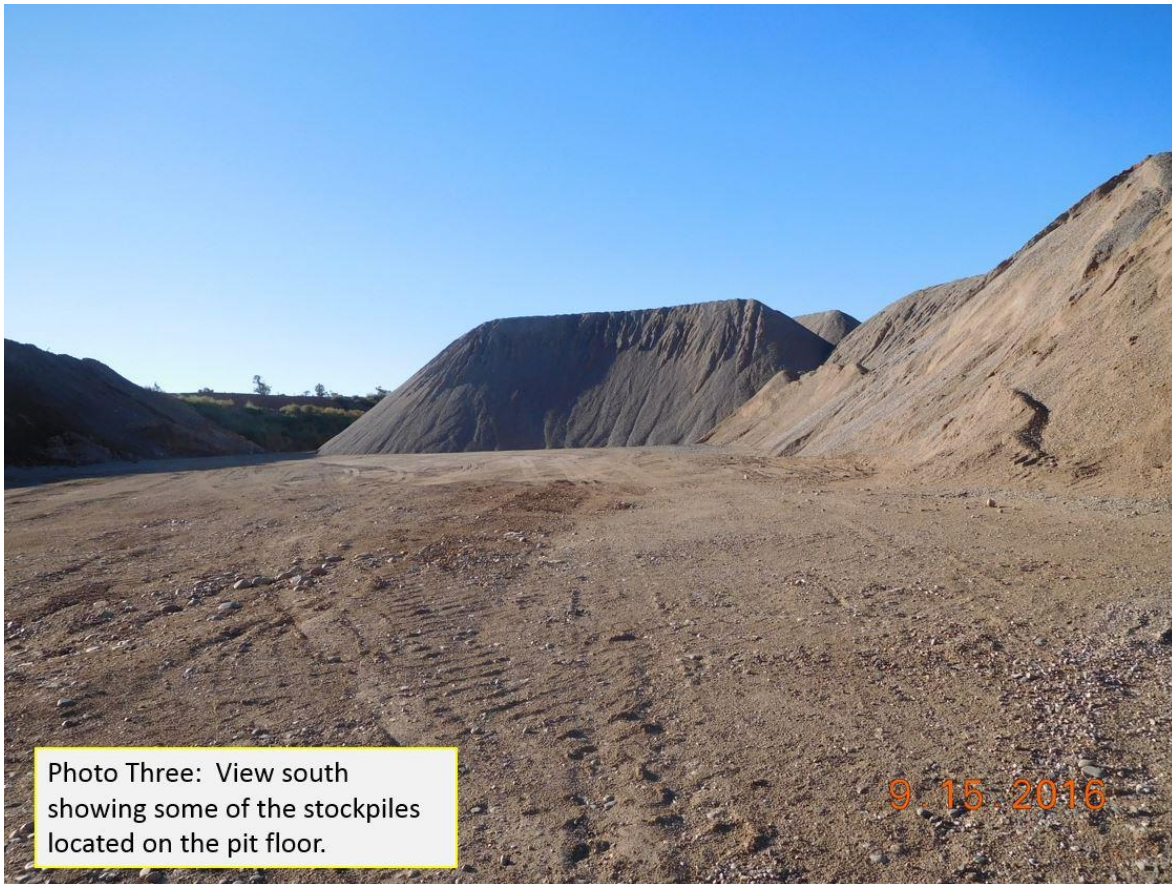
Several stockpiles were observed on site, some being located on the pit floor shown in Photo Three and others being located near the entrance to the site in the un-mined phases. All stockpiles were in good condition and appear to be stable. The un-mined areas of Phase 2 and Phase 8, which are adjacent sections, are being used as a materials storage area and fenced in facility shown in Photos Four and Five. All materials and items being stored both in and out of the fenced area are in a neat and orderly fashion and are not considered a problem. The site exhibits positive drainage and no erosional issues were noted during this inspection. No noxious weeds were observed, and the operator indicated that the site undergoes ongoing weed management by the County weed department. The overall footprint of the site is in good condition and free from trash and debris. No problems or possible violations were noted during the inspection.

Photo Three: View south showing some of the stockpiles located on the pit floor.

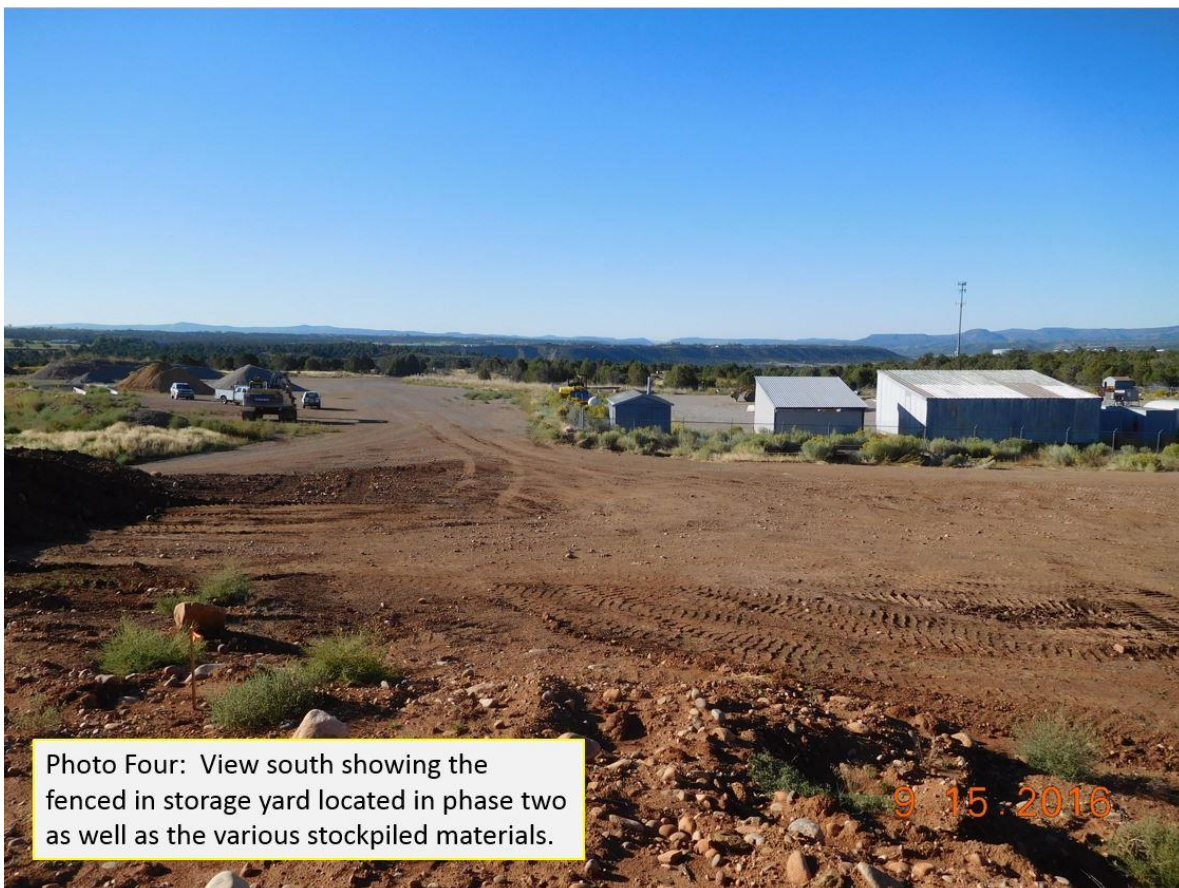
Photo Four: View south showing the fenced in storage yard located in phase two as well as the various stockpiled materials.
