MINERALS PROGRAM INSPECTION REPORT
PHONE: (303) 866-3567

MINE NAME: Henderson Mine	MINE/PROSPECTING ID#: M-1977-342	MINERAL: Molybdenum	COUNTY: Clear Creek, Grand
INSPECTION TYPE: Monitoring	INSPECTOR(S): Peter S. Hays	INSP. DATE: September 22, 2016	INSP. TIME: 09:00
OPERATOR: Climax Molybdenum Company	OPERATOR REPRESENTATIVE: Tim Haynes, Lisa Yenne	TYPE OF OPERATION: 112d-3 - Designated Mining Operation	
REASON FOR INSPECTION: Normal I&E Program	BOND CALCULATION TYPE: None	BOND AMOUNT: \$35,084,835.00	
DATE OF COMPLAINT: NA	POST INSP. CONTACTS: None	JOINT INSP. AGENCY:	
WEATHER: Clear	INSPECTOR'S SIGNATURE:

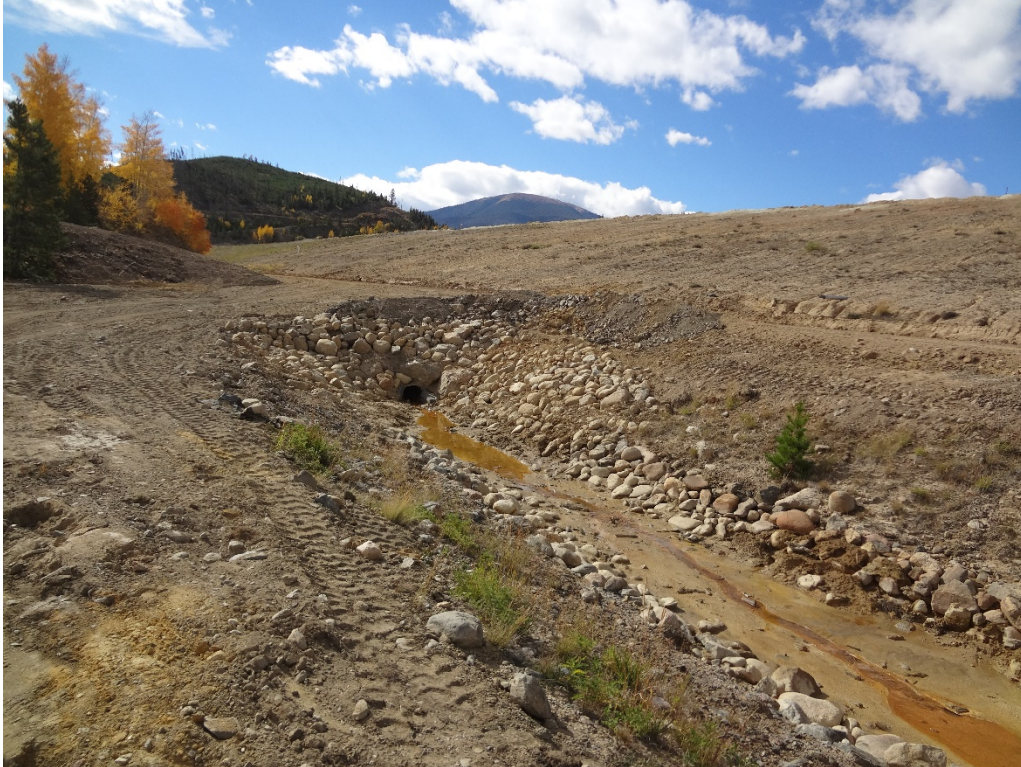
View of reconfigured collection ditch at north toe of 3-Dam

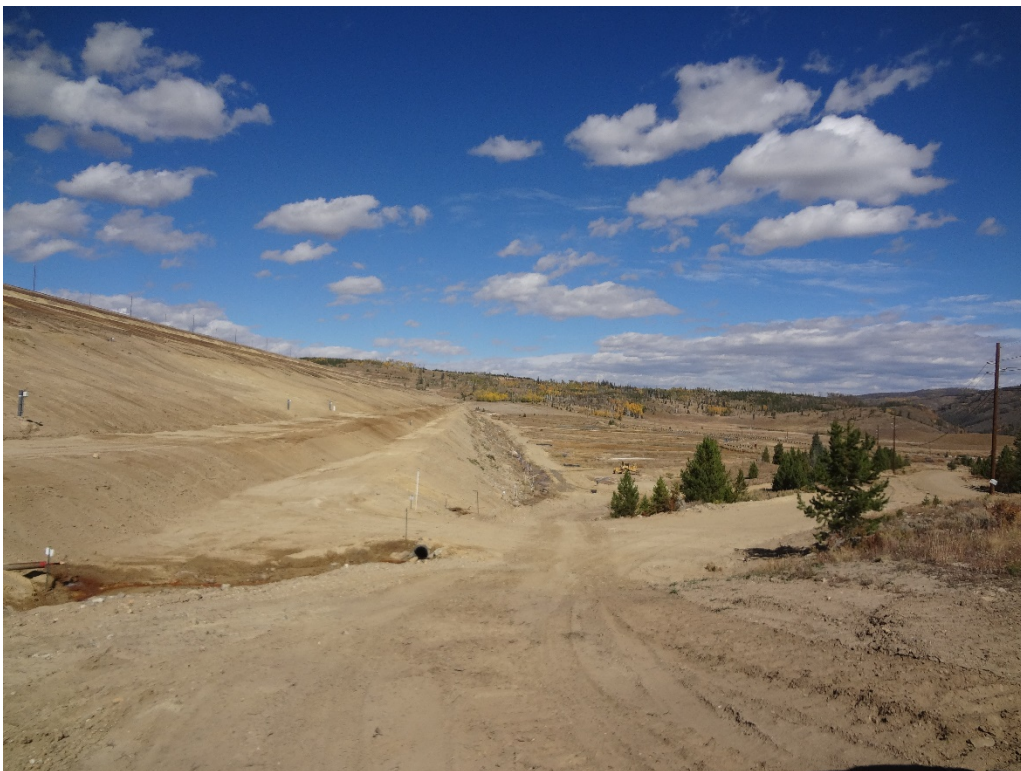
View of 1-Dam "A" Bench from south end looking north

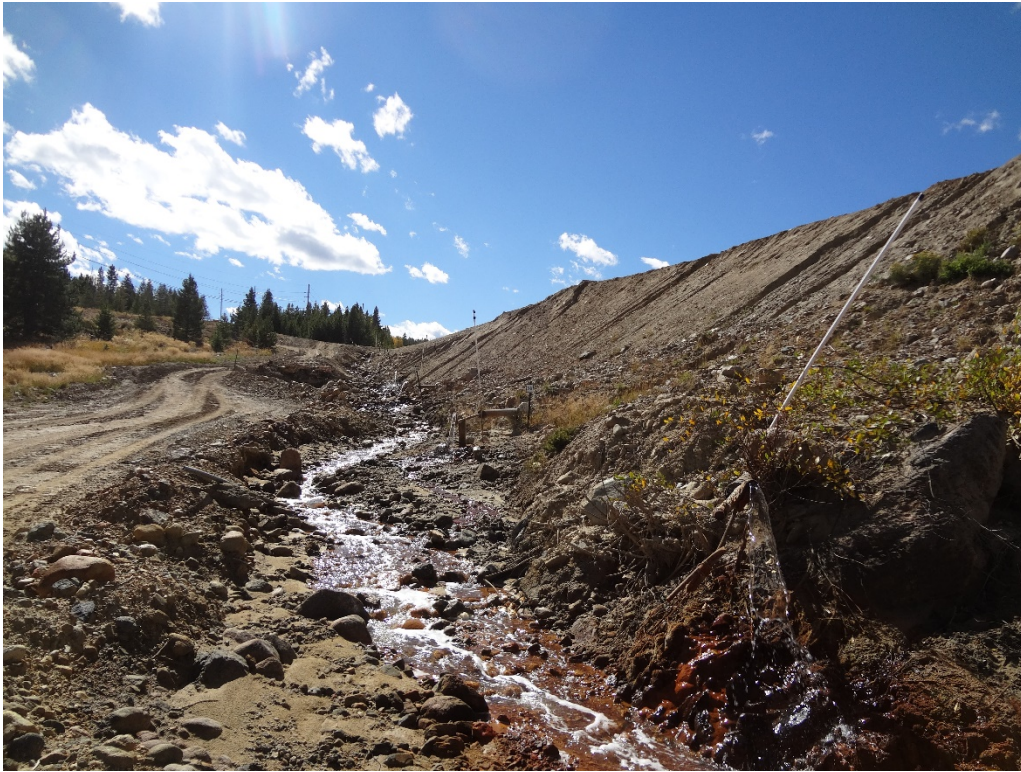
View of horizontal drains at the south end of 1-Dam looking south

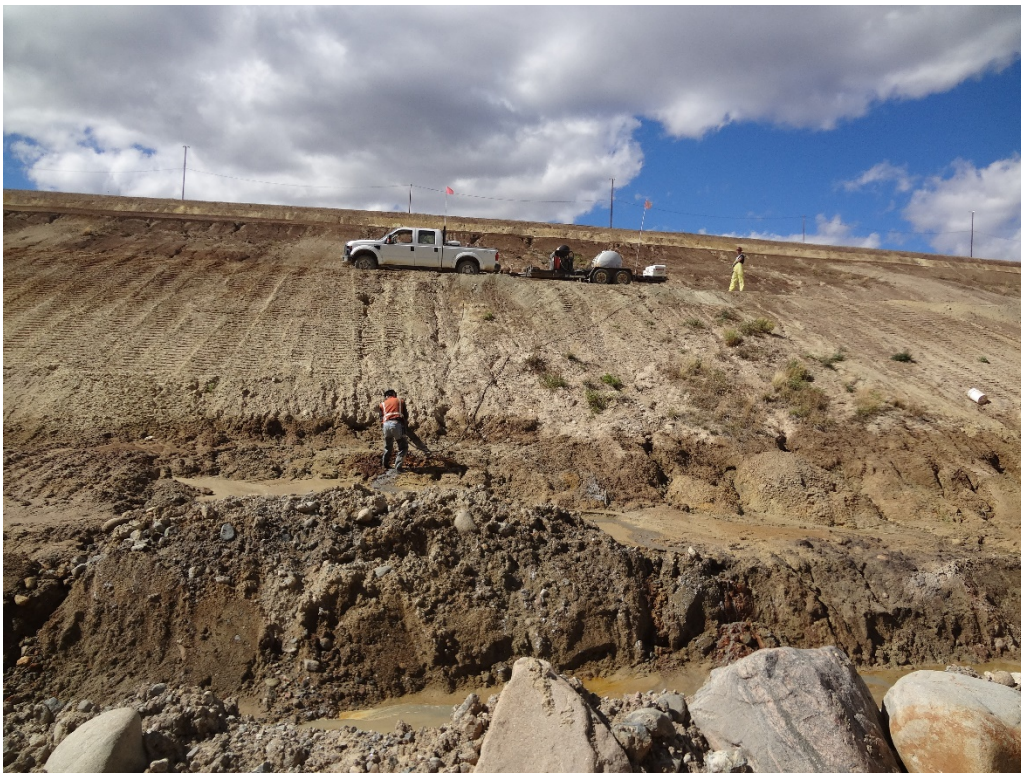
The toe of 3-Dam and 1-Dam were inspected from south to north to observe the flow of water from the foundation and horizontal drains. Evidence of recent horizontal drain jetting were observed at the south end of the 3-Dam. The cleaning of horizontal drains at the north end of 1-Dam was observed during the inspection.

Horizontal drain cleaning at the north end of 1-Dam

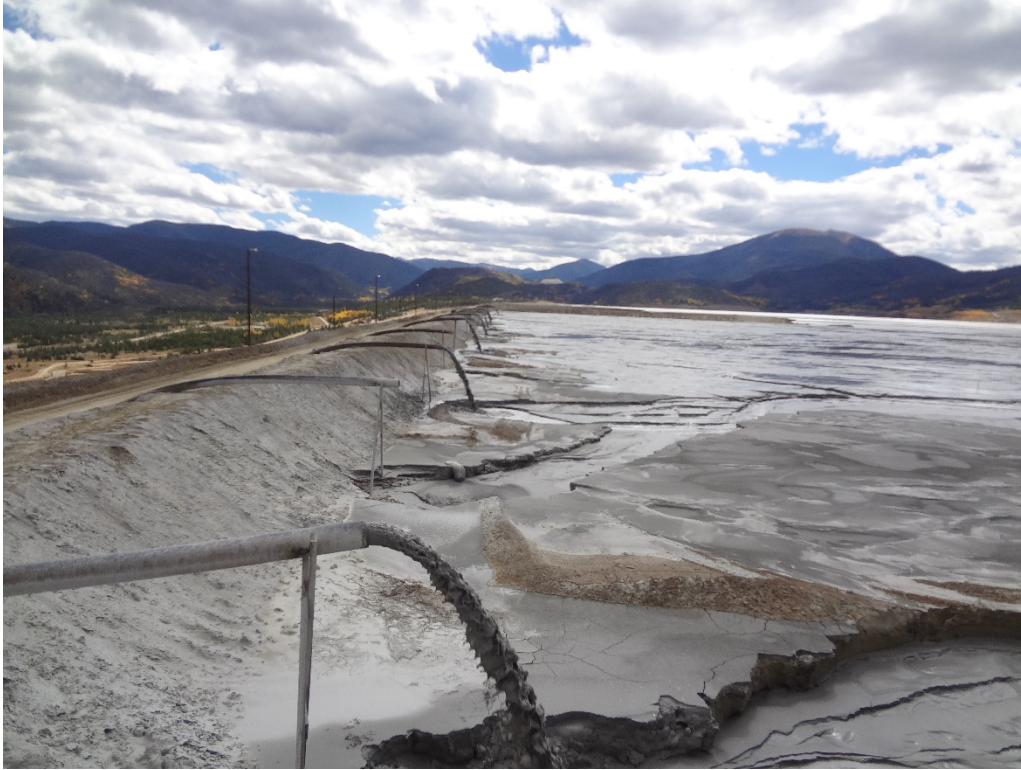
The spigot deposition of tailings was observed in Cells 1 through 7. Cells 6 and 7 were actively depositing during the inspection. Tailings deposition is expect to change to lead-off deposition in November or October. The step-back area of 3-Dam was inspected for stormwater collection and transportation to the toe of the dam.

Spigot deposition of tailings in Cell 7 of 1-Dam
