RE: Fedinec Pit, Permit No. M-1977-057, Unresolved Problem(s) Noted in a Past Inspection Report

COLORADO DIVISION OF RECLAMATION, MINING AND SAFETY
MINERALS PROGRAM INSPECTION REPORT
PHONE: (303) 866-3567

MINE NAME: Fedinec Pit	MINE/PROSPECTING ID#: M-1977-057	MINERAL: Crushed stone material	COUNTY: Moffat
INSPECTION TYPE: Monitoring	INSPECTOR(S): Amy C. Yeldell	INSP. DATE: May 10, 2016	INSP. TIME: 12:00
OPERATOR: Pioneer Sand Company, Inc.	OPERATOR REPRESENTATIVE: Wayne Brantley	TYPE OF OPERATION: 110c - Construction Limited Impact	
REASON FOR INSPECTION: Normal I&E Program	BOND CALCULATION TYPE: None	BOND AMOUNT: \$19,300.00	
DATE OF COMPLAINT: NA	POST INSP. CONTACTS: None	JOINT INSP. AGENCY: None	
WEATHER: Clear	INSPECTOR'S SIGNATURE:

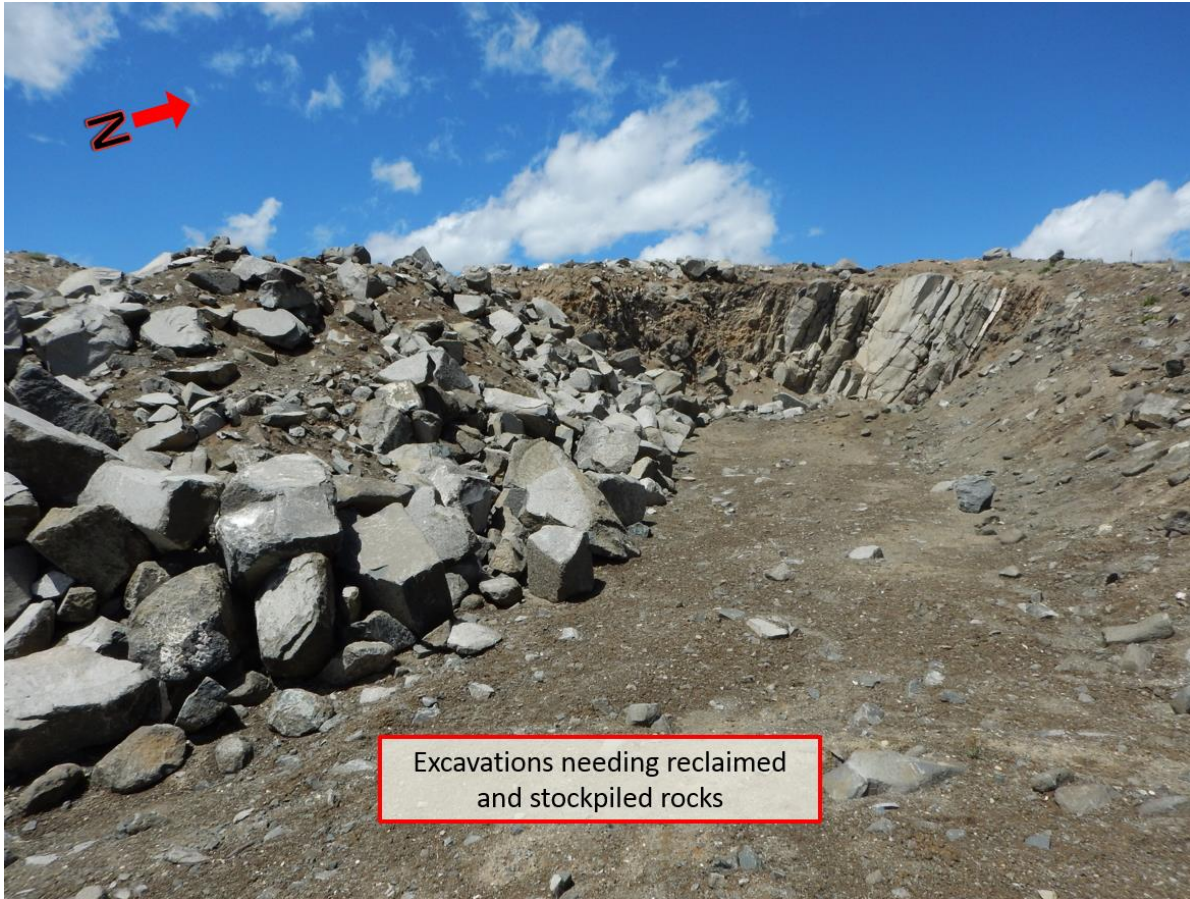
Excavations needing reclaimed
and stockpiled rocks

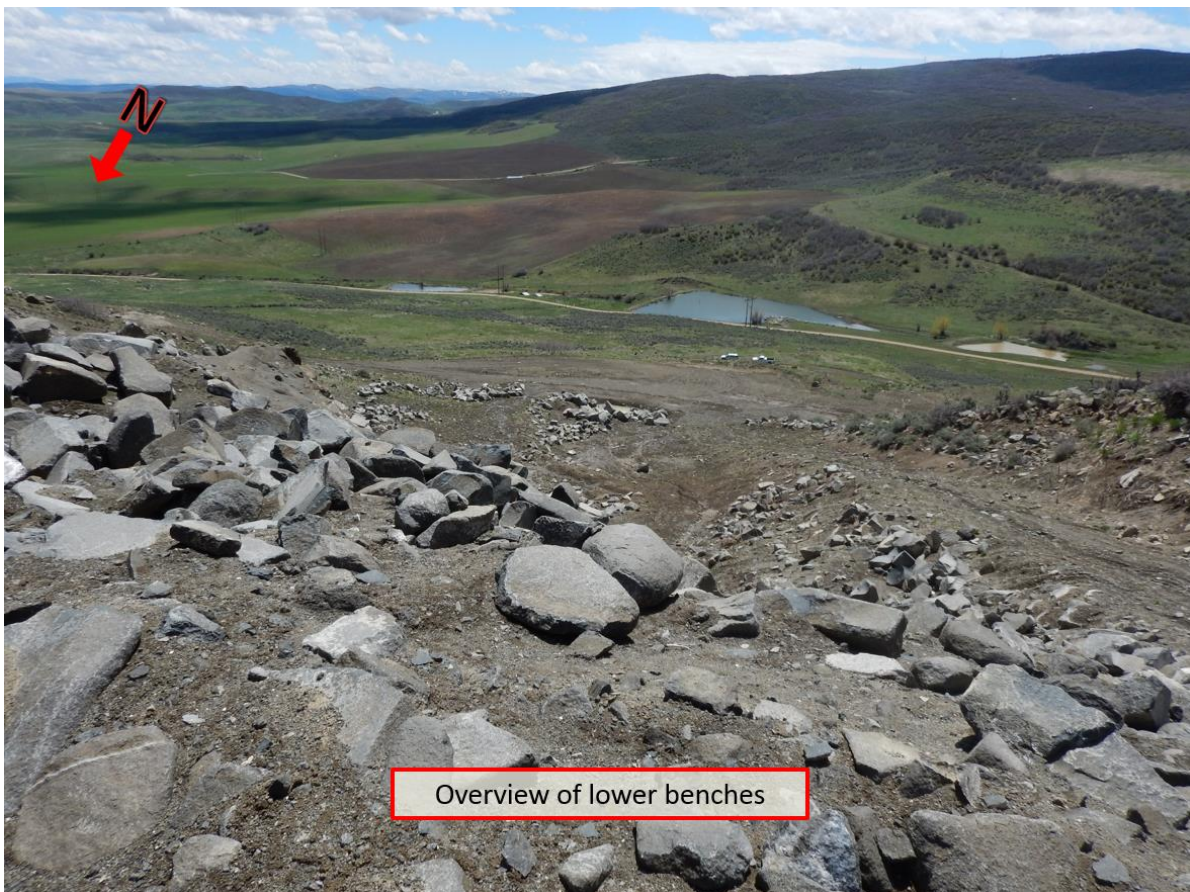
Overview of lower benches

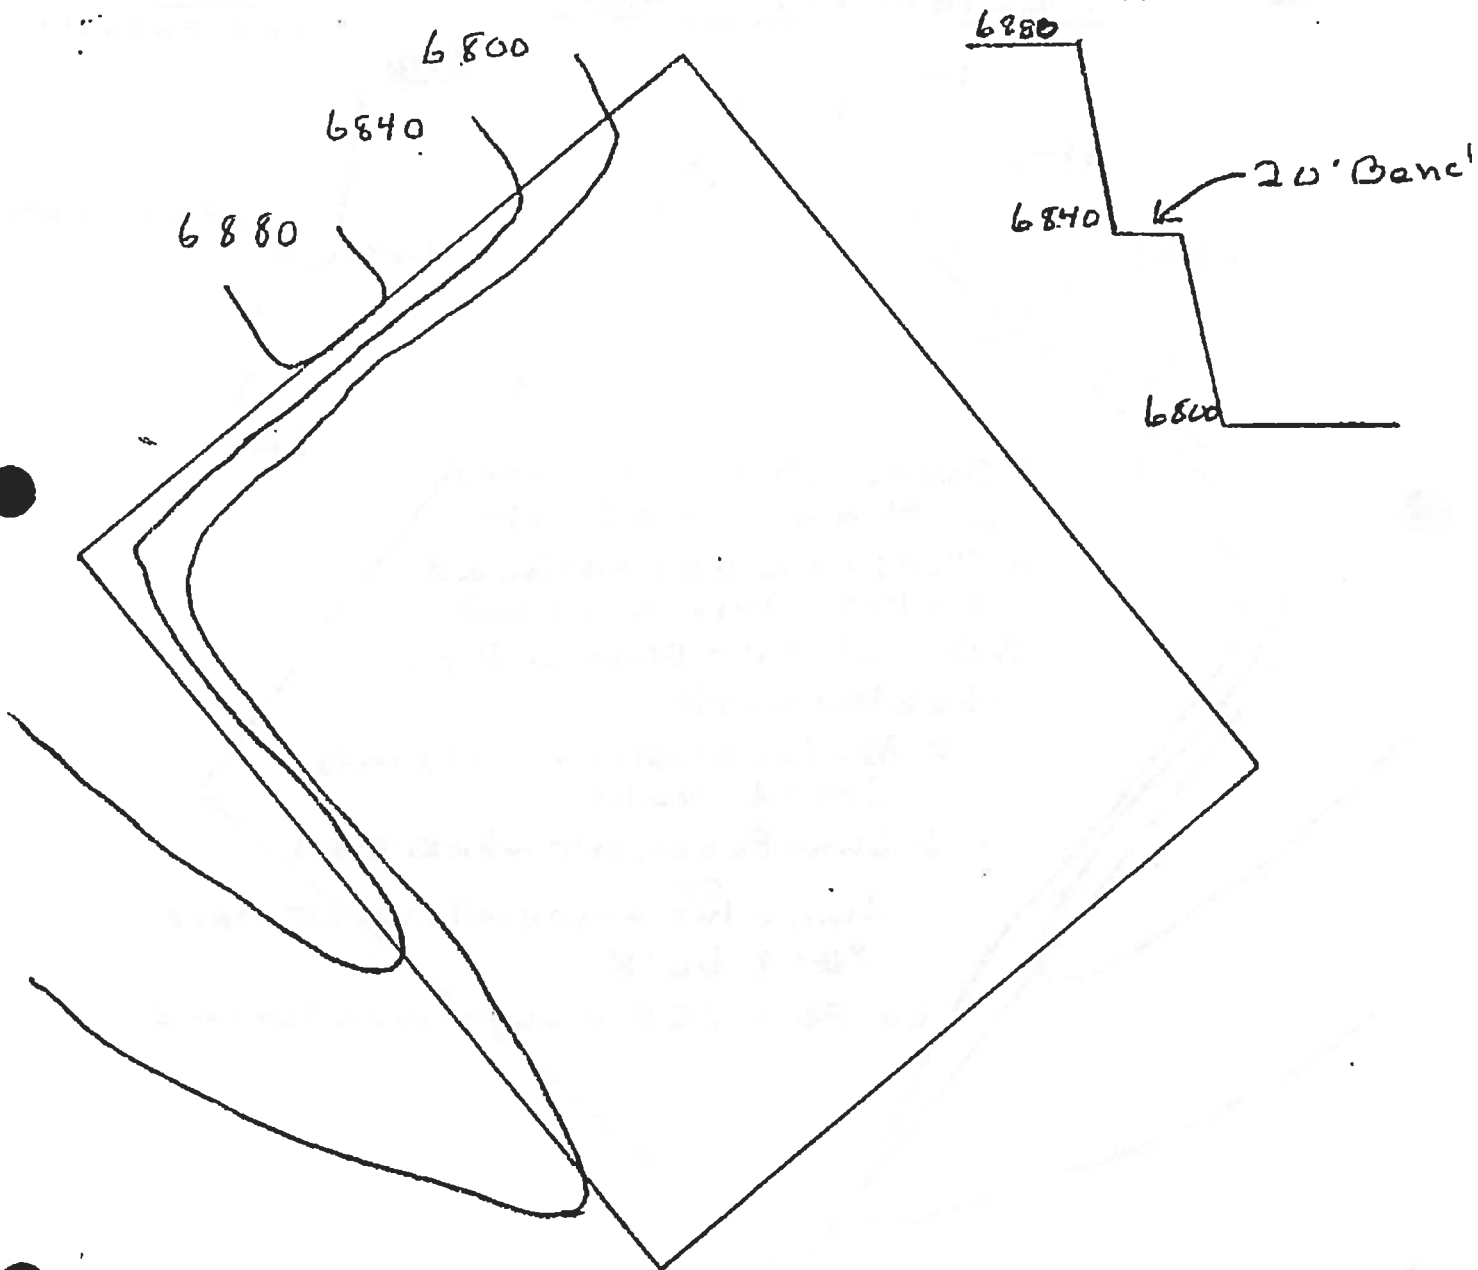
Existing Contours

- the "nearly vertical face" described on NE corner are only 100:60 on the Existing Contour Map - i.e. No where near vertical although steep.

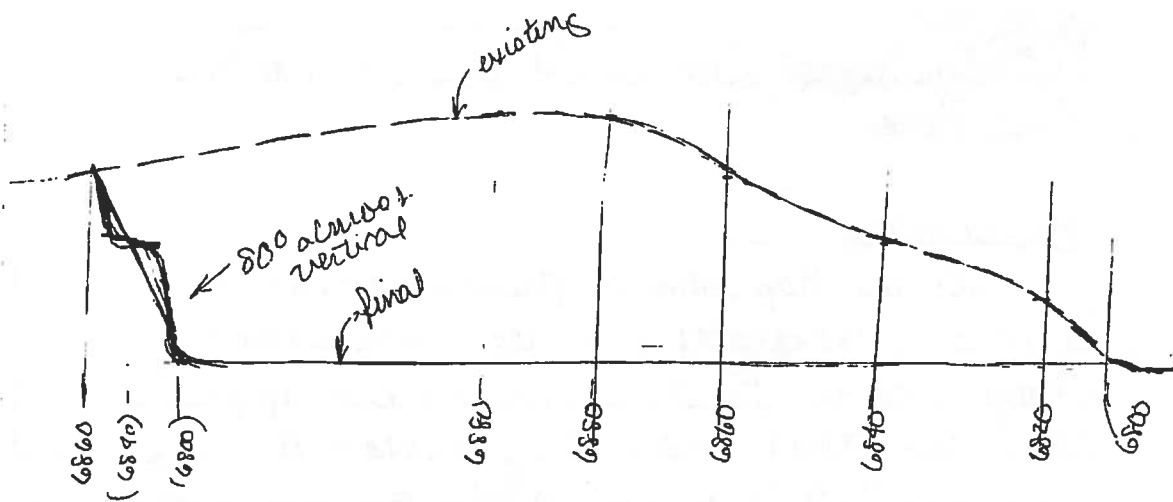
↑ This is cross section through E-W diagonal of area. Max slopes must be compatible with configuration of surrounding conditions & selected land use. (cattle grazing). Is it reasonable to take hilly area & put in vertical walls & flat base & call it compatible? Maybe a line like the red one would be more acceptable. They'd have to remove less material or import backfill. If quantity is a problem they could take a bigger area - 8 acres & get the same amount.
