**MINERALS PROGRAM INSPECTION REPORT**  
**PHONE: (303) 866-3567**

<b>MINE NAME:</b> Longmont Distel Operations	<b>MINE/PROSPECTING ID#:</b> M-1989-029	<b>MINERAL:</b> Sand and gravel	<b>COUNTY:</b> Weld
<b>INSPECTION TYPE:</b> Preoperation Inspection	<b>INSPECTOR(S):</b> Peter S. Hays	<b>INSP. DATE:</b> July 14, 2016	<b>INSP. TIME:</b> 09:00
<b>OPERATOR:</b> Aggregate Industries - WCR, Inc.	<b>OPERATOR REPRESENTATIVE:</b> Connie Davis, Brad Schol, Arron Cook	<b>TYPE OF OPERATION:</b> 112c - Construction Regular Operation	
<b>REASON FOR INSPECTION:</b> Pre-Operation Inspection	<b>BOND CALCULATION TYPE:</b> Partial Bond	<b>BOND AMOUNT:</b> \$1,483,800.00	
<b>DATE OF COMPLAINT:</b> NA	<b>POST INSP. CONTACTS:</b> None	<b>JOINT INSP. AGENCY:</b> None	
<b>WEATHER:</b> Clear	<b>INSPECTOR'S SIGNATURE:</b>

## **OBSERVATIONS**

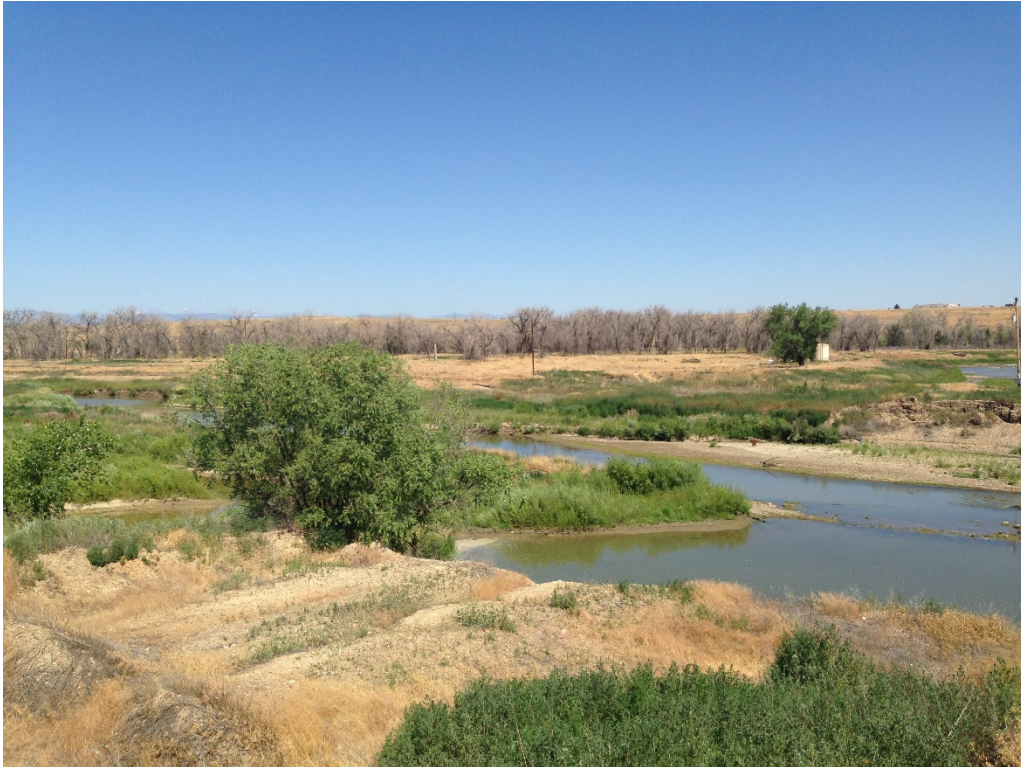
The Boulder Overflow, East Aggregate and East Hayes restoration areas were observed from the northeast corner of the Distel property. The representative from CH2M stated the northeastern most restoration area was removed from the final design due to the proximity of the eagle nest in the area. The design for the pinch point between the East Aggregate and East Hayes areas was changed to rip-rap on both sides.

View looking NW from East Aggregate area

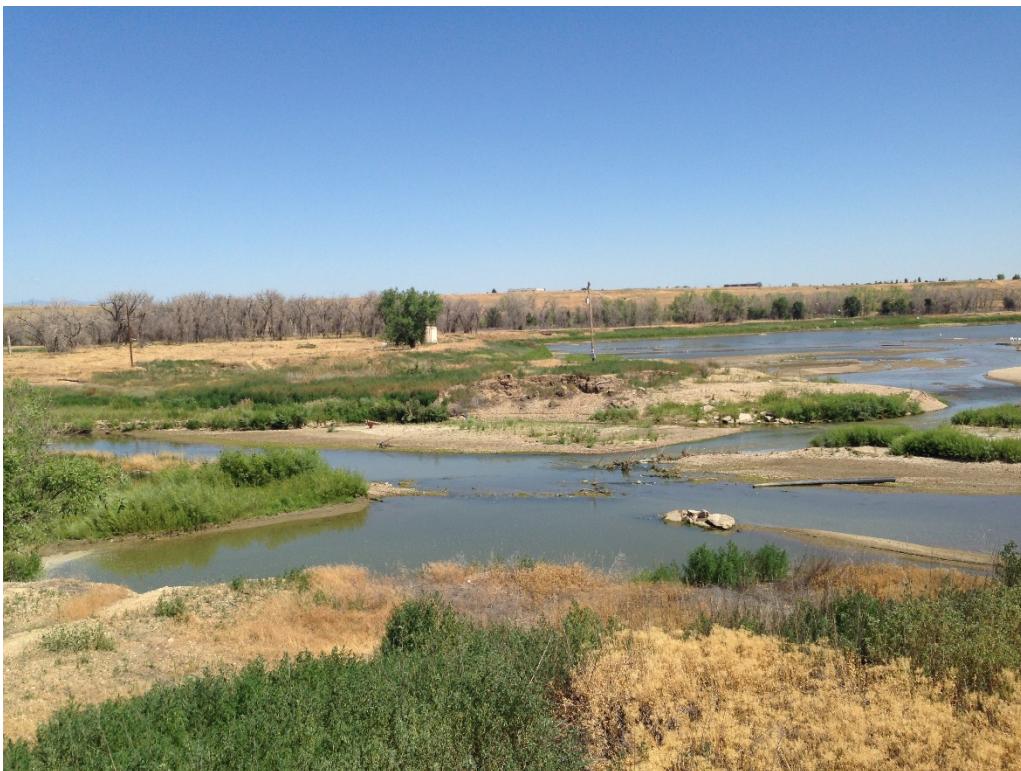
View looking north from East Aggregate area

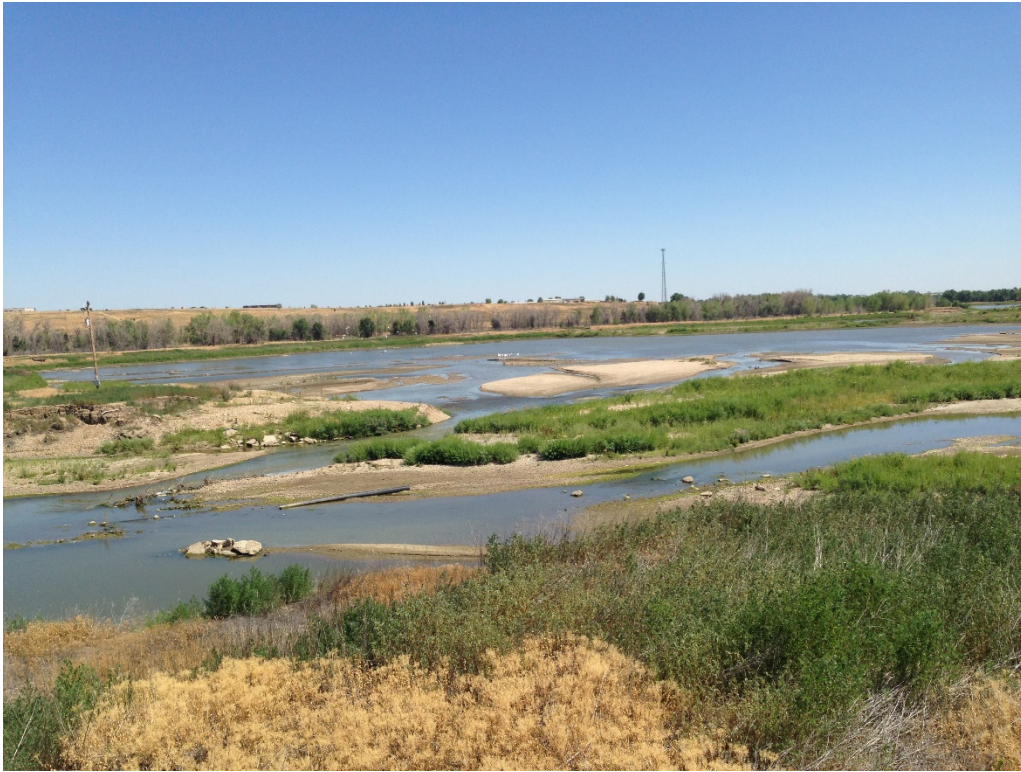
View looking NE from East Aggregate area

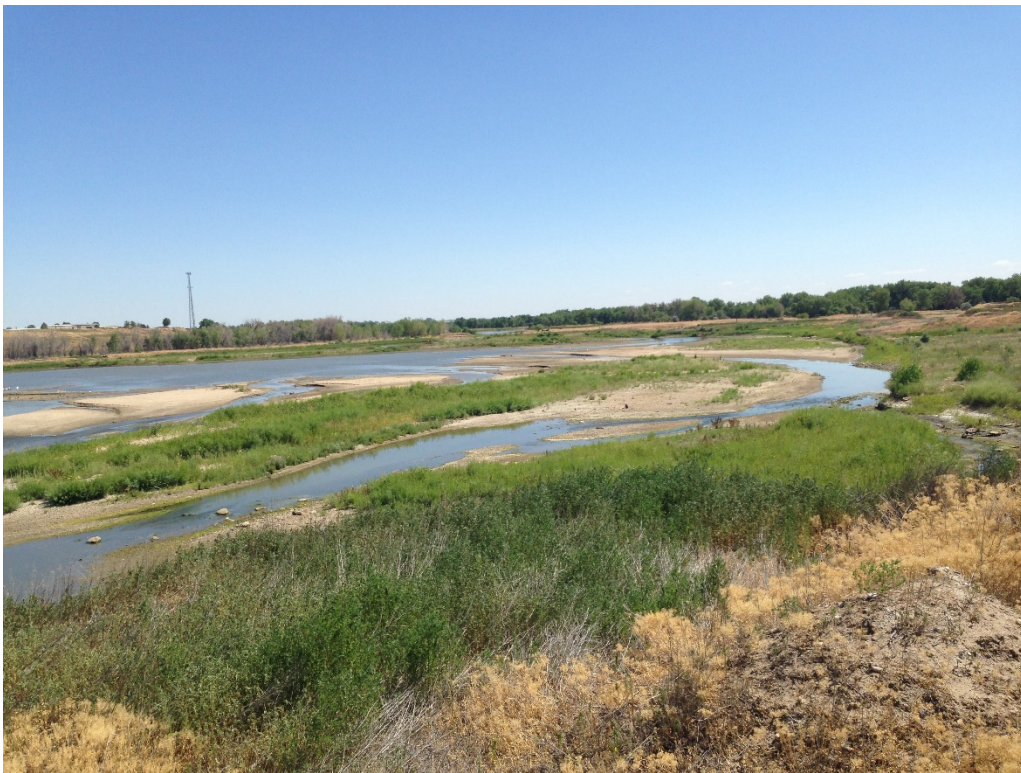
View looking east from East Aggregate area

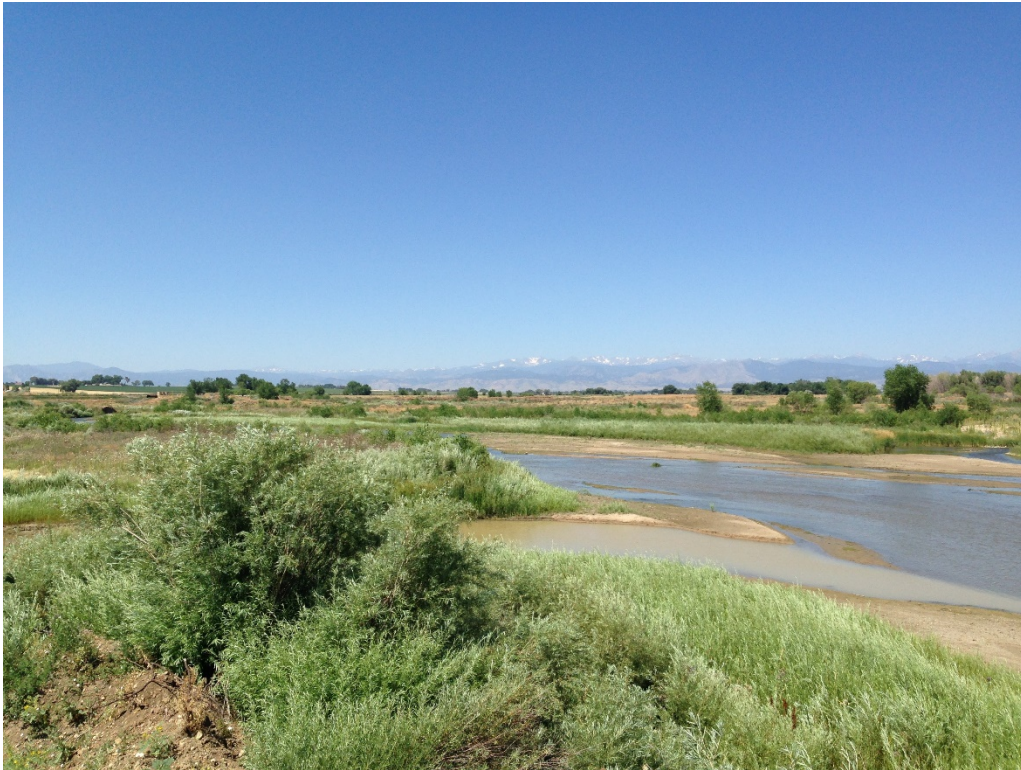
The West Hayes and West Aggregate restoration areas were observed from the northwest corner of the Aggregate Industries owned parcel. The West Hayes area will be rip-rapped with soil cover. There will be a gap in the rip-rap due to work not being allowed from the funding source to be used on private property. The West Aggregate area will consist of rip-rap around the corner and north portion of the area. The south portion of the area will be restored with vegetative cover only.

View looking west from West Aggregate area

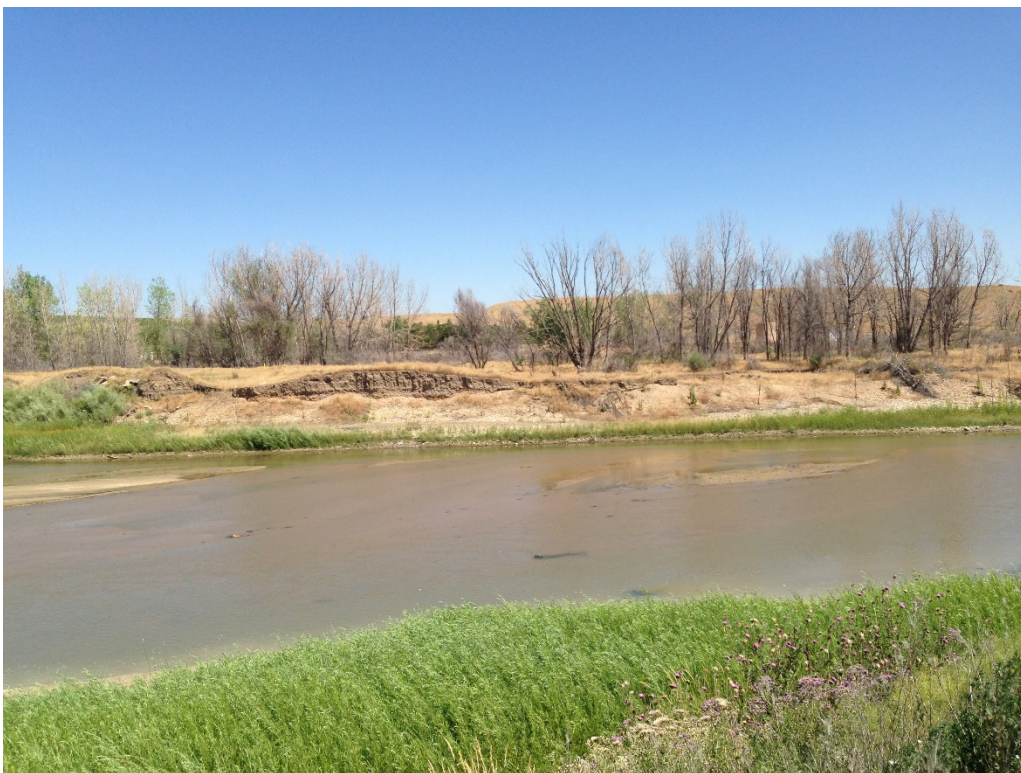
View looking north from West Aggregate area

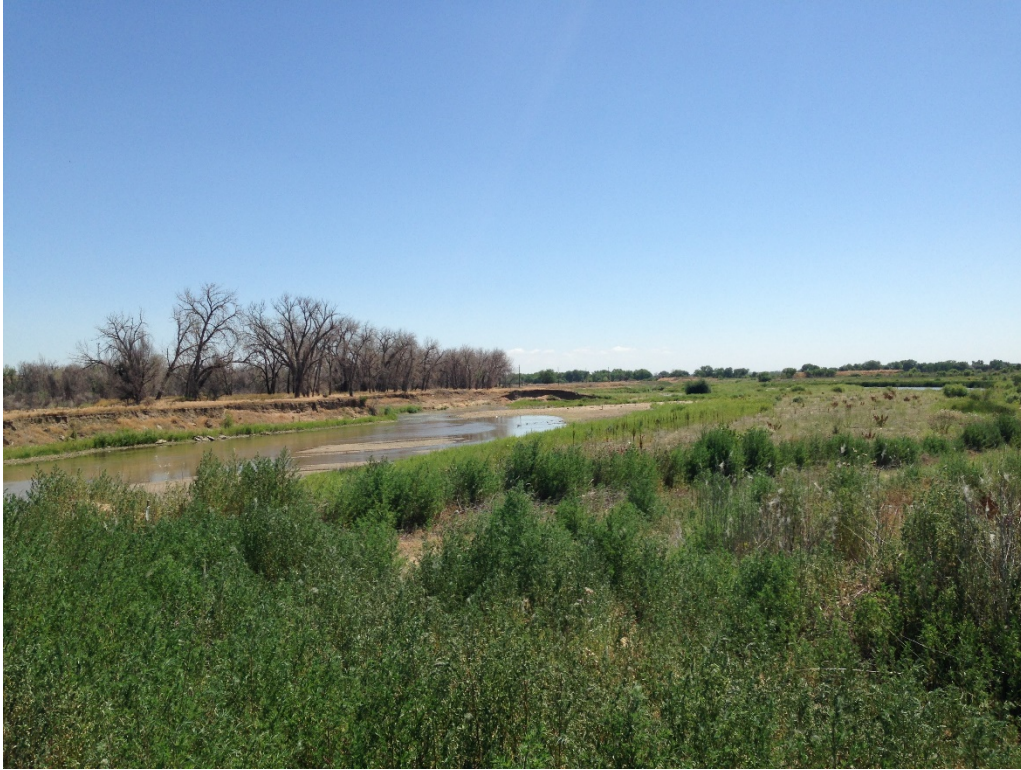
View looking east from West Aggregate area

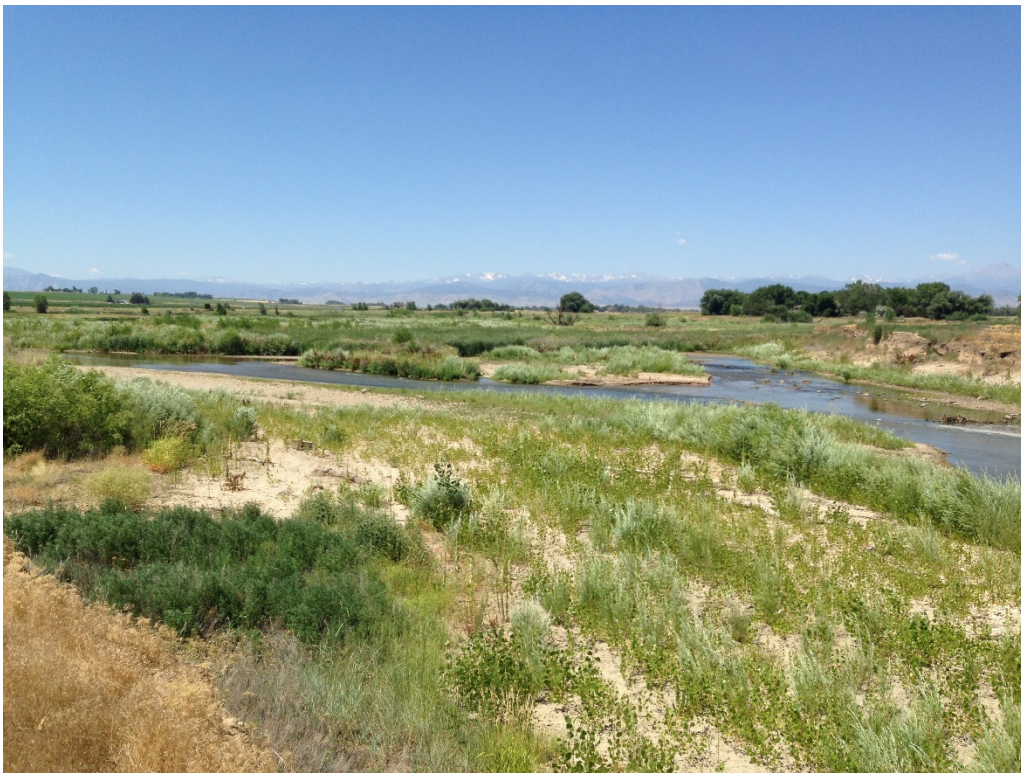
The South Bridge, West Bridge, Bridge/Channel and East Bridge restoration areas were observed from the end of the damaged St. Vrain Trail between the Sherwood and Bigelow properties. The slope in the corner of the South Bridge area and to the south will be regraded to 3H:1V. The topsoil stockpile located east of the South Bridge area will be relocated as part of the restoration project.

View looking west from South Bridge area

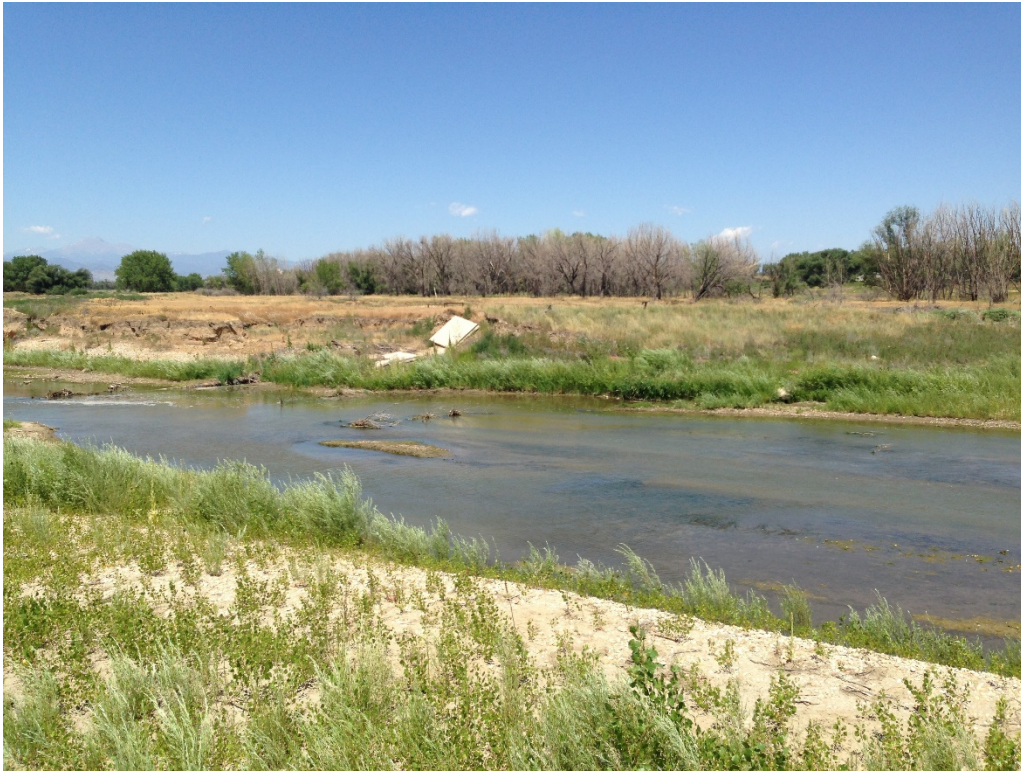
View looking NW from South Bridge area

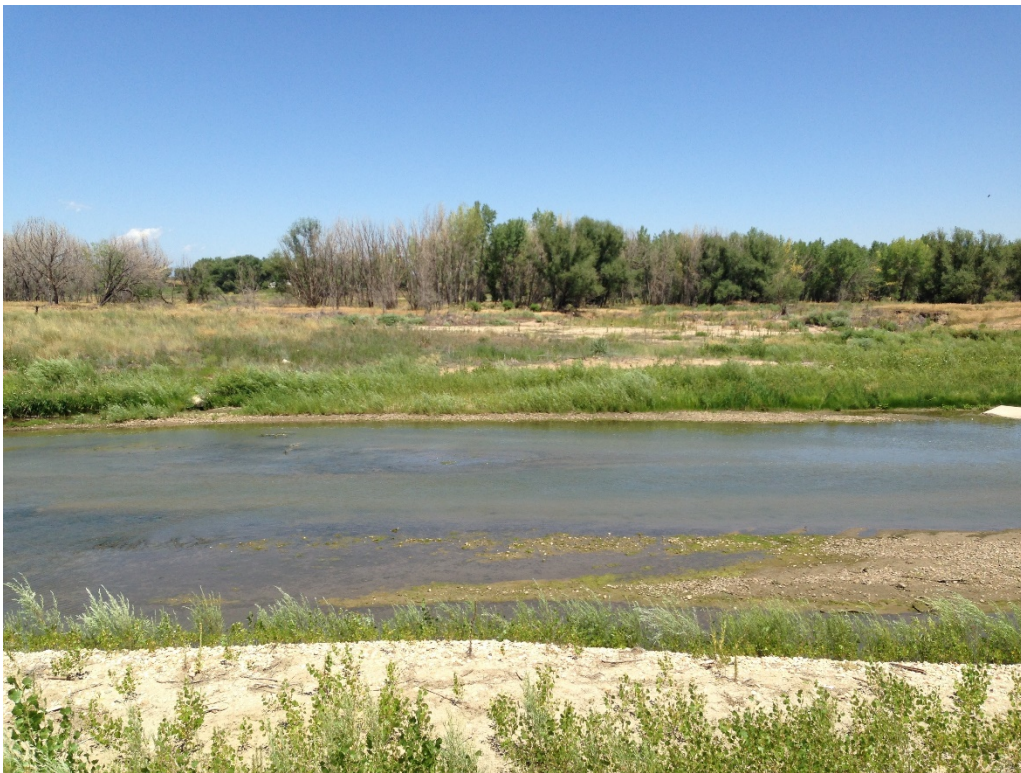
View looking north from South Bridge area

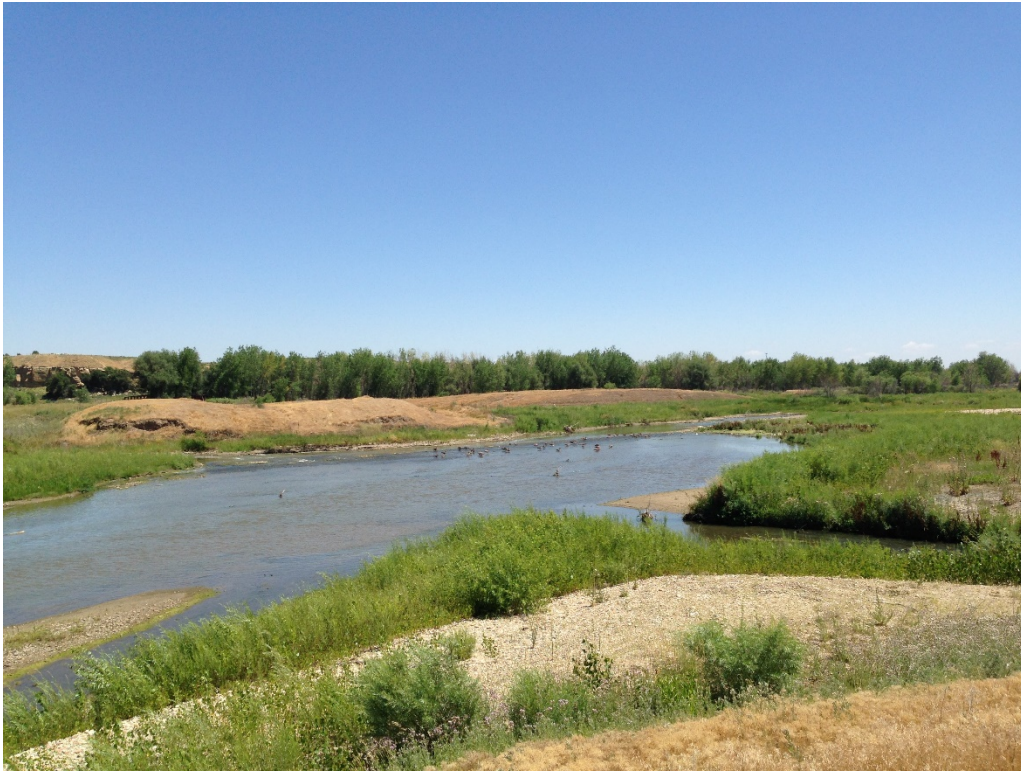
View looking NE from South Bridge area

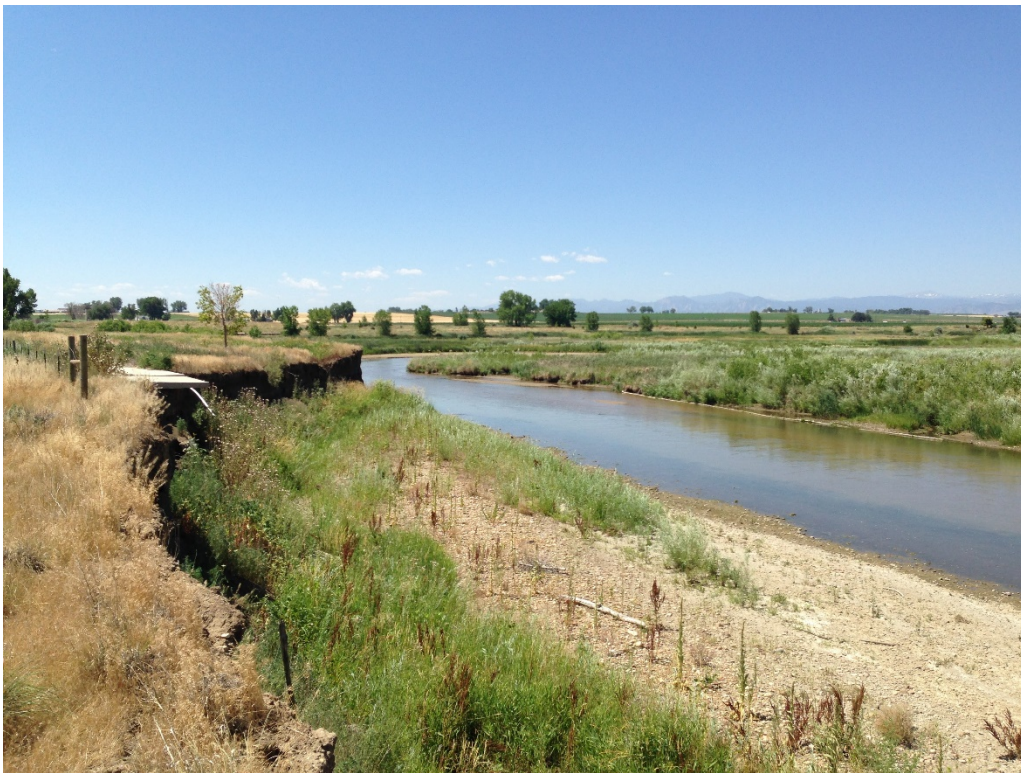
View looking south from corner of South Bridge area

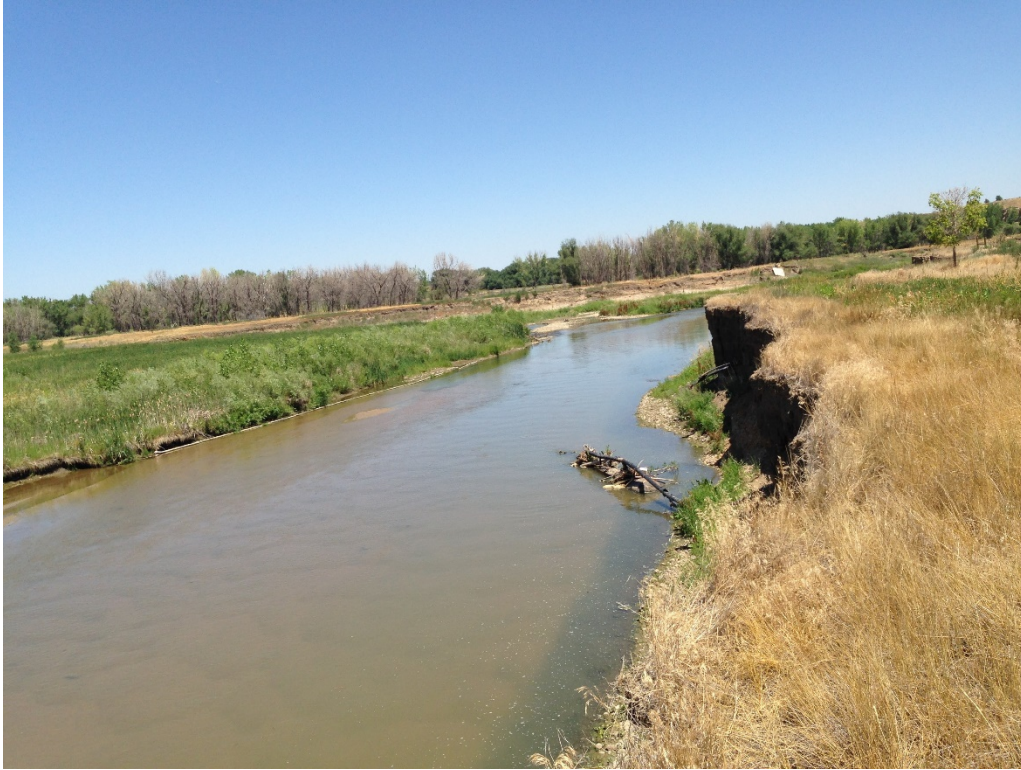
View looking north from SW end of South Bridge area

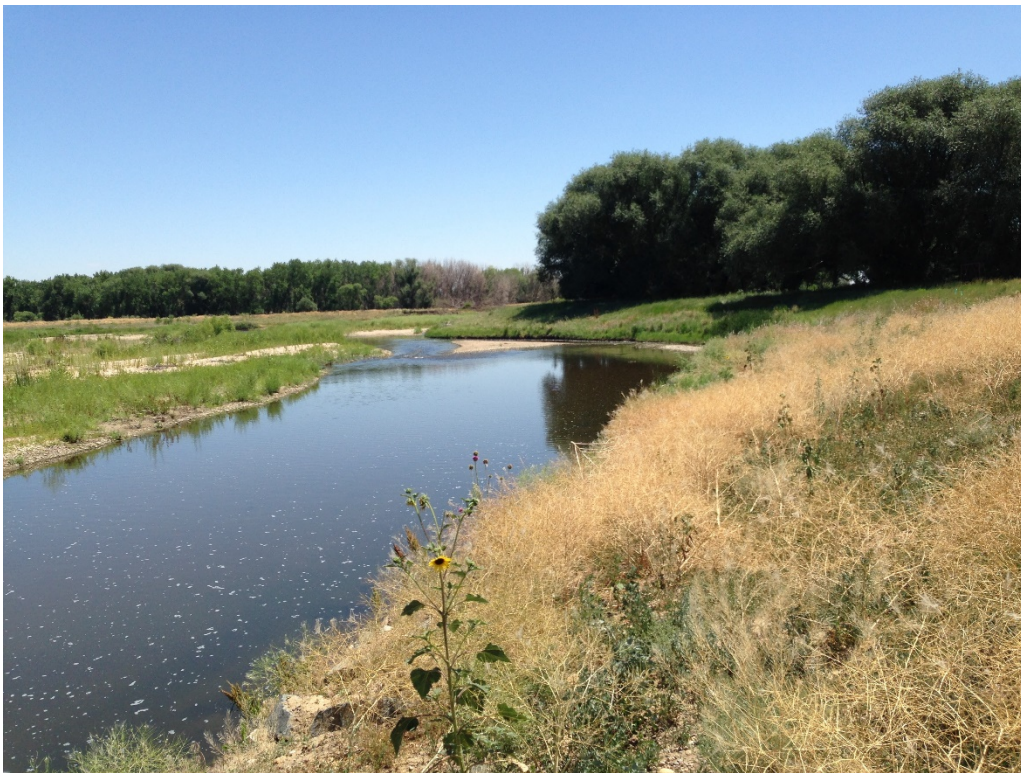
The West Peschel and East Peschel restoration areas was observed from the Peschel driveway. The slope of the West Peschel area has been changed to a final 3H:1V slope to protect the driveway. The restoration of the East Peschel area will include soil blanket lifts and root wads. Root wads were stockpiled south of the Peschel driveway near County Line Road.

View looking east from West Peschel area

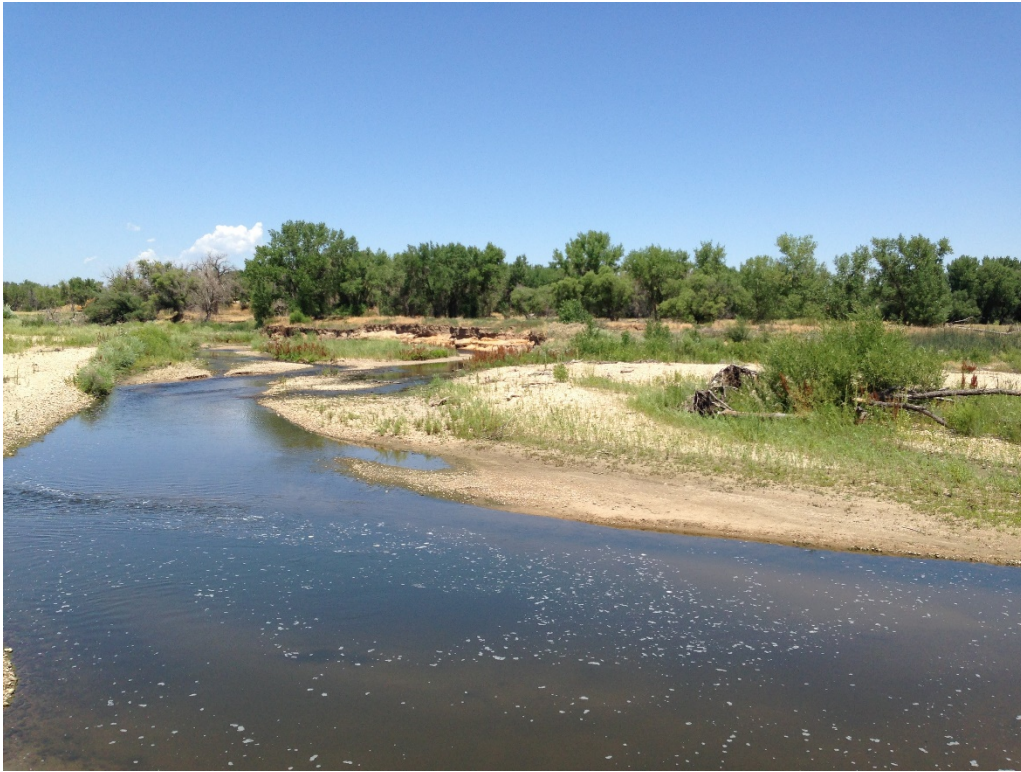
View looking NW from West Peschel area

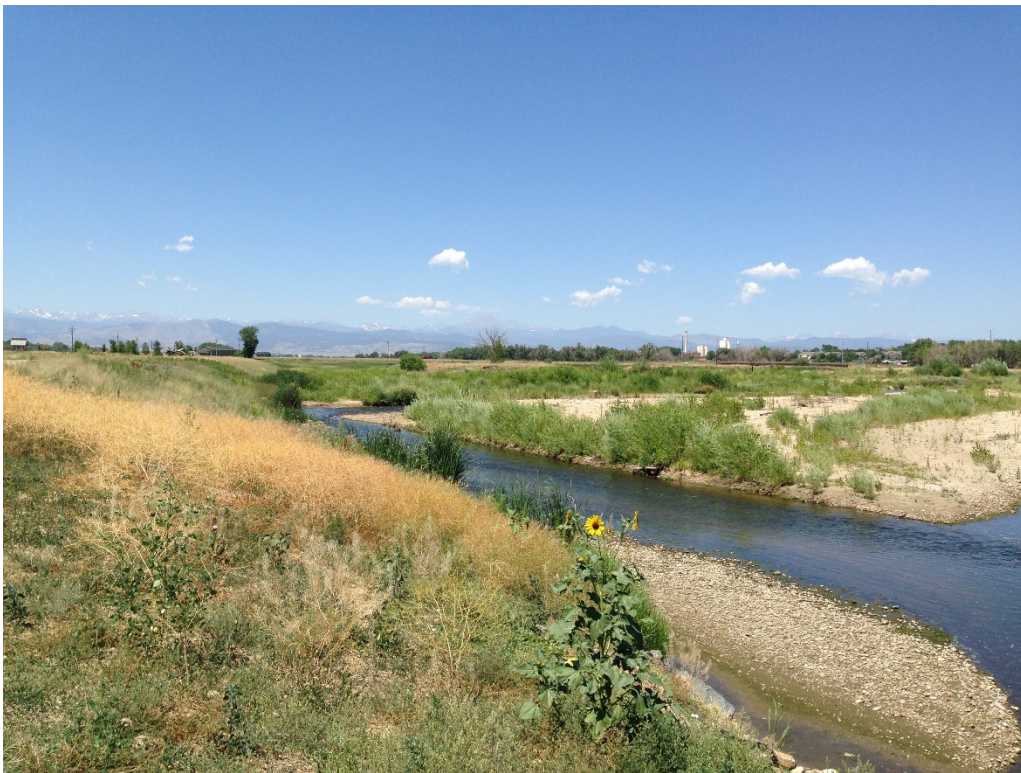
View looking west from West Peschel area
