MINERALS PROGRAM INSPECTION REPORT
PHONE: (303) 866-3567

MINE NAME: Ignacio Pit	MINE/PROSPECTING ID#: M-1977-446	MINERAL: Sand and gravel	COUNTY: La Plata
INSPECTION TYPE: Monitoring	INSPECTOR(S): Lucas J. West	INSP. DATE: September 15, 2016	INSP. TIME: 10:00
OPERATOR: Hocker Construction, LLP	OPERATOR REPRESENTATIVE: Roy Hocker	TYPE OF OPERATION: 112c - Construction Regular Operation	
REASON FOR INSPECTION: Normal I&E Program	BOND CALCULATION TYPE: Complete Bond	BOND AMOUNT: \$115,646.00	
DATE OF COMPLAINT: NA	POST INSP. CONTACTS: None	JOINT INSP. AGENCY: None	
WEATHER: Clear	INSPECTOR'S SIGNATURE:

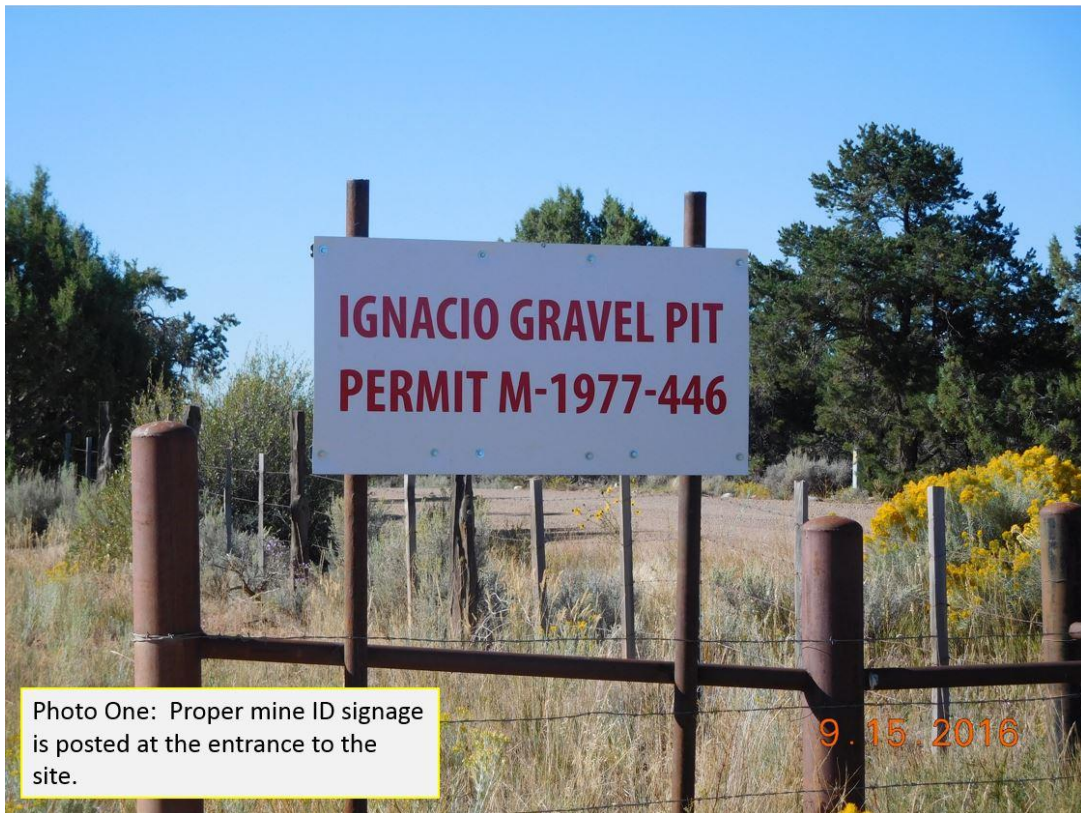
Photo One: Proper mine ID signage is posted at the entrance to the site.

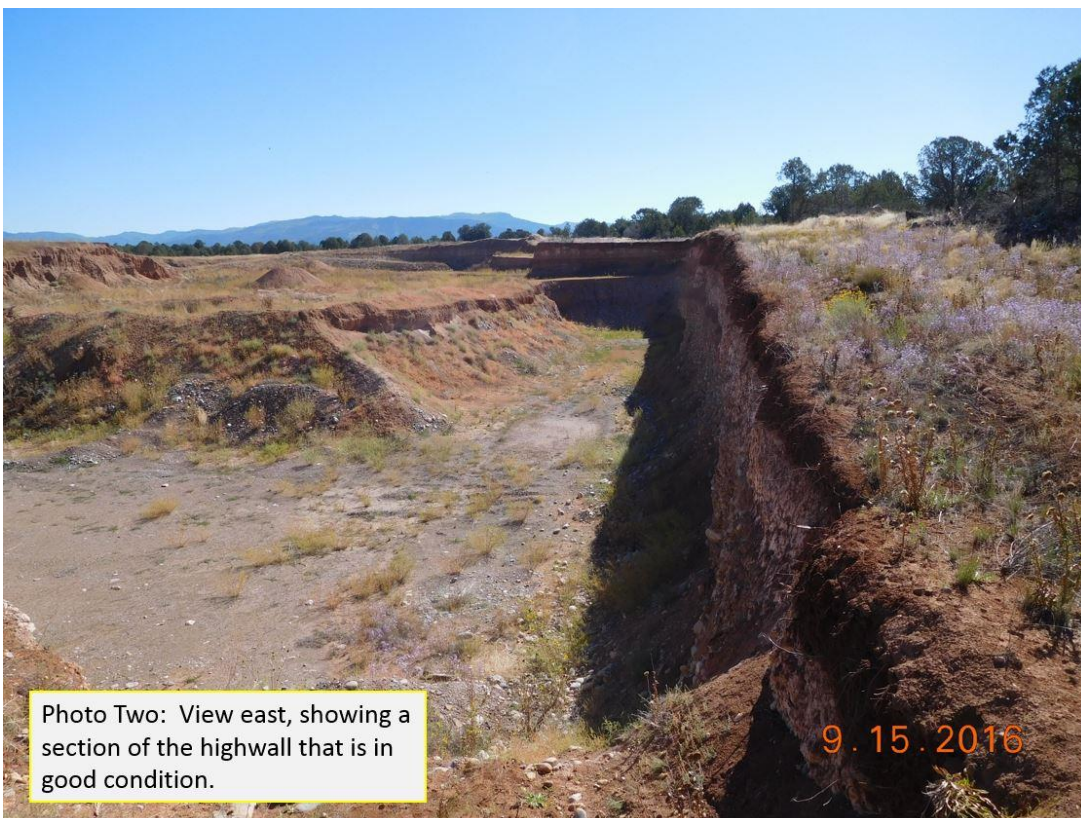
Photo Two: View east, showing a section of the highwall that is in good condition.

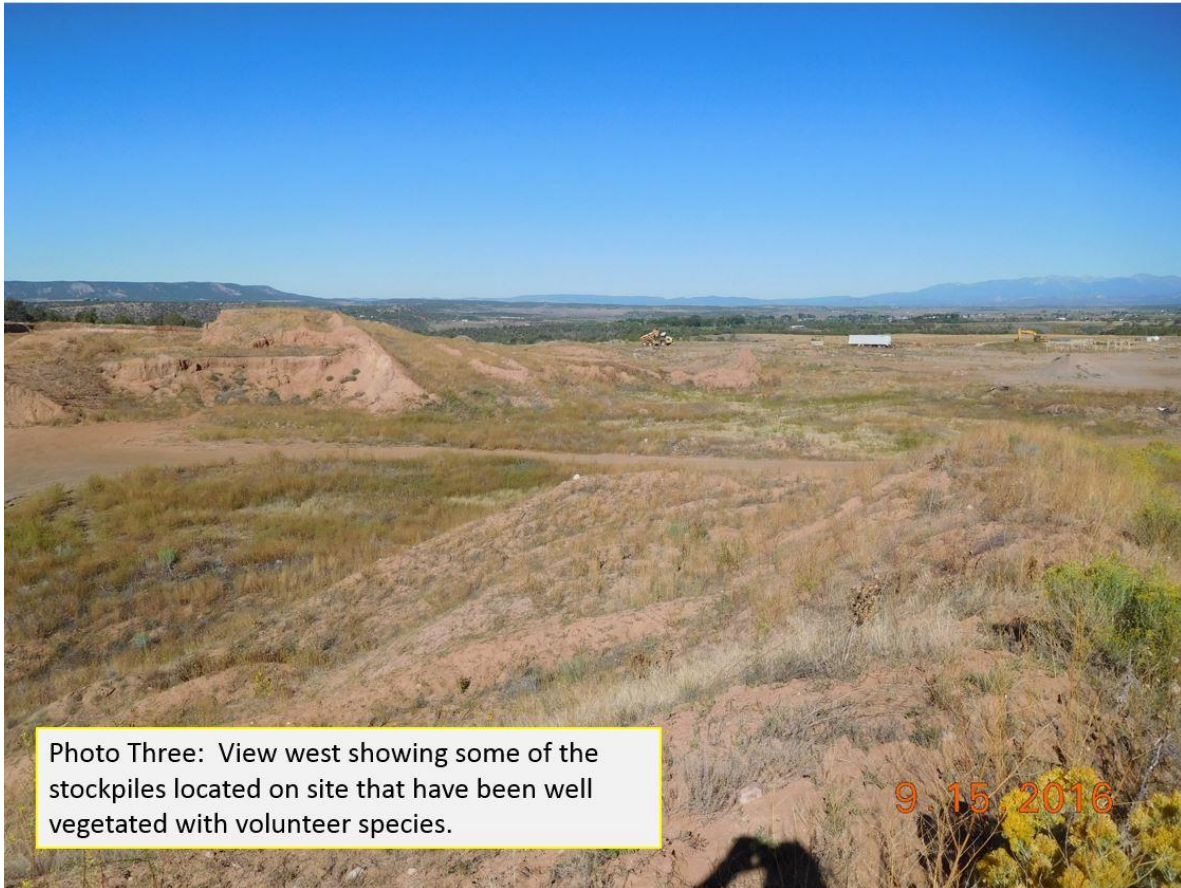
Photo Three: View west showing some of the stockpiles located on site that have been well vegetated with volunteer species.

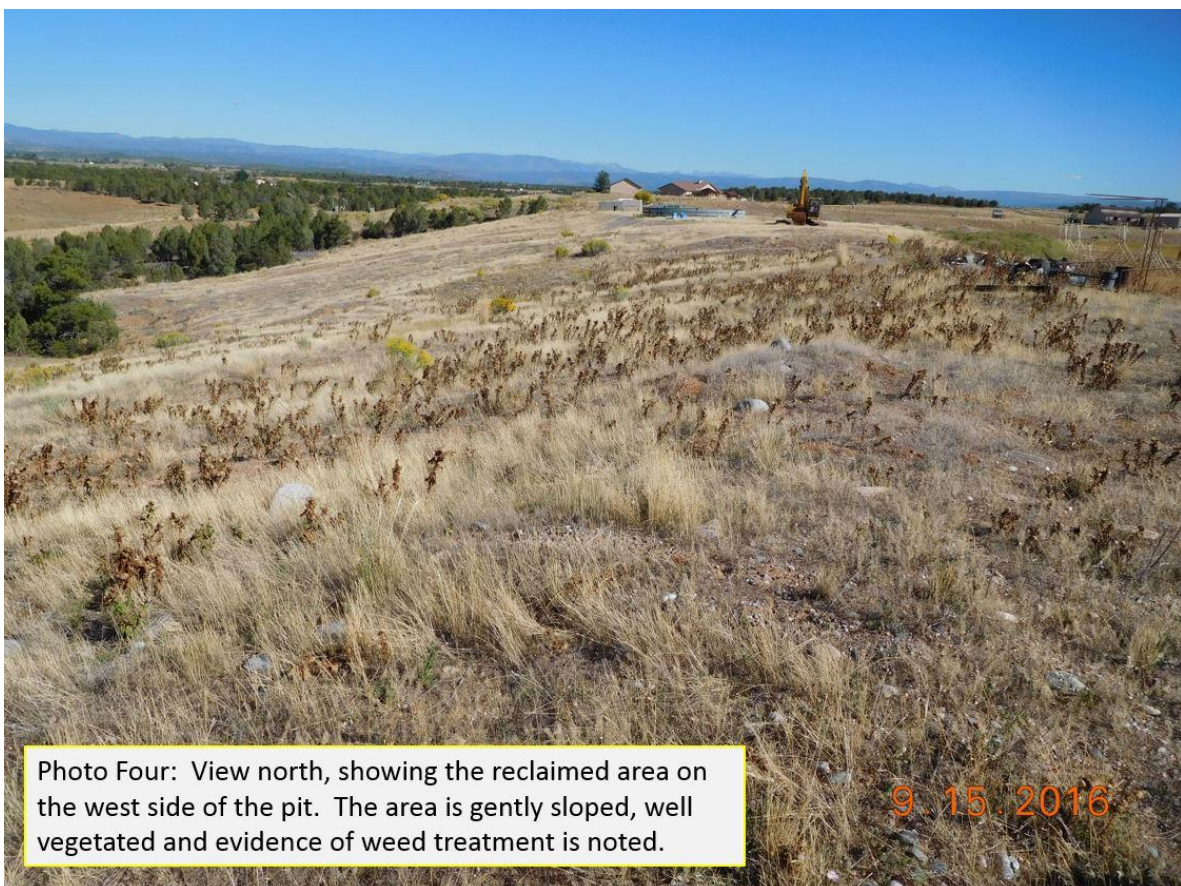
A large area on the west side of the site, approximately 10 acres, has undergone reclamation. The grading of the area appears to be stable and no erosional features were noted. The area has also been vegetated, which is adequate in both density and diversity. The vegetation also shows signs of self-propagation with multiple years growth observed. Photos Four and Five show the reclaimed area. Evidence of chemical treatment of noxious weeds was observed, and conversations with the operator indicate that the weed management plan is active and on-going.

Photo Four: View north, showing the reclaimed area on the west side of the pit. The area is gently sloped, well vegetated and evidence of weed treatment is noted.

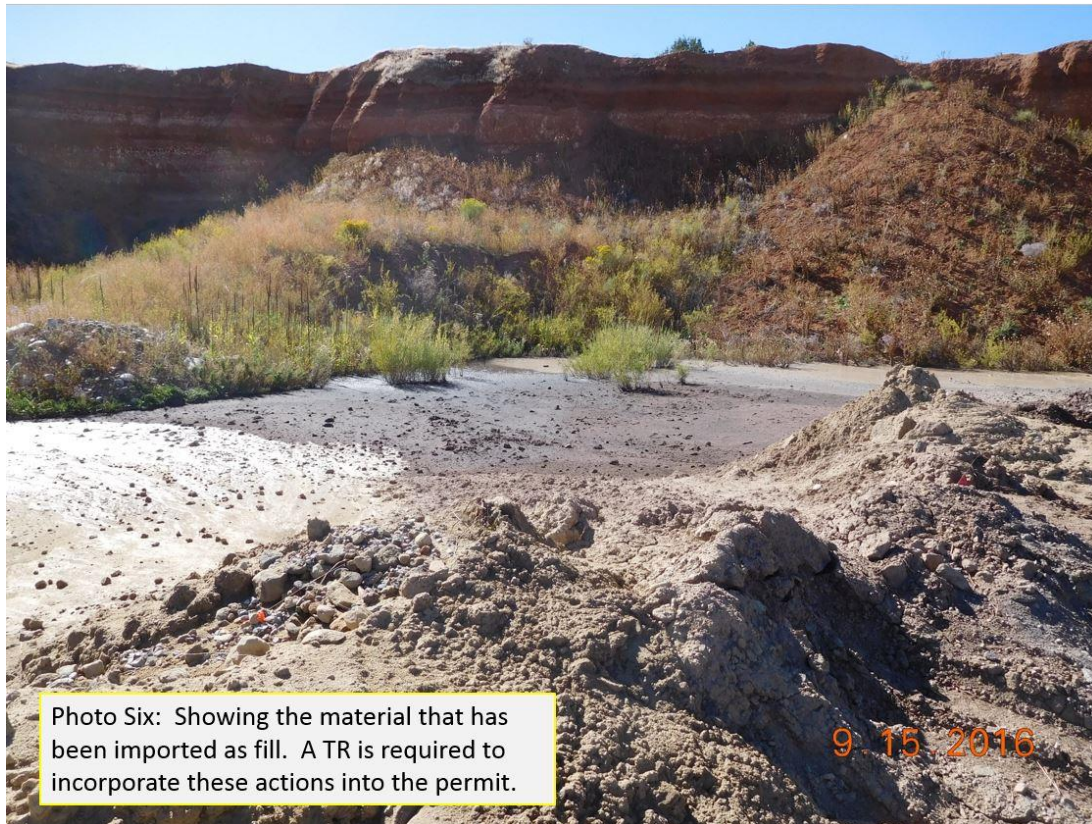
An area adjacent to the highwall was observed to have offsite fill material imported to be used as backfill materials. The material can be seen in Photo Six and conversations with the operator indicate that it is material dumped by a hydro-vac company that has certified the material clean and inert. Records kept by the division do not indicate that a Technical Revision (TR) was carried out to incorporate offsite fill materials into the permit. The operator shall submit, **within 60 days** of the date of this letter, a request for a Technical Revision, as well as an affidavit in accordance with Rule 3.1.5(9) of the Rules for the Extraction of Construction Materials to allow for the importation of this material. Included with this TR should be the report from the hydro-vac company certifying the material is clean and inert. Enclosed with this report is the Request for a Technical Revision cover letter. Please fill out and return the cover letter in addition to the other requested documentation should be received by the Division's Denver office no later than **Monday November 28, 2016**.
