MINERALS PROGRAM INSPECTION REPORT

MINE NAME: Hocker Gravel Pit	MINE/PROSPECTING ID#: M-2004-063	MINERAL: Sand and gravel	COUNTY: La Plata
INSPECTION TYPE: Monitoring	INSPECTOR(S): Lucas J. West	INSP. DATE: September 15, 2016	INSP. TIME: 11:00
OPERATOR: Hocker Construction, LLP	OPERATOR REPRESENTATIVE: Roy Hocker	TYPE OF OPERATION: 112c - Construction Regular Operation

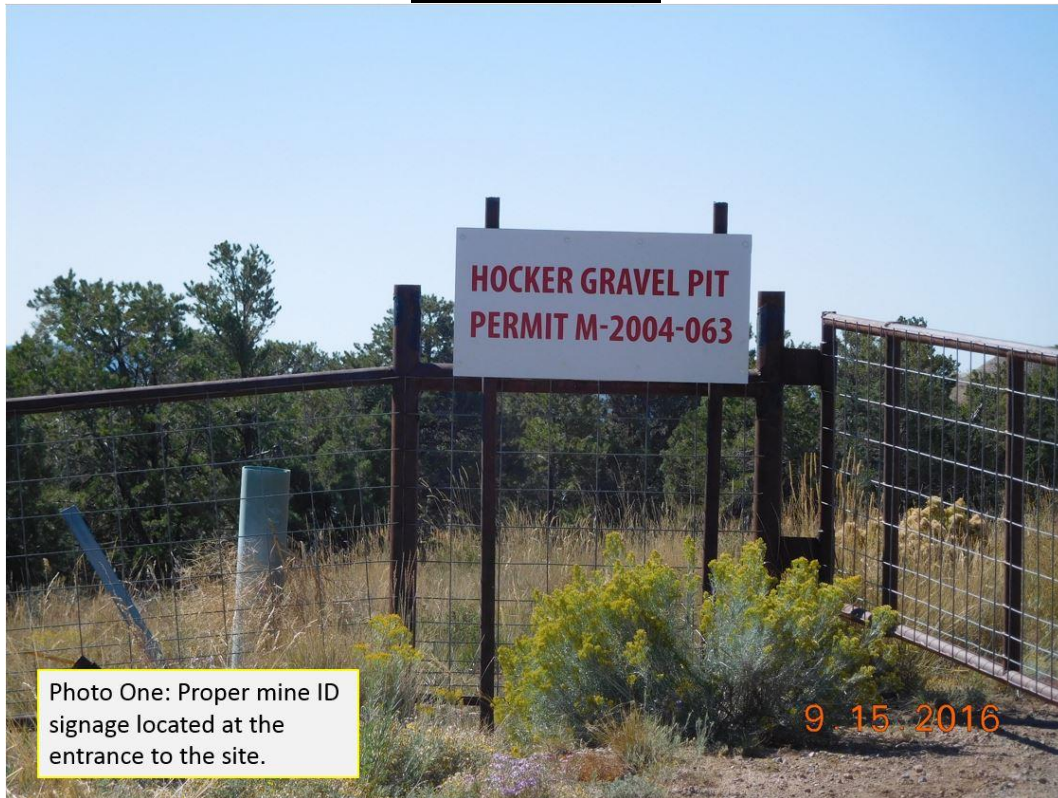
Proper mine identification signage was posted at the entrance to the site, as seen in Photo One. The permit boundaries were clearly outlined with a mixture of T-posts, fence lines and earthen berms. All disturbances are contained within the permitted areas. The active mining area located in phase two appeared to be stable and in good condition. The mining activity has left the slopes at approximately 3H: 1V or shallower and all slopes appear to be stable. Photo Two shows the area of activity. Several stockpiles of overburden was observed on the pit floor. All stockpiles are in good condition and appear to be stable. Photo Three shows some of the stockpiles which are well vegetated with volunteer species. Material stockpiles area noted adjacent to the haul road that runs through the site and topsoil stockpiles are located at various locations throughout the site. Although the site was not active during the inspection, several pieces of equipment were on site. An area of the site is also being used as storage for trailers and various scrap items, which are being stored in a neat and orderly fashion. This is not being considered a problem at this time and the area can be seen in Photo Four.

Photo One: Proper mine ID signage located at the entrance to the site.

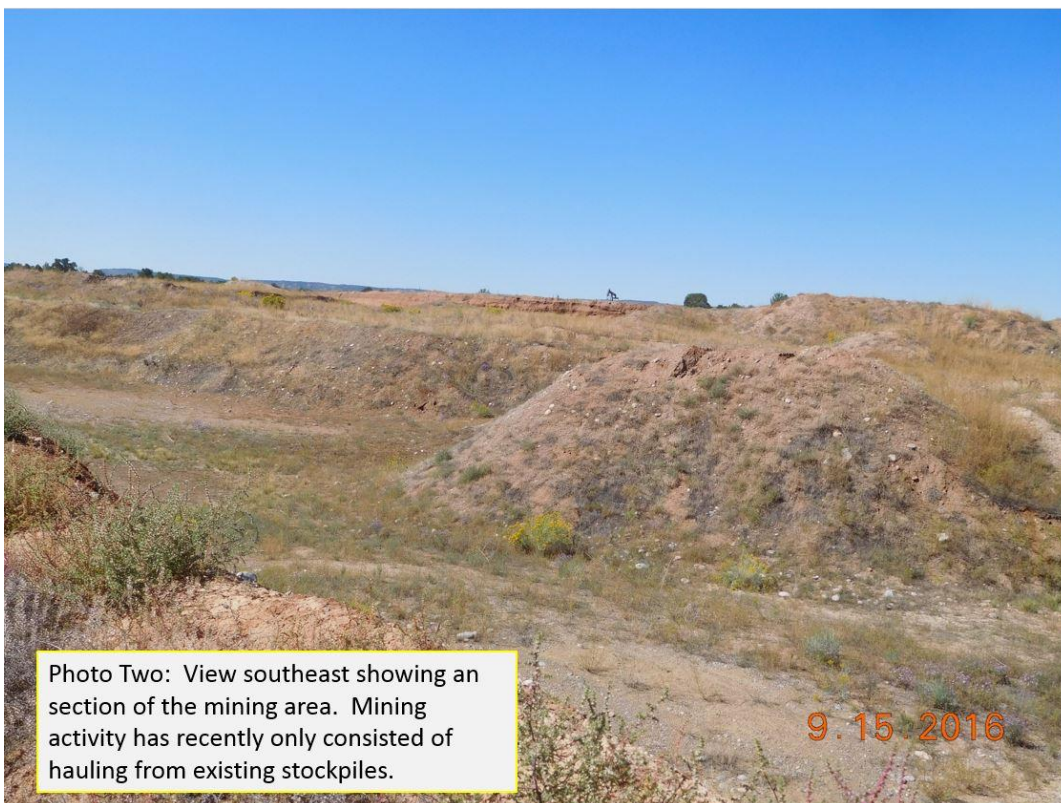
Photo Two: View southeast showing an section of the mining area. Mining activity has recently only consisted of hauling from existing stockpiles.

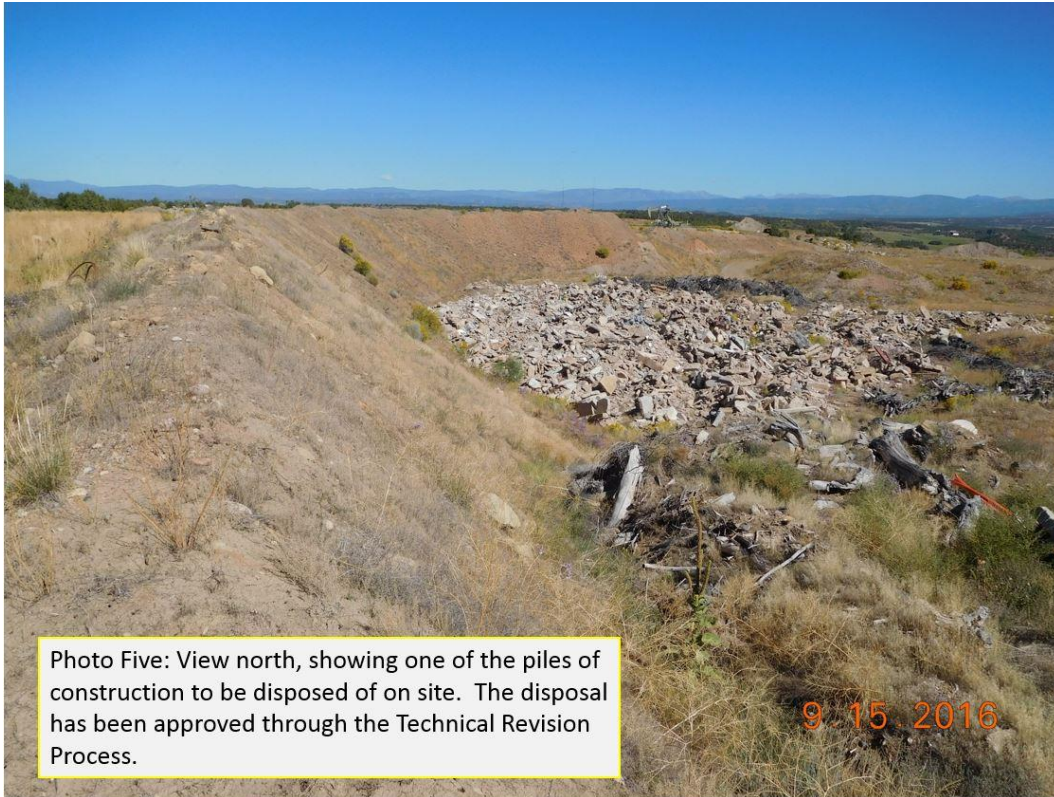
Two areas within the site are being used for storage of construction debris. A Technical Revision was completed to allow for the importation and on site disposal of the material. Photos Five and Six show the areas containing the debris. On site discussions with the operator indicate that he intends to recycle the metal in both areas, which includes protruding rebar from the concrete, prior to covering the piles with an earthen cap. The earthen cap will also be topsoiled and revegetated upon final reclamation.

Photo Five: View north, showing one of the piles of construction debris to be disposed of on site. The disposal has been approved through the Technical Revision Process.

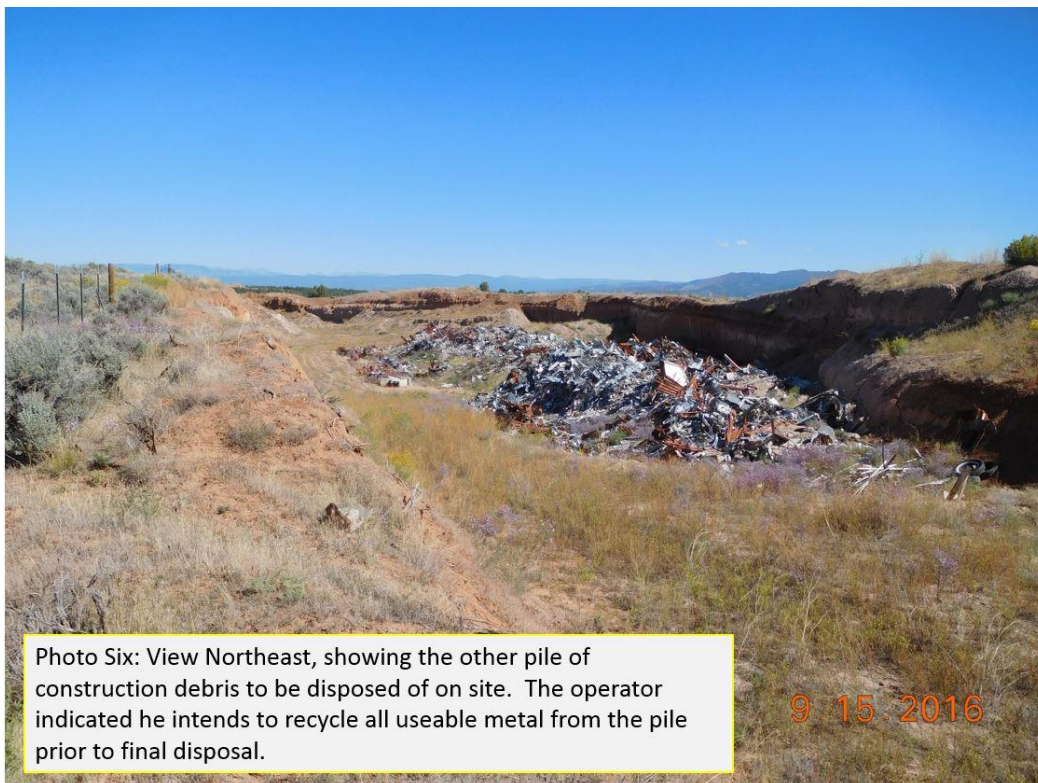
Photo Six: View Northeast, showing the other pile of construction debris to be disposed of on site. The operator indicated he intends to recycle all useable metal from the pile prior to final disposal.
