MINERALS PROGRAM INSPECTION REPORT
PHONE: (303) 866-3567

MINE NAME: Riverbend Operation	MINE/PROSPECTING ID#: M-2000-016	MINERAL: Sand and gravel	COUNTY: Weld
INSPECTION TYPE: Monitoring	INSPECTOR(S): Peter S. Hays	INSP. DATE: August 29, 2016	INSP. TIME: 13:00
OPERATOR: Martin Marietta Materials, Inc.	OPERATOR REPRESENTATIVE: Julie Mikulas	TYPE OF OPERATION: 112c - Construction Regular Operation	
REASON FOR INSPECTION: Normal I&E Program	BOND CALCULATION TYPE: IT.Bondcalculationtype.CD.Desc	BOND AMOUNT: \$3,450,600.00	
DATE OF COMPLAINT: NA	POST INSP. CONTACTS: None	JOINT INSP. AGENCY: None	
WEATHER: Clear	INSPECTOR'S SIGNATURE:

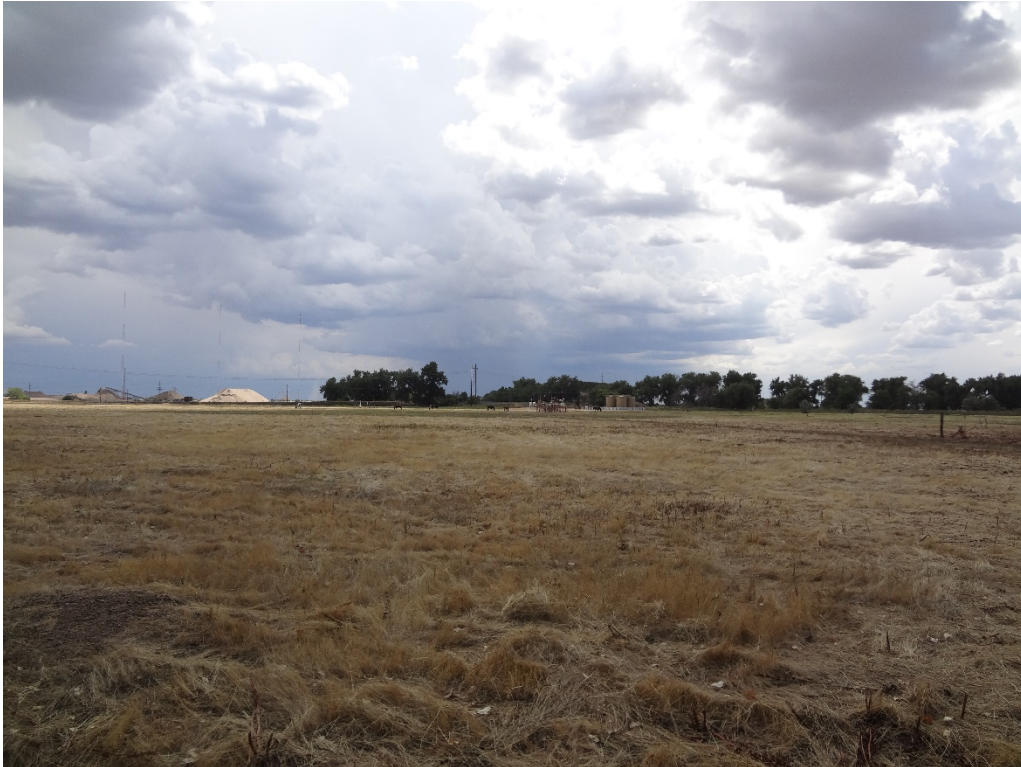
View of Rittenhouse parcel looking south from north side

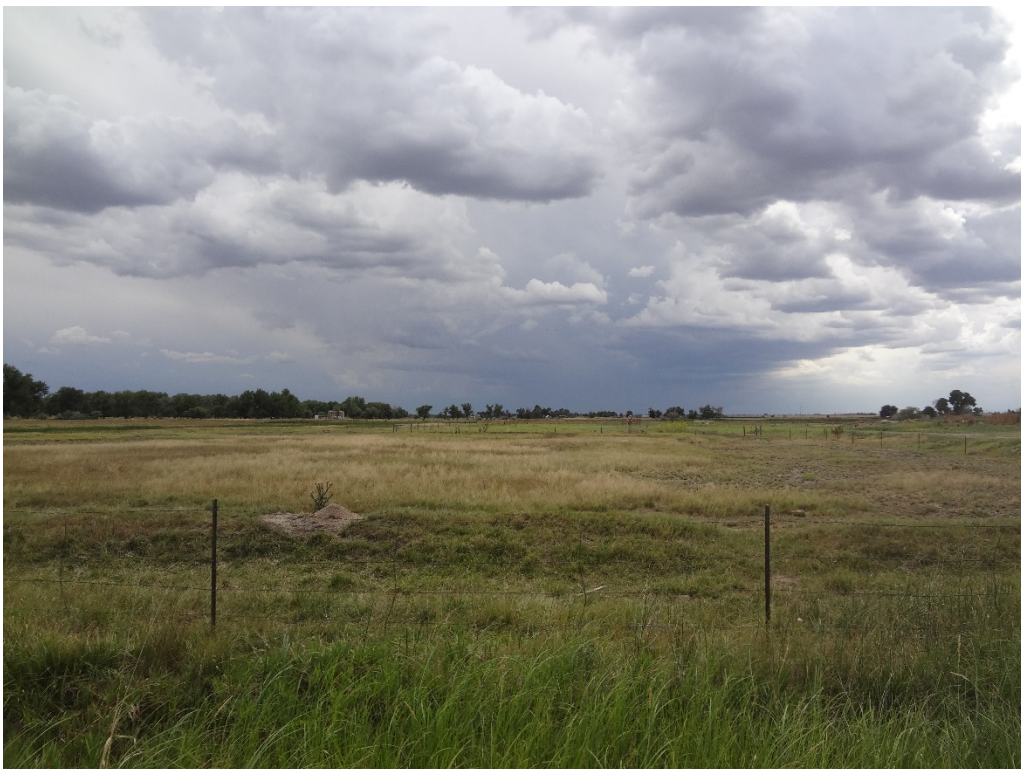
View of Martin Marietta owned parcel from CR 8 looking south

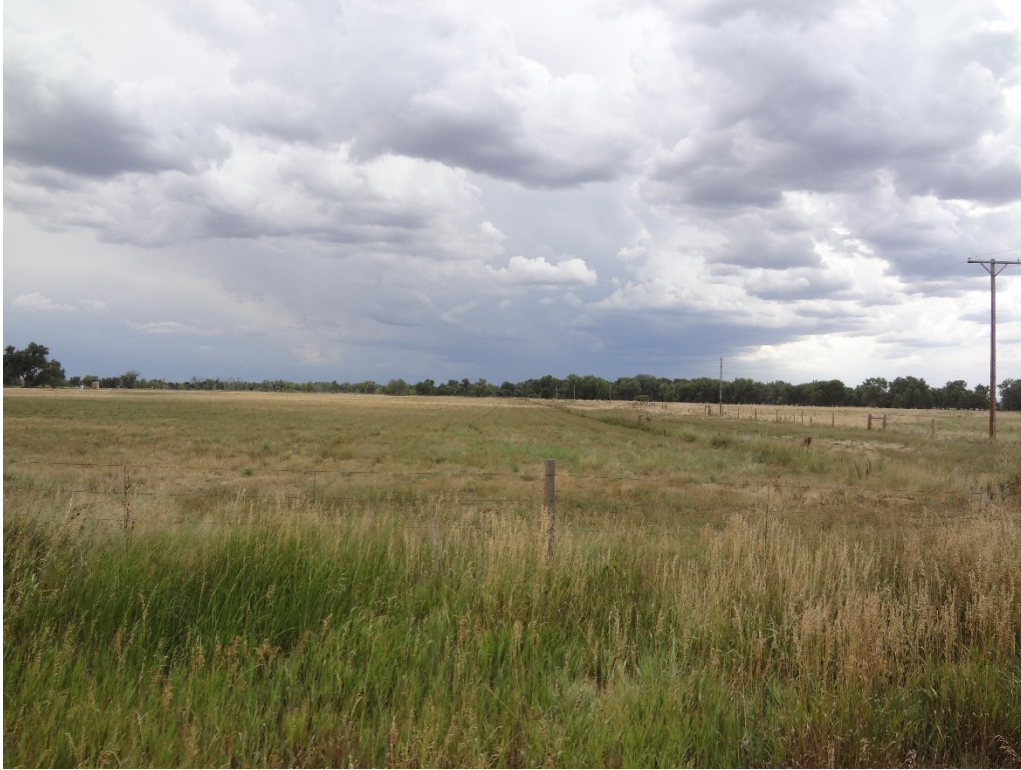
View of Stevens parcel (Aurora owned) from CR 8 looking south

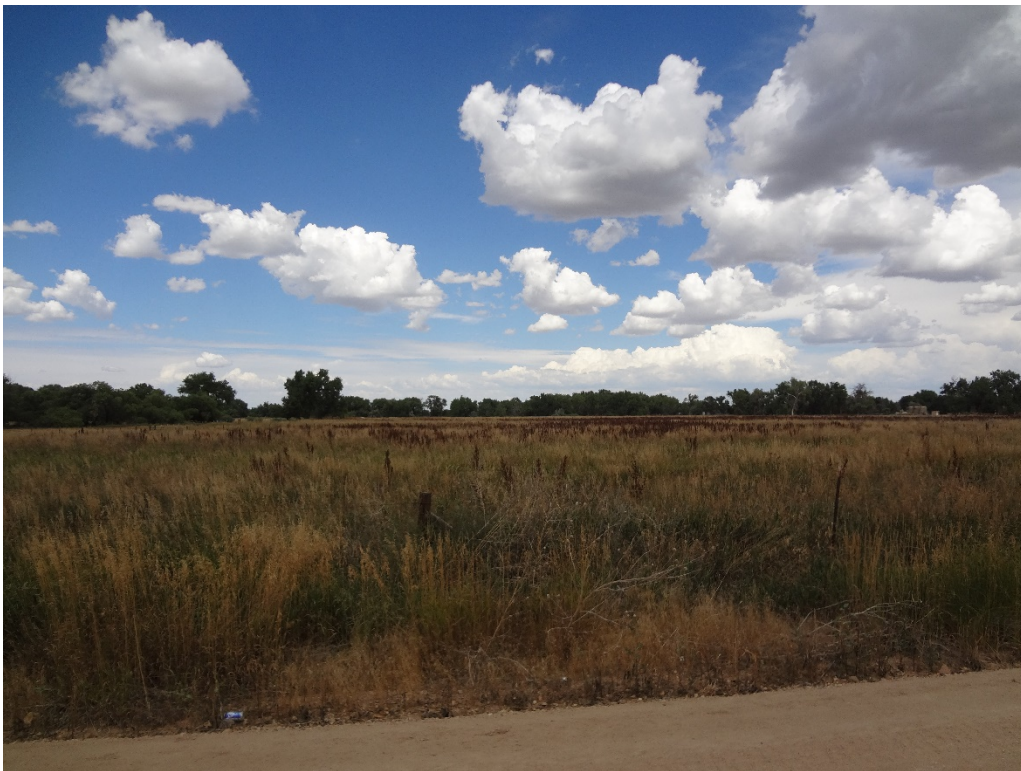
View of Martin Marietta owned parcel from CR 8 looking north

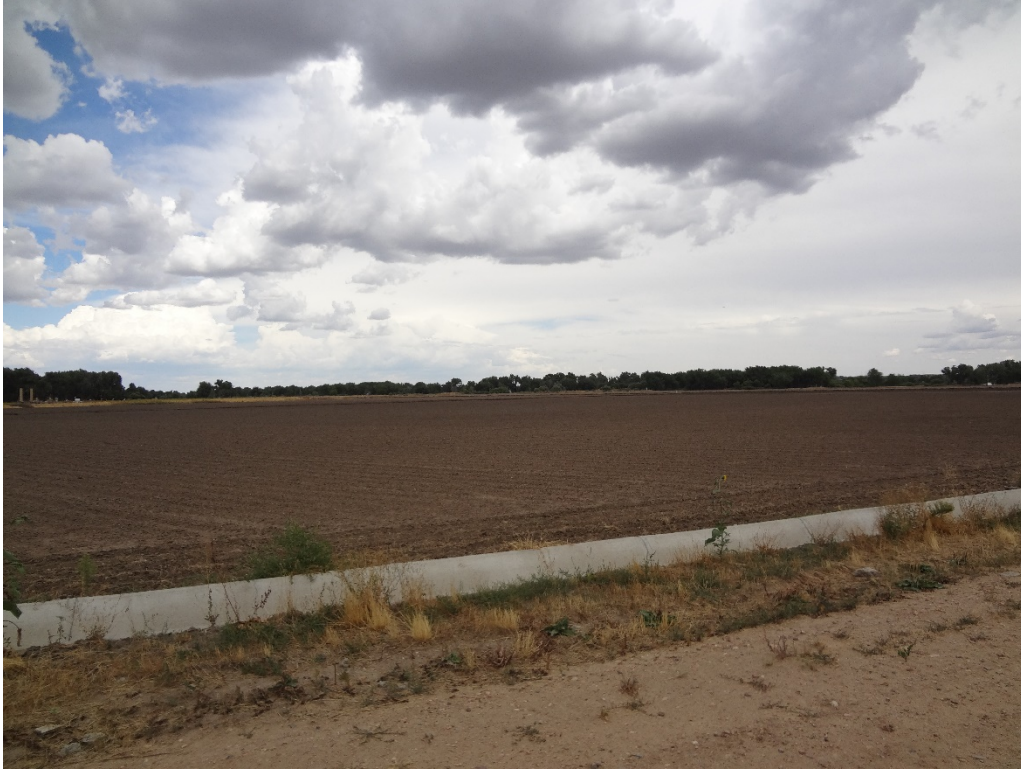
View of Chikuma parcel at end of CR 10.5 looking NE

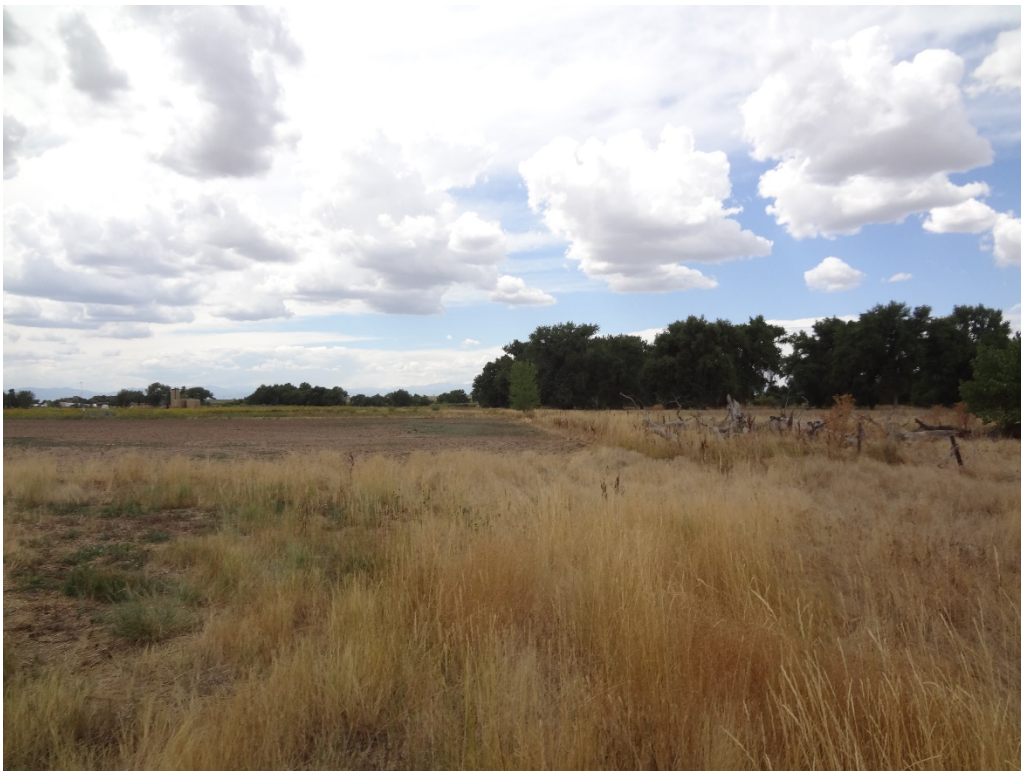
View of Chikuma parcel from gate to Thornton parcel looking west

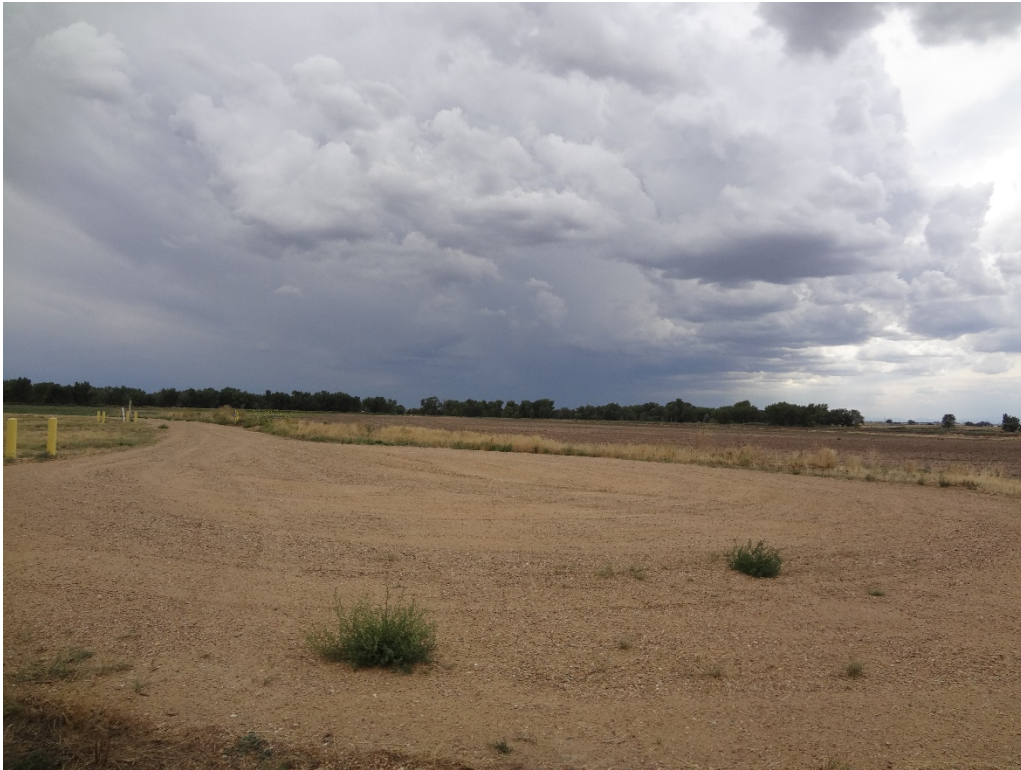
View of Chikuma parcel from gate to Thornton parcel looking south

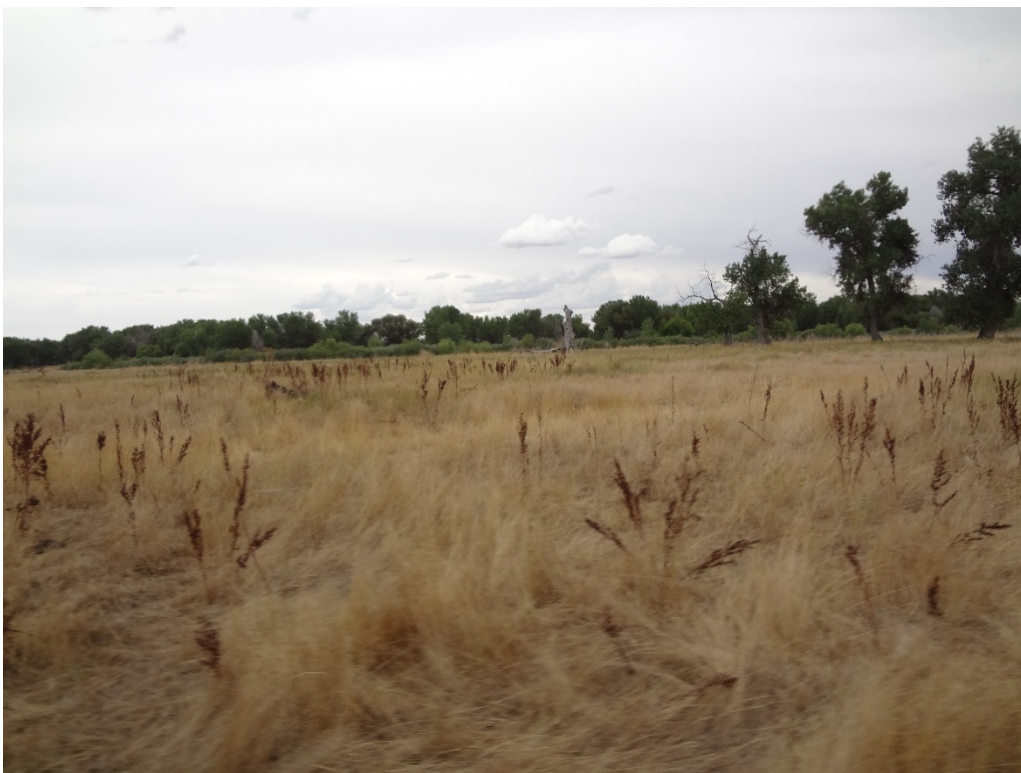
View of Thornton parcel from middle looking east

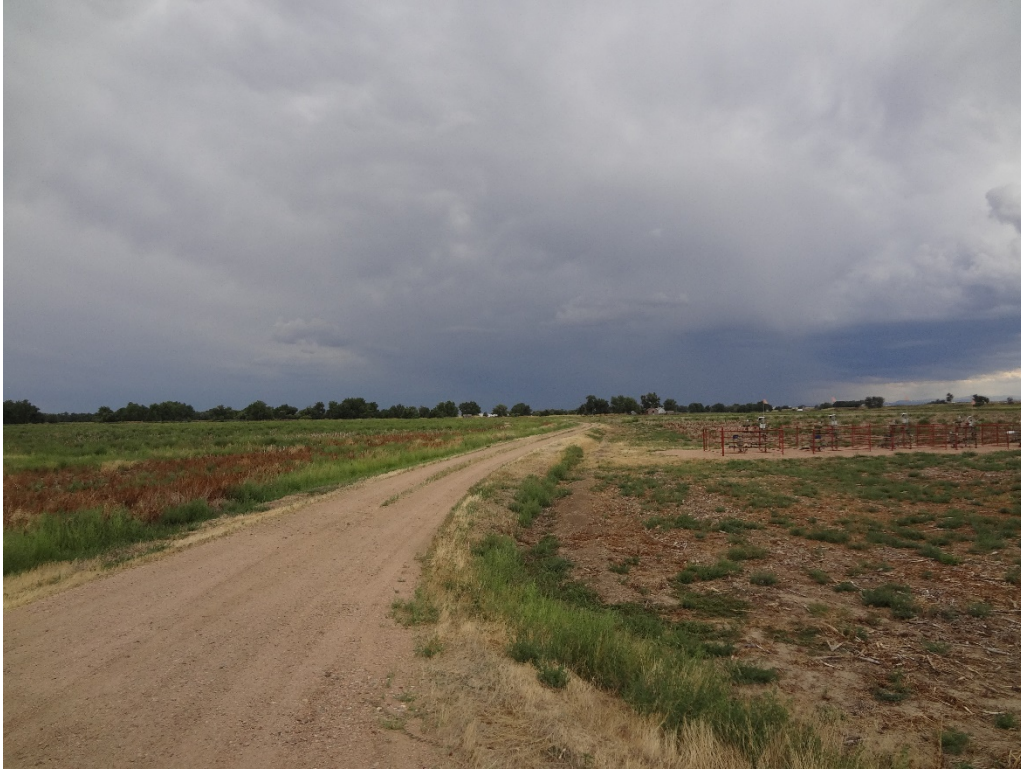
View looking south from corner of MM parcel near Section 12

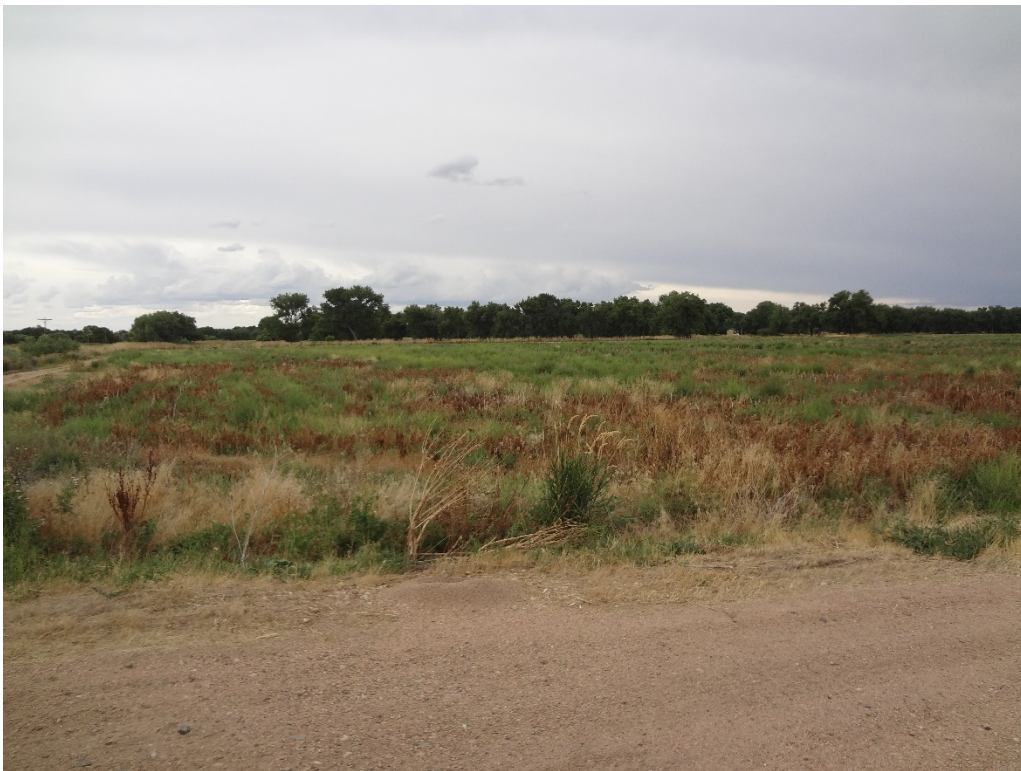
View looking east from corner of MM parcel near Section 12

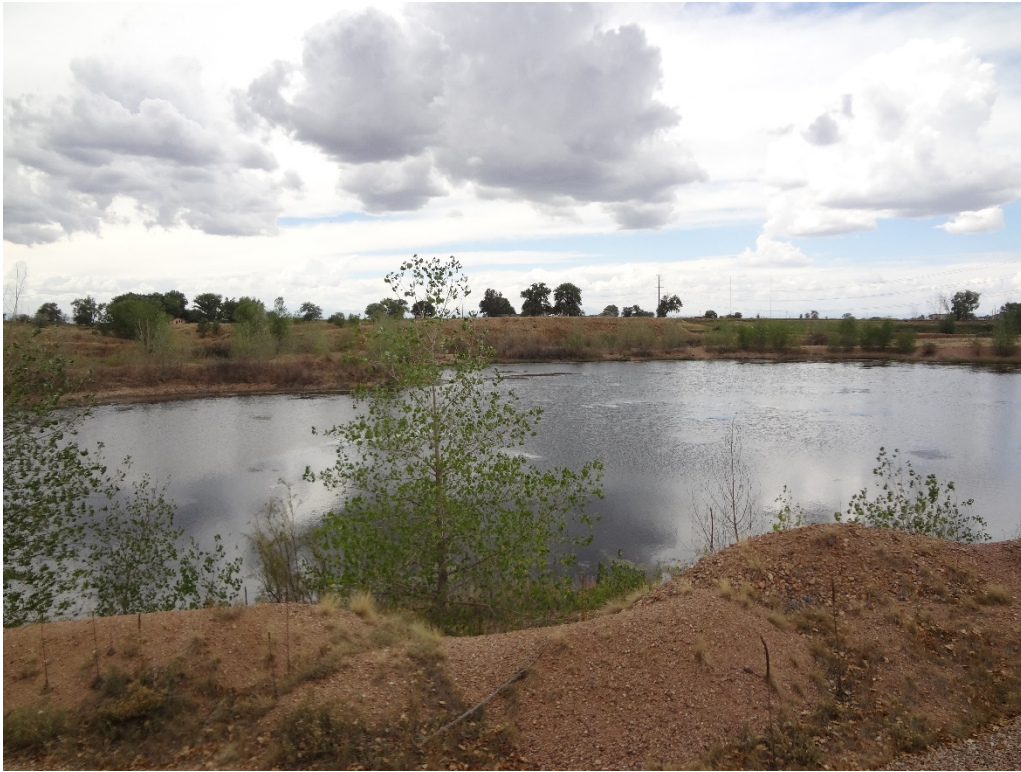
The long-term groundwater augmentation plan for the site has not been address by the Operator. The Operator will need to comply with the Division's letter dated April 30, 2010 addressing operations with exposed groundwater prior to exposing groundwater at the site. The short-term groundwater exposure at the old Ft. Lupton Pit is covered by a well permit and substitute water supply plan.

View of Old Ft. Lupton Pit lake

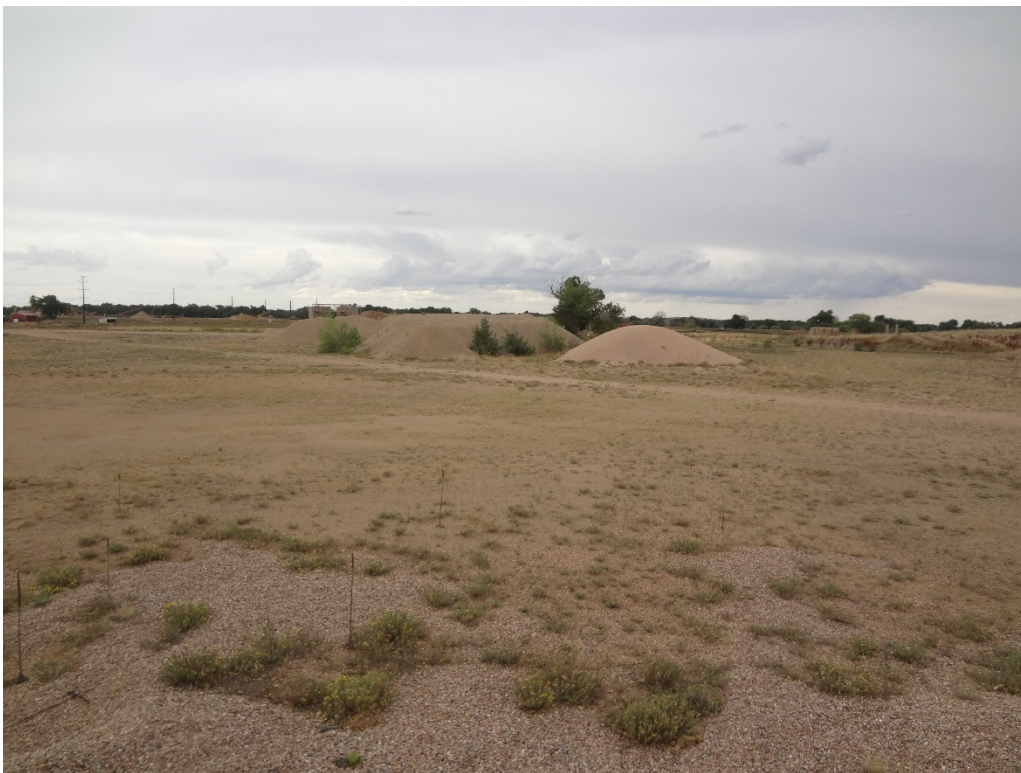
View of Old Ft. Lupton Pit stockpiles
