**COLORADO**Division of Reclamation,  
Mining and Safety

**MINERALS PROGRAM INSPECTION REPORT****PHONE: (303) 866-3567**

<b>MINE NAME:</b> Tellier Gravel Pit	<b>MINE/PROSPECTING ID#:</b> M-1998-058	<b>MINERAL:</b> Sand and gravel and material for construc	<b>COUNTY:</b> Routt
<b>INSPECTION TYPE:</b> Monitoring	<b>INSPECTOR(S):</b> Amy C. Yeldell	<b>INSP. DATE:</b> September 20, 2016	<b>INSP. TIME:</b> 11:30
<b>OPERATOR:</b> Connell Resources, Inc.	<b>OPERATOR REPRESENTATIVE:</b> Kevin Anderson & Tony Connell	<b>TYPE OF OPERATION:</b> 112c - Construction Regular Operation	
<b>REASON FOR INSPECTION:</b> Normal I&E Program	<b>BOND CALCULATION TYPE:</b> Complete Bond	<b>BOND AMOUNT:</b> \$80,000.00	
<b>DATE OF COMPLAINT:</b> NA	<b>POST INSP. CONTACTS:</b> None	<b>JOINT INSP. AGENCY:</b> None	
<b>WEATHER:</b> Cloudy	<b>INSPECTOR'S SIGNATURE:</b>

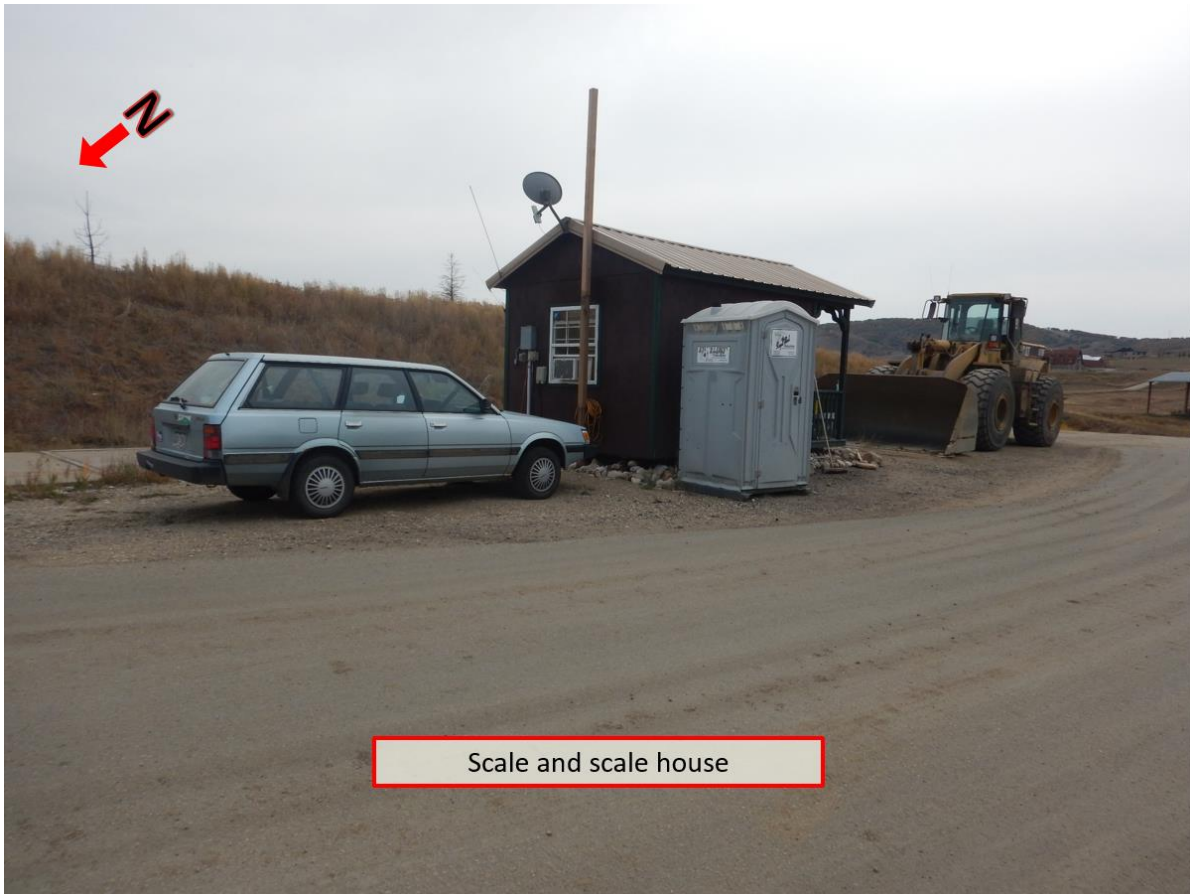
The site was active at the time of the inspection. A dozer was observed. No fuel storage was observed on site. The scale and scale house need to be removed. There is an asphalt mine road up to just past the scales then it turns to dirt. It was indicated that the landowner would like this road to remain. If that is the case a technical revision will be necessary to depict the road post reclamation.

Scale and scale house

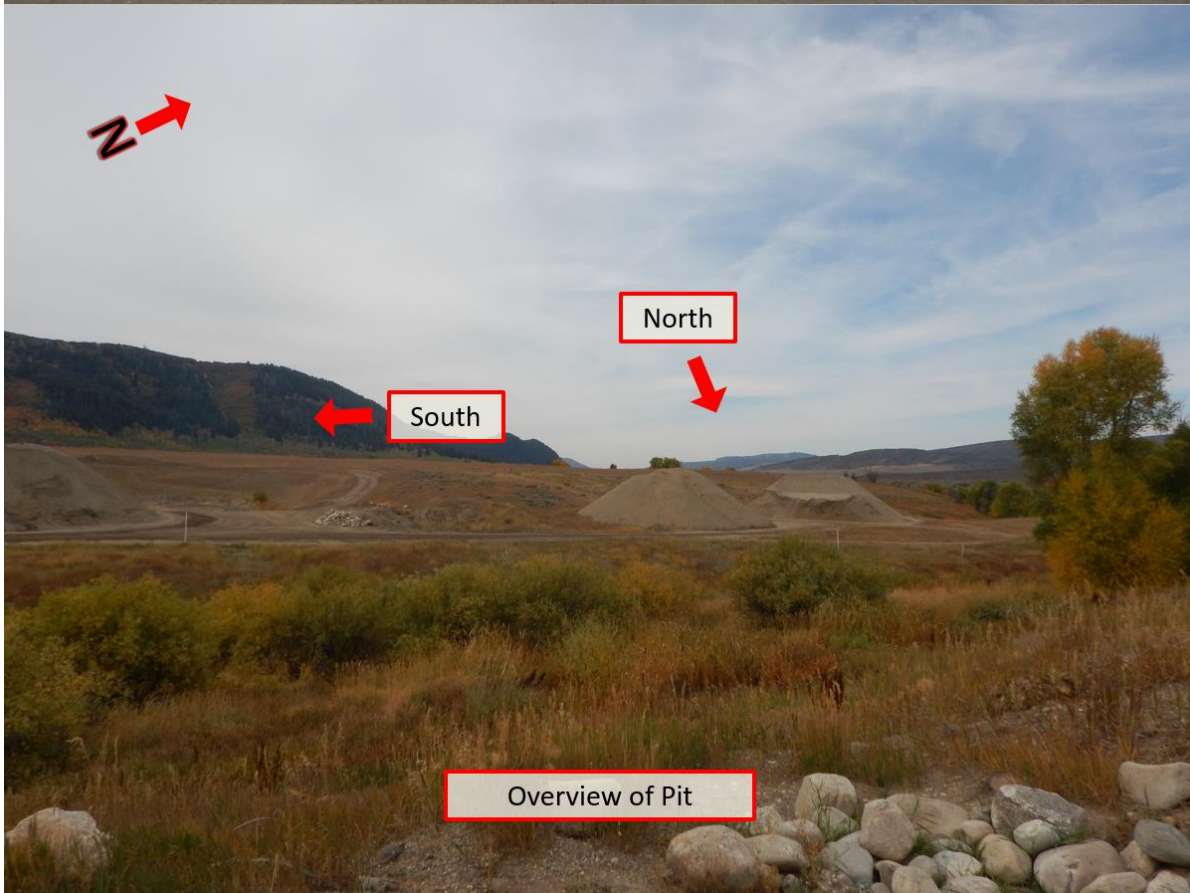
Overview of Pit

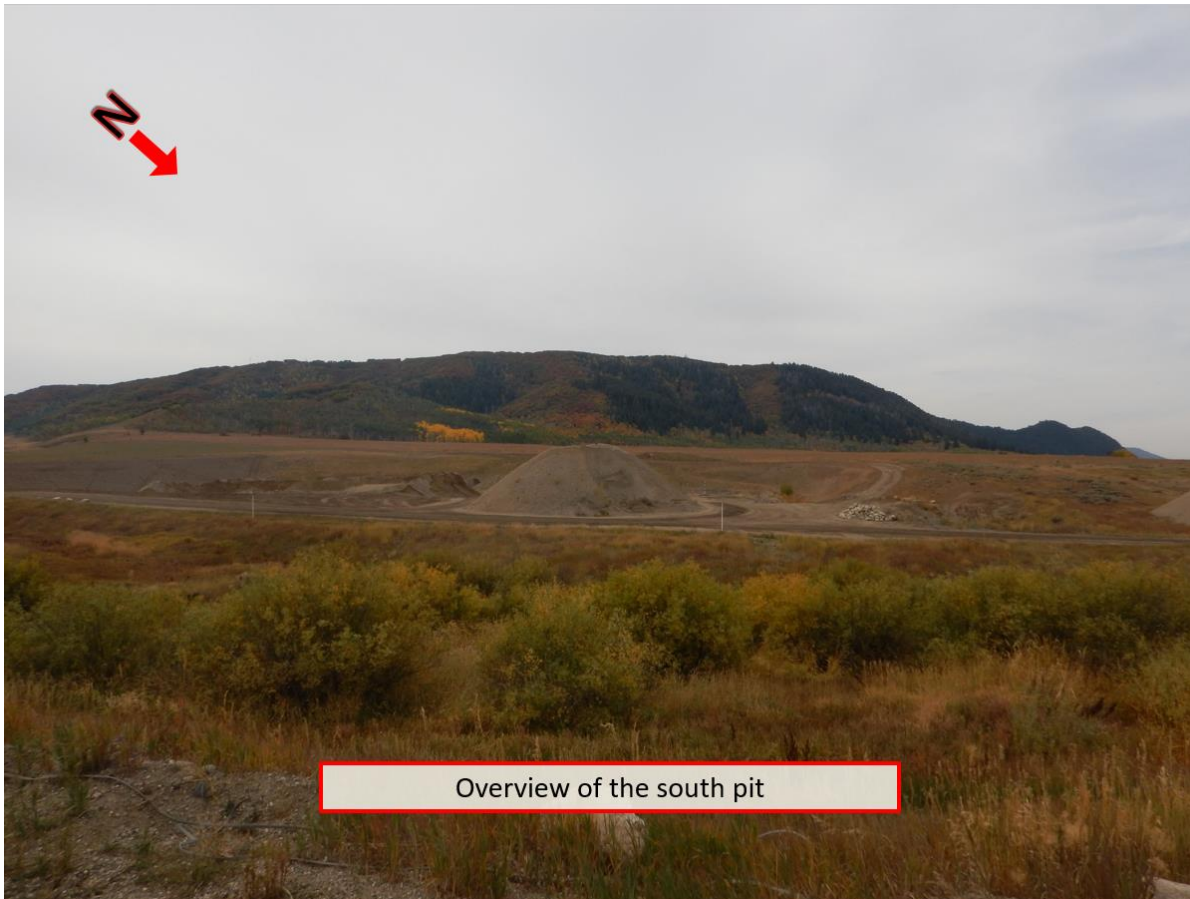
Overview of the south pit

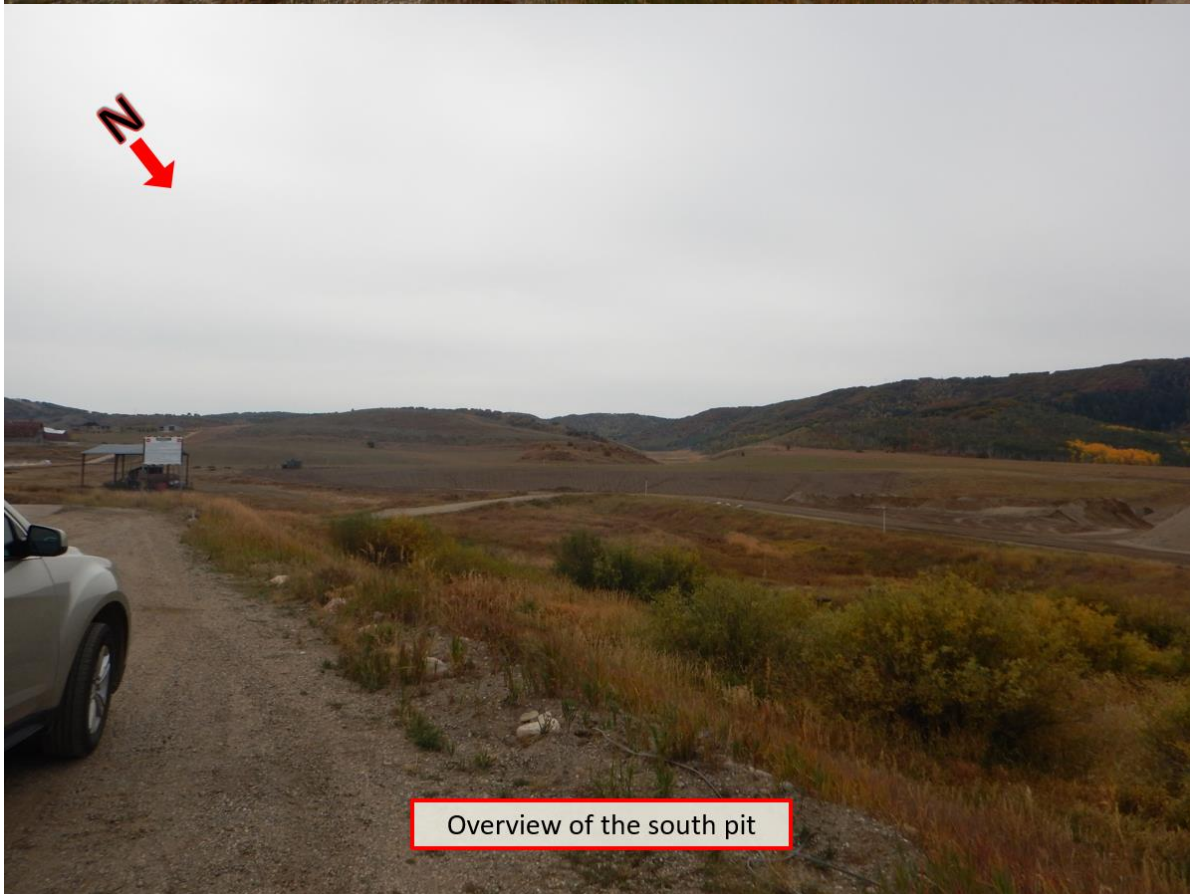
Overview of the south pit
