MINERALS PROGRAM INSPECTION REPORT
PHONE: (303) 866-3567

MINE NAME: Tomichi Pit	MINE/PROSPECTING ID#: M-2013-081	MINERAL: Gravel and sand	COUNTY: Gunnison
INSPECTION TYPE: Monitoring	INSPECTOR(S): Dustin M. Czaplá	INSP. DATE: September 15, 2016	INSP. TIME: 08:00
OPERATOR: Tomichi Materials, LLC	OPERATOR REPRESENTATIVE: Clay Varra	TYPE OF OPERATION: 112c - Construction Regular Operation	
REASON FOR INSPECTION: Normal I&E Program	BOND CALCULATION TYPE: None	BOND AMOUNT: \$269,536.10	
DATE OF COMPLAINT: NA	POST INSP. CONTACTS: None	JOINT INSP. AGENCY: None	
WEATHER: Clear	INSPECTOR'S SIGNATURE:

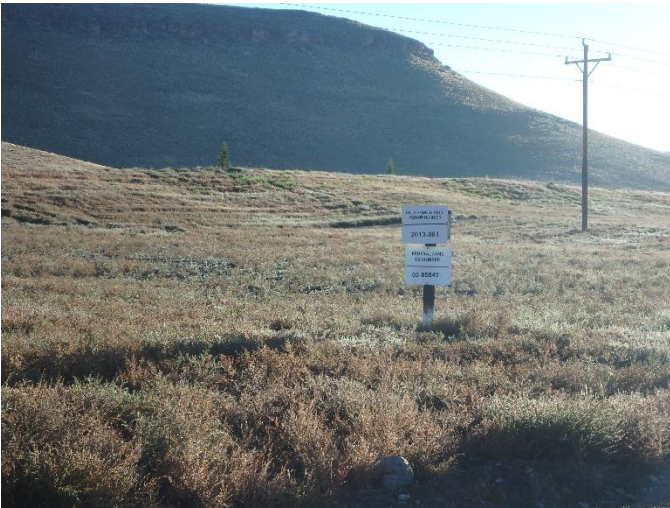
Adequate mine identification signage was noted at the entrance to the site.

Figure 1: Mine identification sign at entrance

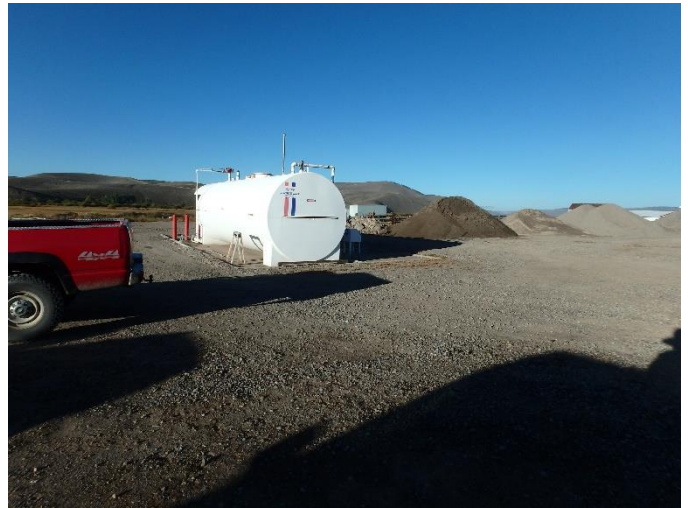
Figure 2: Fuel containment near scale house

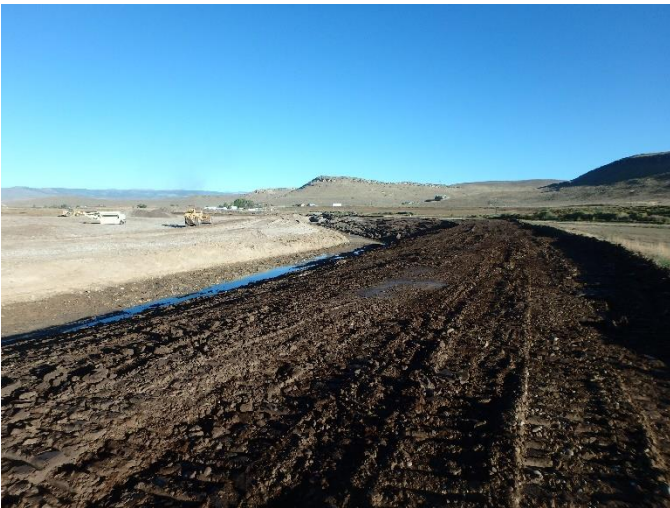
Figure 3: Phase 1 pit viewed from east side

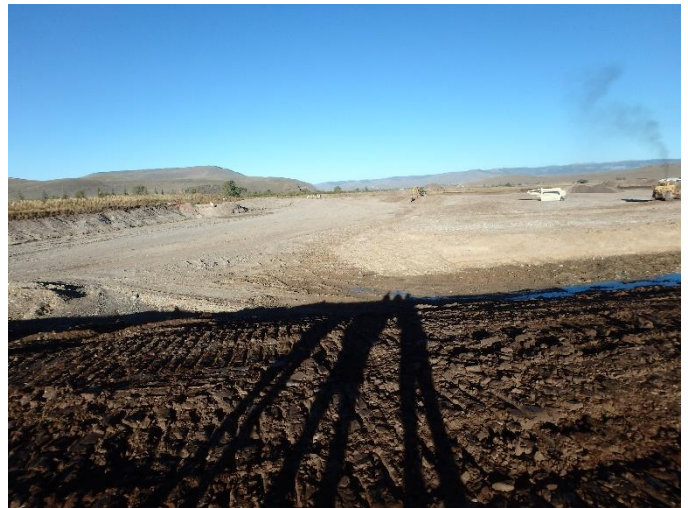
Figure 4: Phase 1 pit viewed from east side

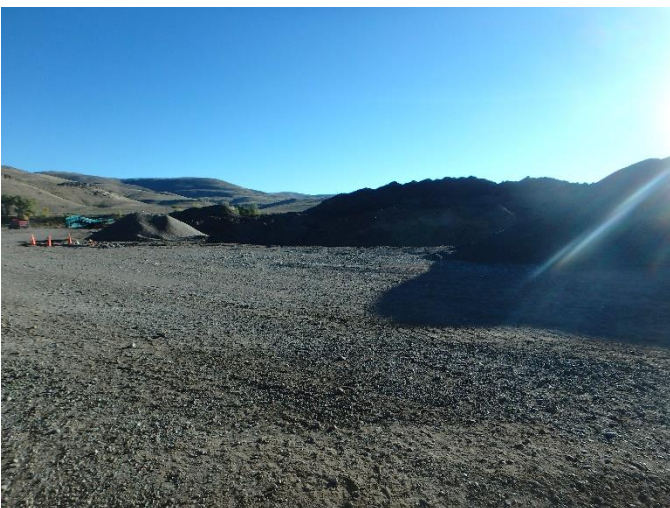
Figure 5: Topsoil and stockpile area on east side of plant area

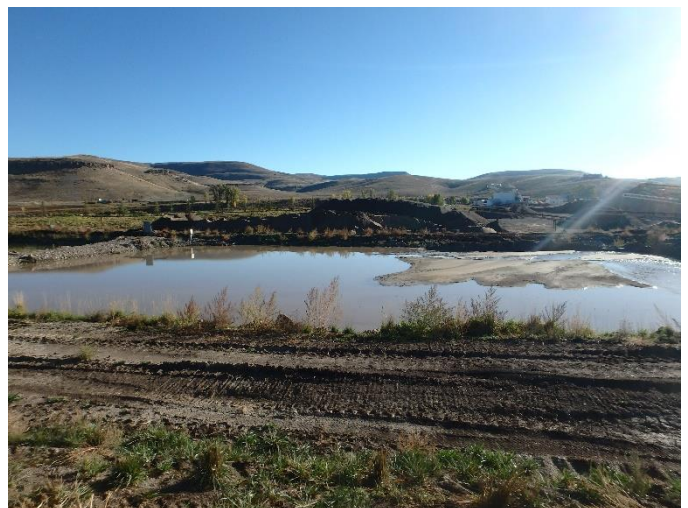
Figure 6: Sediment pond on southeast side of plant area

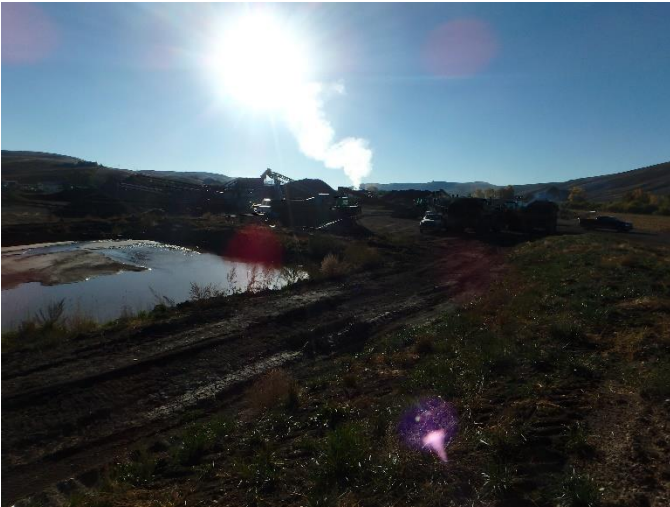
Figure 7: Sediment pond on southeast side of plant area

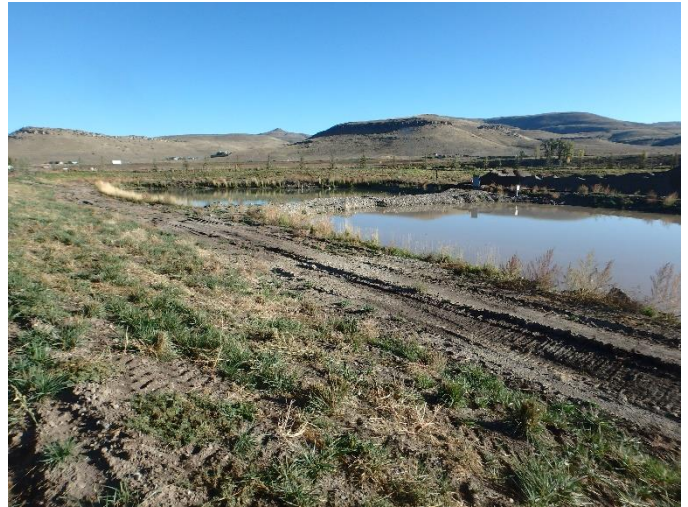
Figure 8: Wash ponds on west side of plant area

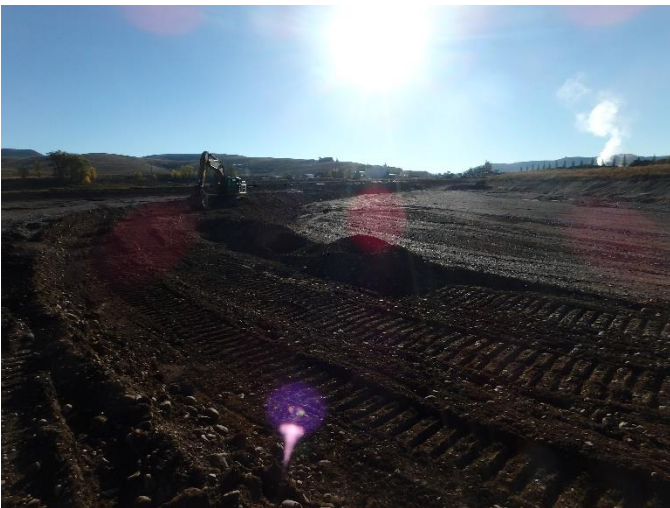
Figure 9: Phase 1 pit viewed from west side

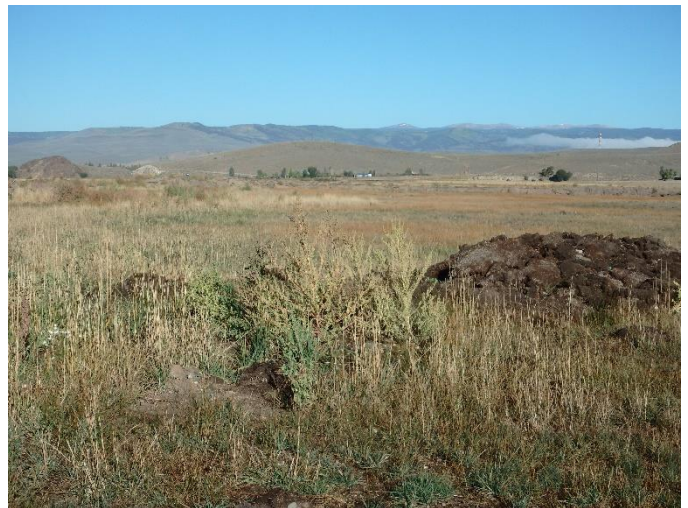
Figure 10: Phase 2 area undisturbed
