Division of Reclamation,
Mining and Safety

MINERALS PROGRAM INSPECTION REPORT

MINE NAME: Sea Horse Ranch West Gravel Pit	MINE/PROSPECTING ID#: M-2001-113	MINERAL: Sand and aggregate	COUNTY: Gunnison
INSPECTION TYPE: Monitoring	INSPECTOR(S): Dustin M. Czapl	INSP. DATE: September 15, 2016	INSP. TIME: 09:00
OPERATOR: Oldcastle SW Group, Inc. dba United Compas County	OPERATOR REPRESENTATIVE:	TYPE OF OPERATION: 112c - Construction Regular Operation

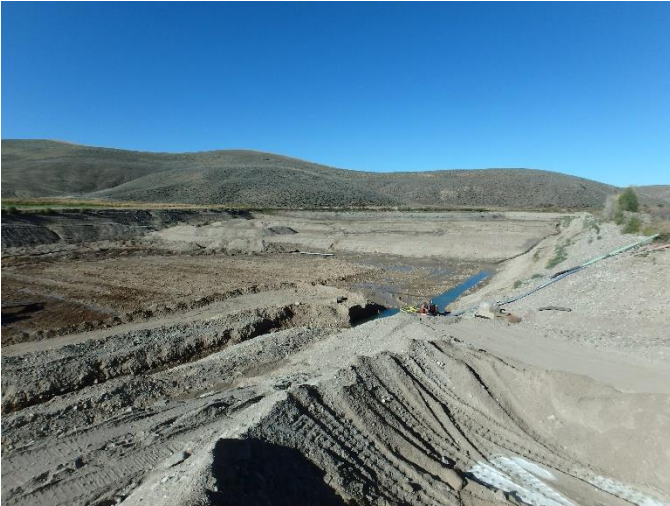
The pit was dewatered and active mining was occurring. Nearly the entire 40 acre permit area has been disturbed by the operation. The highwalls have been mined at approximately 1.5H:1V. Backfilling the slopes to 3H:1V will be required pursuant to the approved reclamation plan.

Figure 1: View from north side of pit

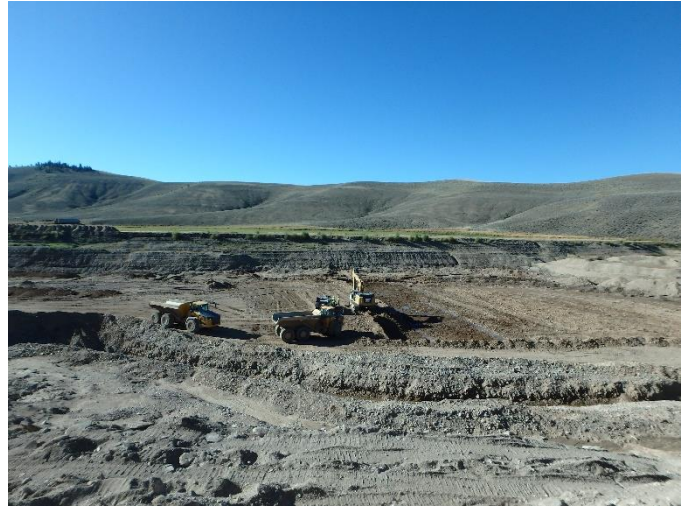
Figure 2: View from north side of pit

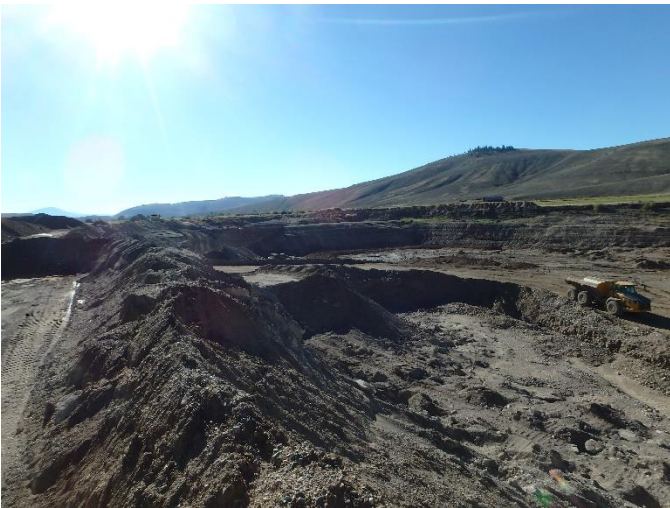
Figure 3: View from north side of pit

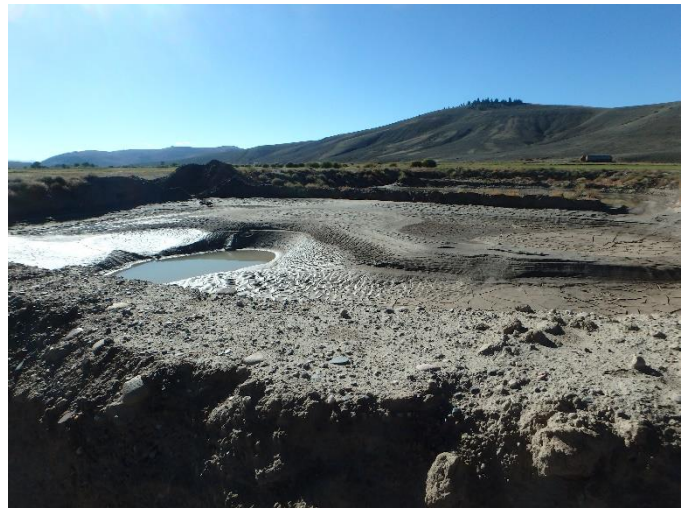
Two sediment retention ponds are located on the east end of the pit. Seepage or stability issues were not noted at the pond slopes.

Figure 4: Sediment ponds at east end of pit

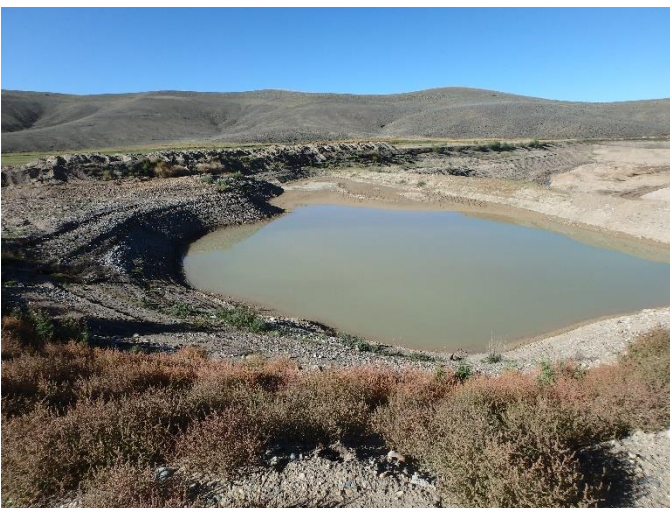
Figure 5: Sediment ponds at east end of pit

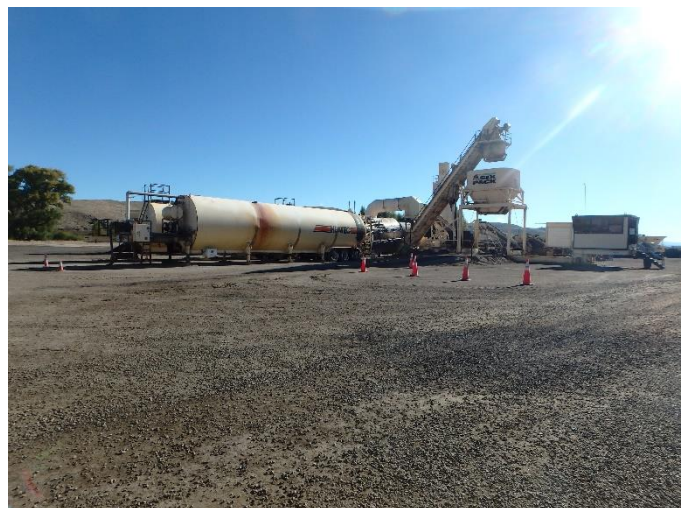
Crushing and stockpiling take place in the northeast part of the permit area. A gravel stormwater berm is constructed around this area. Improperly stored fuels were not noted.

Figure 6: Plant/stockpile area in northeast permit area

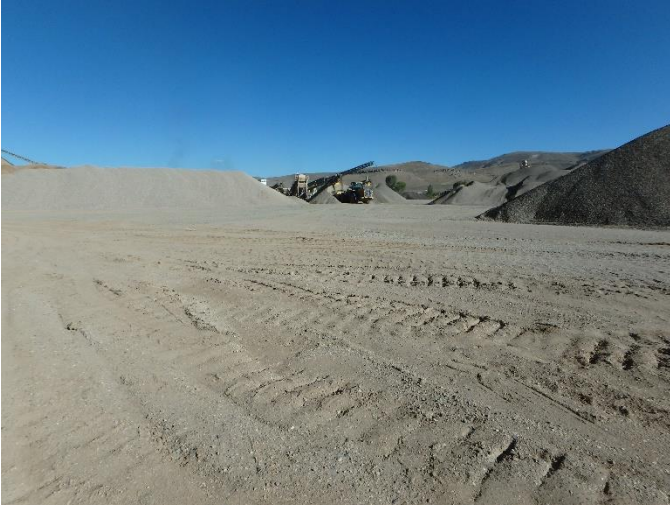
Figure 7: Plant/stockpile area in northeast permit area

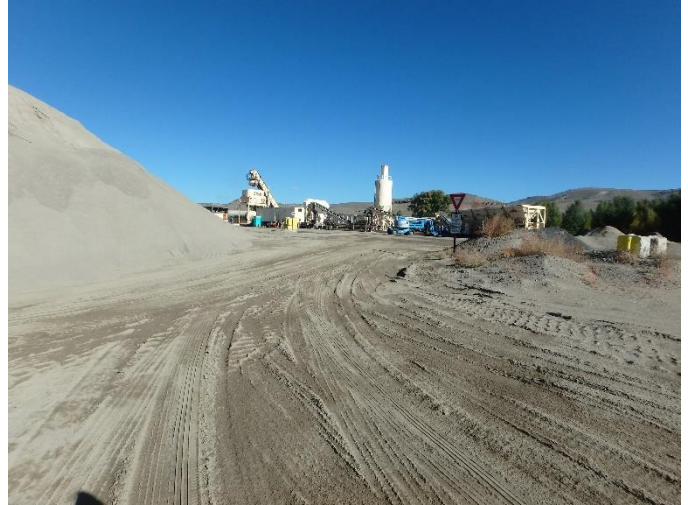
Figure 8: Plant/stockpile area in northeast permit area
