MINERALS PROGRAM INSPECTION REPORT

MINE NAME: Vader Pit	MINE/PROSPECTING ID#: M-1978-287	MINERAL: Sand and gravel	COUNTY: Gunnison
INSPECTION TYPE: Monitoring	INSPECTOR(S): Dustin M. Czapla	INSP. DATE: September 15, 2016	INSP. TIME: 09:30
OPERATOR: Oldcastle SW Group, Inc. dba United Companies of Mesa County	OPERATOR REPRESENTATIVE:	TYPE OF OPERATION: 112c - Construction Regular Operation

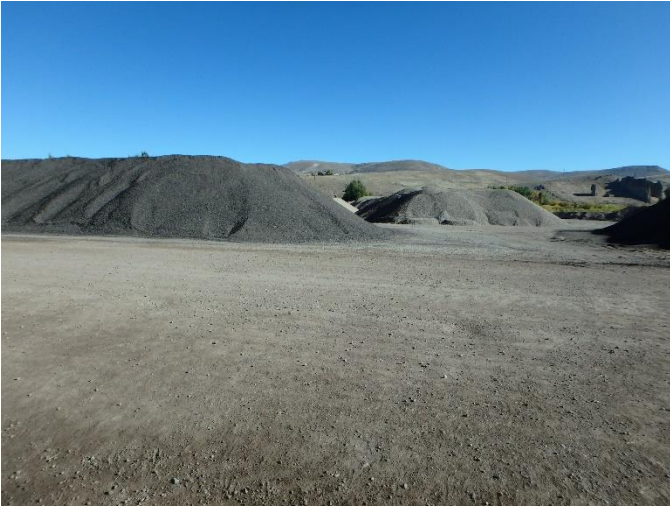
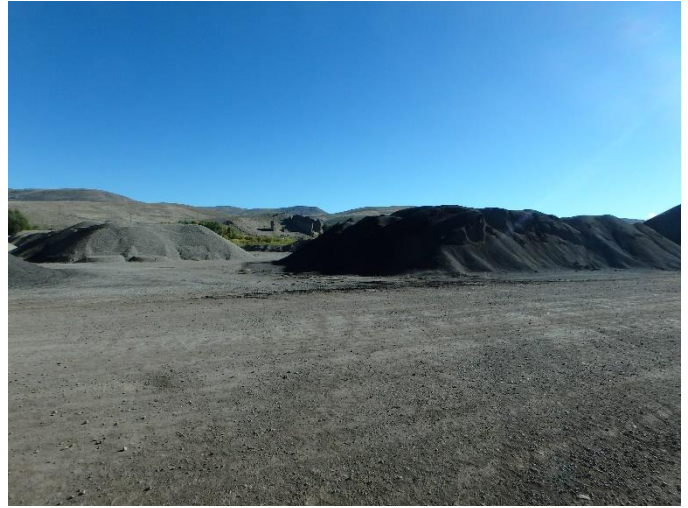
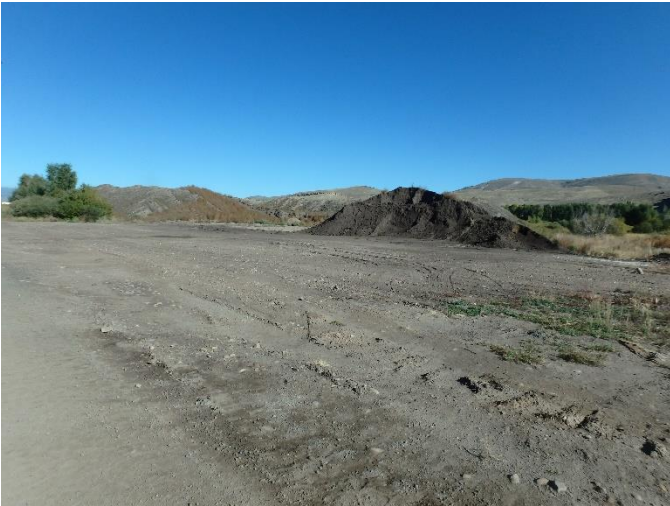
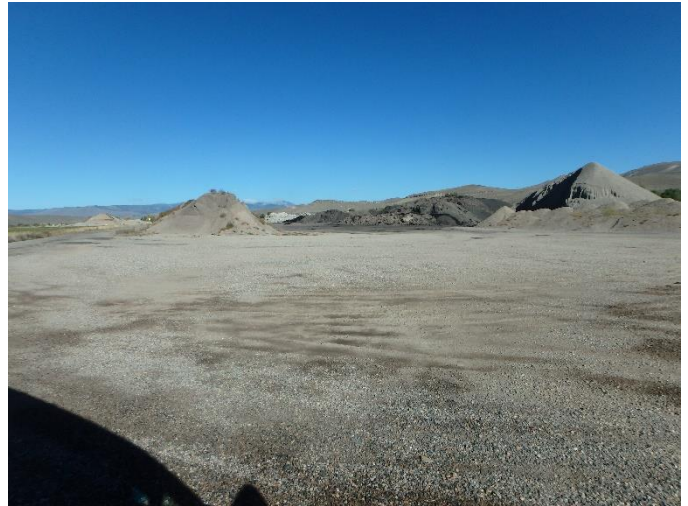
The area south of Tomichi Creek is primarily used for stockpiling materials. Noxious weeds were not noted in this area.

Figure 1: Stockpile area on south side of Tomichi Creek

Figure 2: Stockpile area on south side of Tomichi Creek

Figure 3: Stockpile area on south side of Tomichi Creek

Figure 4: Stockpile area on south side of Tomichi Creek

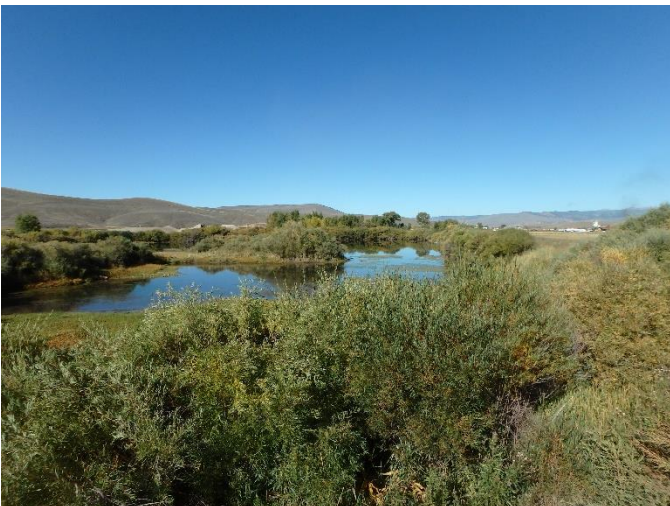
Past mining in the area north of Tomichi Creek has created a pond. The banks of the pond are well vegetated and appear stable. Because the pond is not dewatered it is uncertain if the grading of the banks is compliant with the final reclamation plan. The area immediately east of the pond appeared to have been used in the past for stockpiling and/or processing. This area does not appear to have been seeded or topsoiled yet as part of reclamation, although there is considerable volunteer vegetation becoming established in this area. A significant noxious weed infestation was noted in this area, including bull thistle and halogeton. Noxious weeds were noted in this area during the Division's August 2012 inspection as well. This area needs to be addressed as part of the ongoing weed management at the site. If it is not anticipated that future mining will occur in this area, than it should be reclaimed.

Figure 5: Pond on north side of Tomichi Creek

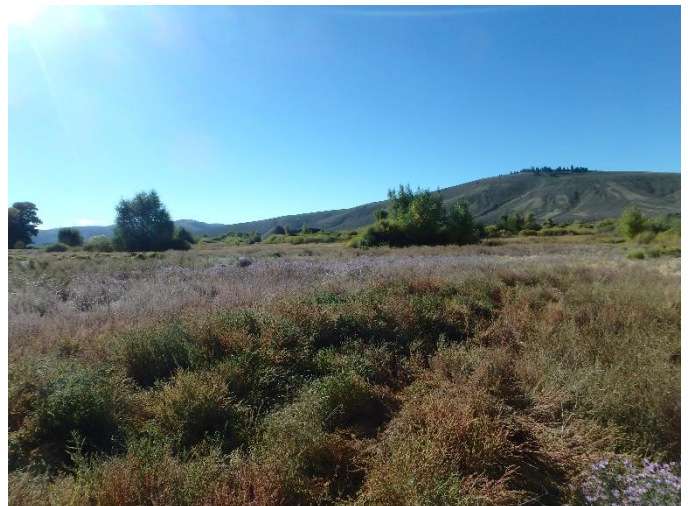
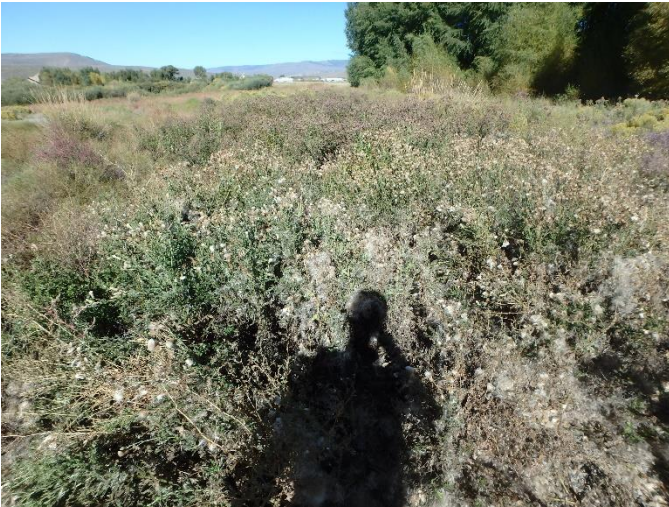
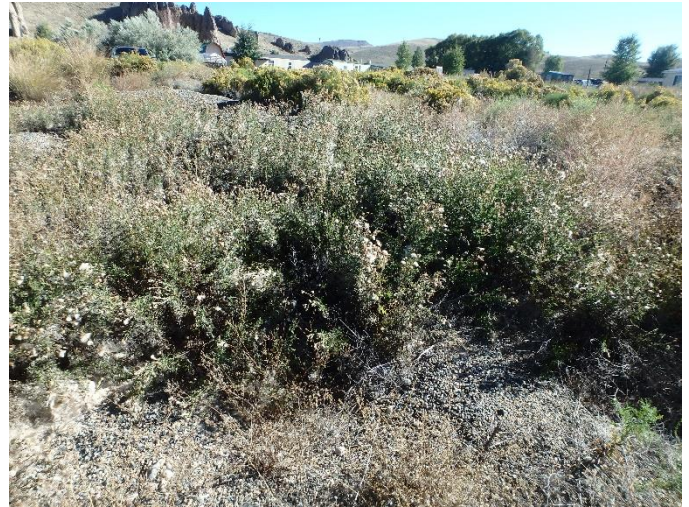
PROBLEM/POSSIBLE VIOLATION: Problem: There are state-listed noxious weeds present on site. This is a problem for failure to employ weed control methods for state listed noxious weed species within the permitted area, and to reduce the spread of weeds to nearby areas as required by Section 3.1.10 (6) of the rule.

Figure 6: Noxious weeds noted on north side of Tomichi Creek

Figure 7: Noxious weeds noted on north side of Tomichi Creek

Figure 8: Noxious weeds noted on north side of Tomichi Creek

CORRECTIVE ACTIONS: Implement approved weed control plan and provide proof to the Division that this has been done.
