MINERALS PROGRAM INSPECTION REPORT PHONE: (303) 866-3567

MINE NAME:		MINE/PROSPECTING ID#:	MINERAL:	COUNTY:	
Pit No 6		M-1978-192	Sand and gravel	Chaffee	
INSPECTION TYPE:		INSPECTOR(S):	INSP. DATE:	INSP. TIME:	
Monitoring		Dustin M. Czapla	September 21, 2016	14:00	
OPERATOR:		OPERATOR REPRESENTATIVE:	TYPE OF OPERAT	TION:	
Chaffee County			110c - Construction l	Limited Impact	
REASON FOR INSPECTION:		BOND CALCULATION TYPE:	BOND AMOUNT:		
Normal I&E Program		None	\$0.00		
DATE OF COMPLAINT:		POST INSP. CONTACTS:	JOINT INSP. AGENCY:		
NA		None	None		
WEATHER:	INSPECTOR'S SIGNATURE:		SIGNATURE DATE:		
Raining	R		September 27, 2016

PERMIT #: M-1978-192 INSPECTOR'S INITIALS: DMC INSPECTION DATE: September 21, 2016

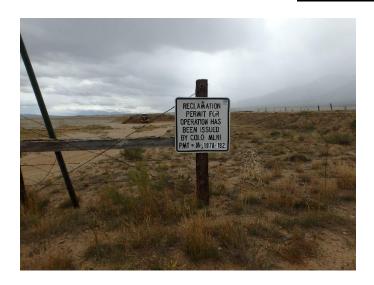
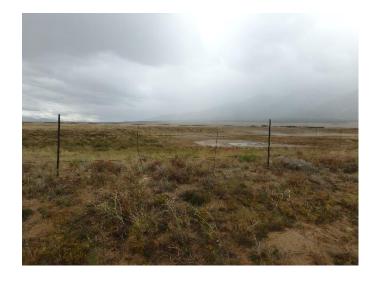
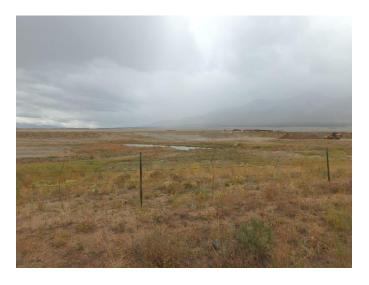
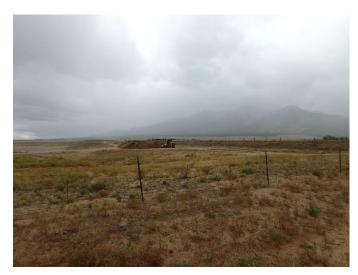
Adequate mine identification signage was noted at the entrance to the site.

The affected area boundary was not clearly marked on the south and east sides, but the disturbance at the site appears to be contained within the footprint of the pre-permit pit.

There was hauling activity occurring at the site during this inspection. Several materials stockpiles were located in the central pit area.

The slope along the west pit boundary has been graded to an approximate 1.5H:1V slope. Some slope reduction of this slope will be necessary during final reclamation. The remainder of the slopes around the pit appeared to be 3H:1V or less.
