**MINERALS PROGRAM INSPECTION REPORT**  
**PHONE: (303) 866-3567**

<b>MINE NAME:</b> Pitch Project	<b>MINE/PROSPECTING ID#:</b> M-1977-004	<b>MINERAL:</b> Uranium	<b>COUNTY:</b> Saguache
<b>INSPECTION TYPE:</b> Monitoring	<b>INSPECTOR(S):</b> Dustin M. Czapla	<b>INSP. DATE:</b> September 14, 2016	<b>INSP. TIME:</b> 11:00
<b>OPERATOR:</b> Homestake Mining Company	<b>OPERATOR REPRESENTATIVE:</b> Dale Davis	<b>TYPE OF OPERATION:</b> 112d-1 - Designated Mining Operation	
<b>REASON FOR INSPECTION:</b> Normal I&E Program	<b>BOND CALCULATION TYPE:</b> None	<b>BOND AMOUNT:</b> \$2,263,000.00	
<b>DATE OF COMPLAINT:</b> NA	<b>POST INSP. CONTACTS:</b> None	<b>JOINT INSP. AGENCY:</b> None	
<b>WEATHER:</b> Clear	<b>INSPECTOR'S SIGNATURE:</b>

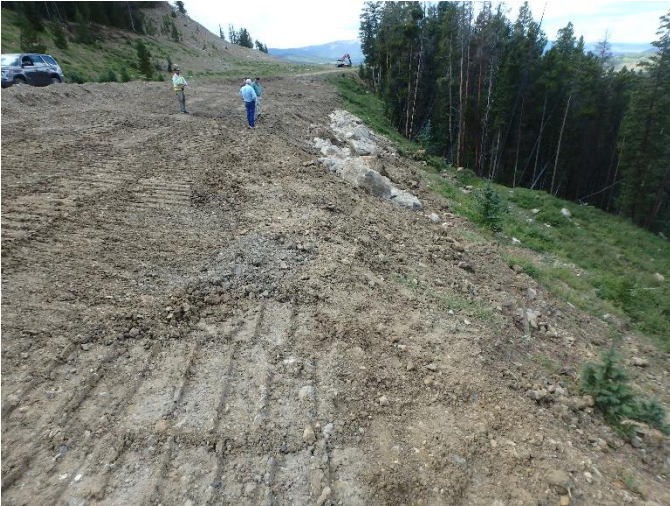
Access Road: The failed slope along the access road noted during the June 2015 inspection has been repaired and appears stable. The repair disturbance has been seeded but vegetation is not yet established on the slope.

Figure 1: Access road repair work

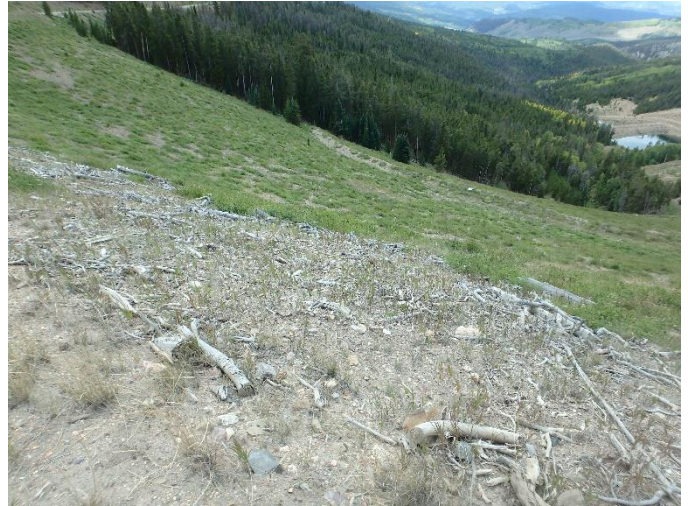
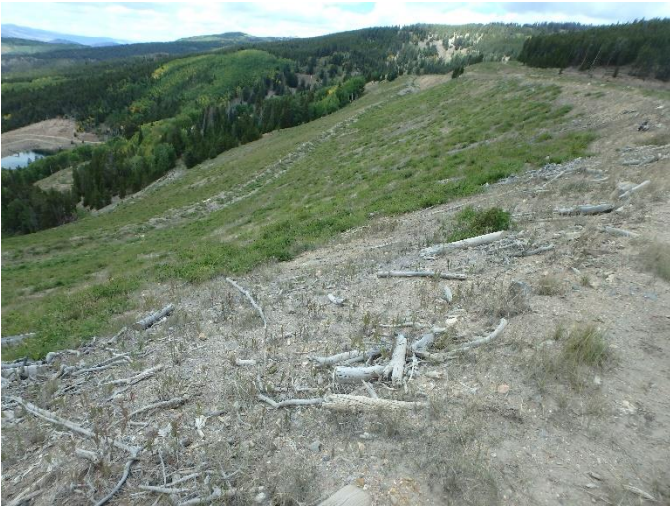
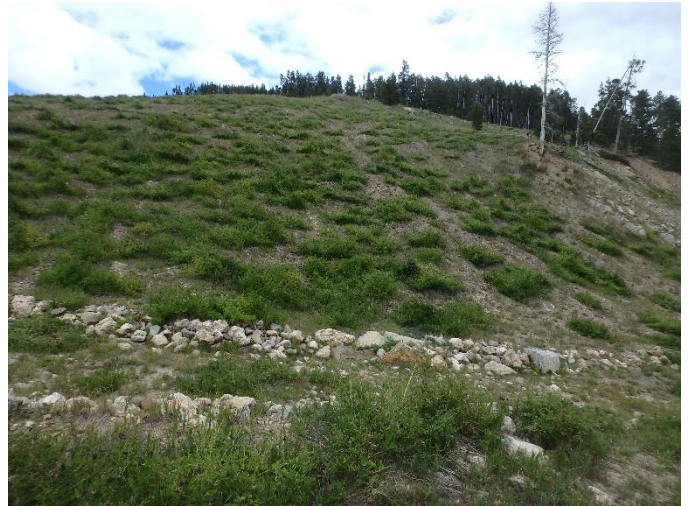
Tie Camp Rock Dump: The slope below the road appears stable and vegetation is becoming well established. No significant erosional features were noted.

Figure 2: Tie Camp Rock Dump below access road

Figure 3: Tie Camp Rock Dump below access road

Figure 4: Tie Camp Rock Dump above access road

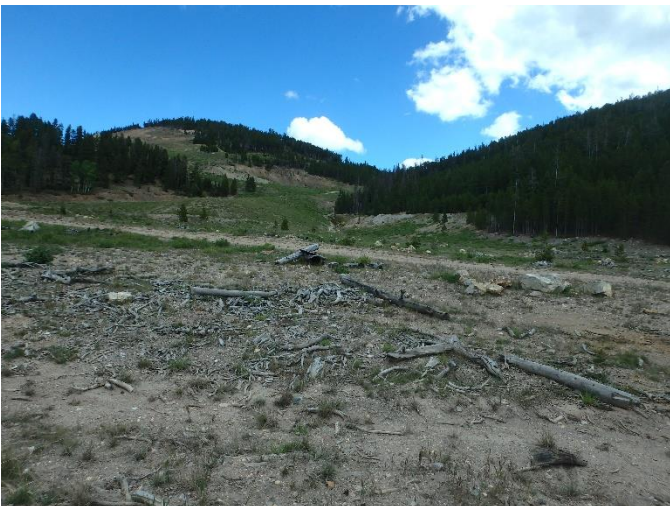
Tie Camp Disposal Cell: Slopes appear stable and vegetation is becoming well established. No significant erosional features were noted.

Figure 5: Tie Camp disposal cell

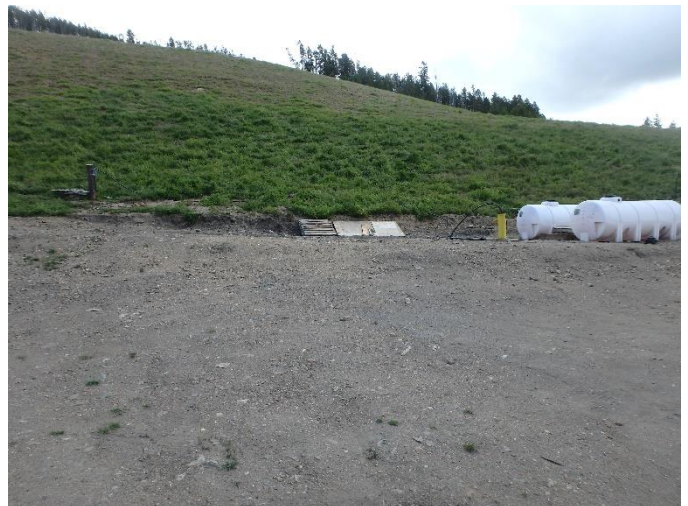
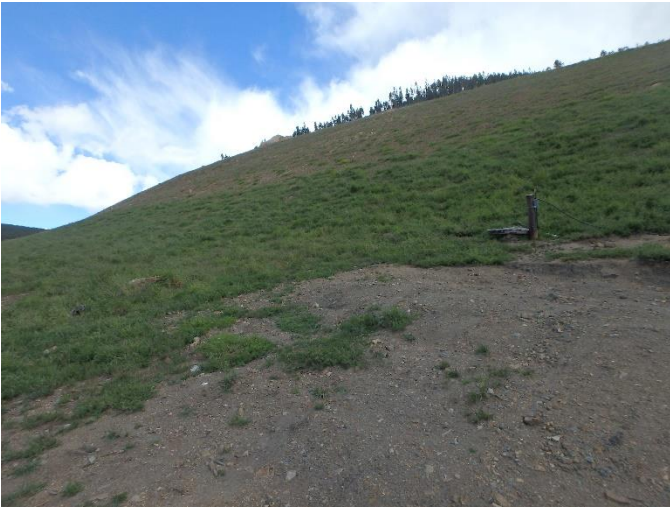
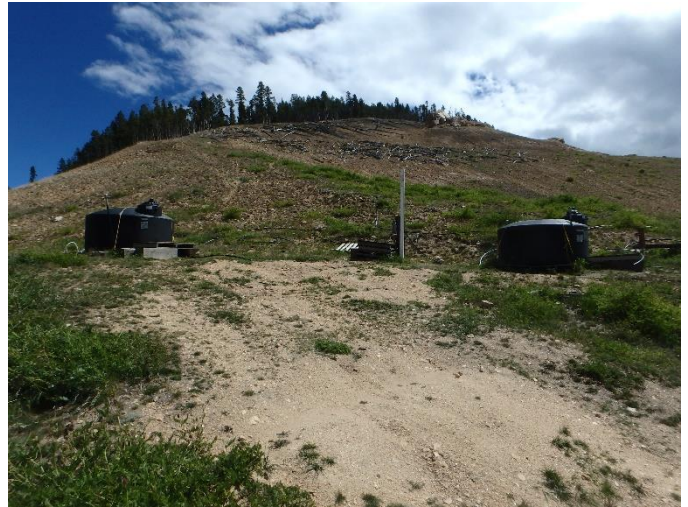
South Pit: Some of the reclamation has been redisturbed in this area to accommodate installation of several injection wells. No problems relating to the injection wells were noted. The reclaimed slopes in the south pit area appear stable and vegetation is becoming well established. No significant erosional features were noted.

Figure 6: South Pit injection wells

Figure 7: South Pit injection wells

Figure 8: South Pit injection wells

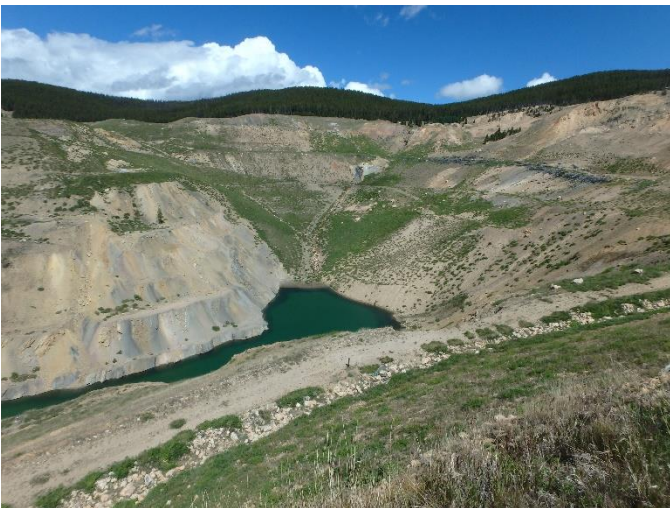
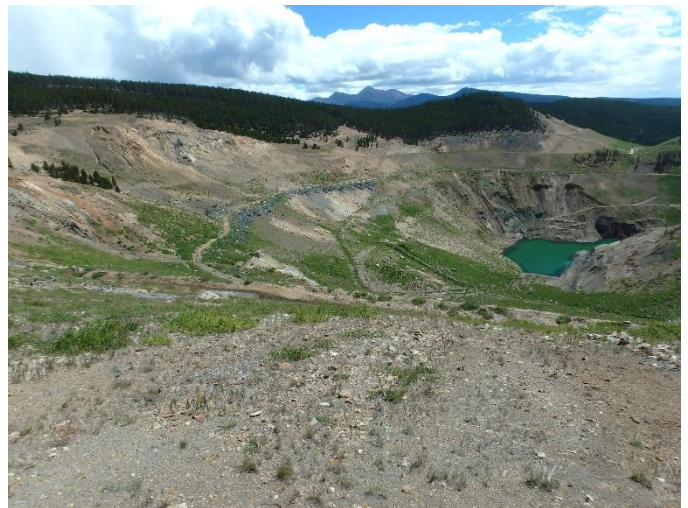
North Pit: Slope movement above the North Pit Lake continues to be monitored. A final reclamation/stabilization plan is not yet developed for this area. Efforts are ongoing and progress is being made to control erosion and drainage on the east wall of the north pit where several gullies have formed.

Figure 9: North Pit viewed from the south

Figure 10: North Pit viewed from the north

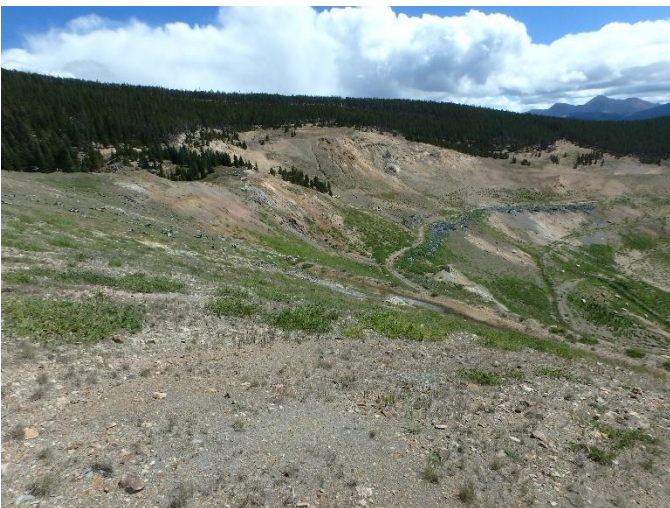
Figure 11: North Pit northeast wall

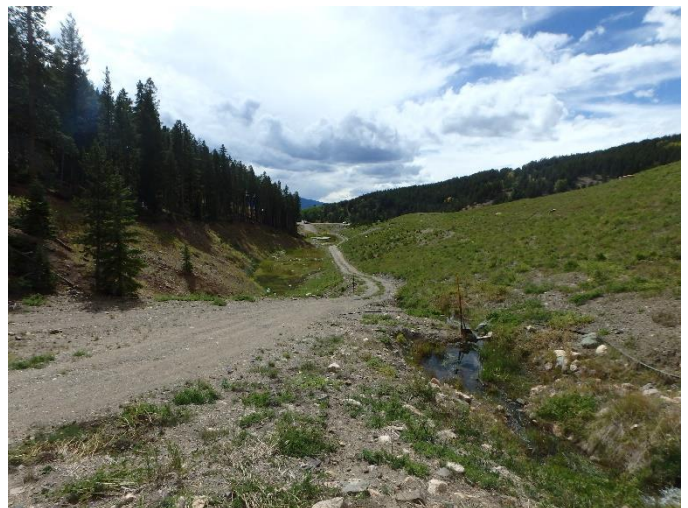
Discharge from the North Pit Lake flows through the valve and culvert as designed. The Pinnacle Portal continues to discharge and flow is measured through a v-notch weir. The discharge reports to a marsh area above the facilities shop building. Cattails and sedges are becoming well established in the marsh area.

Figure 12: North Pit lake discharge and marsh area

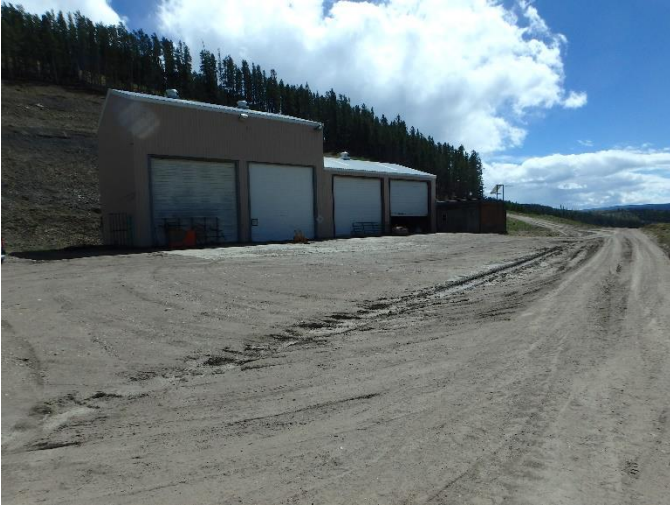
Several pieces of equipment were parked in the area near the shop building. The area around the shop building is well kept and orderly. The radium treatment plant has been removed from this area.

Figure 13: Shop facility below North Pit

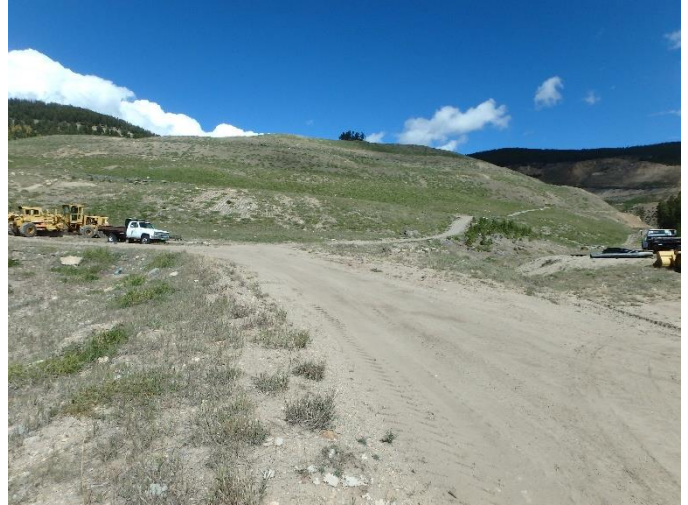
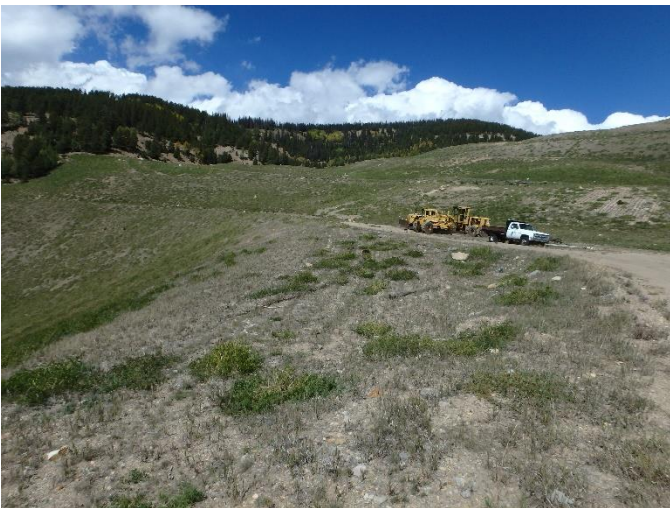
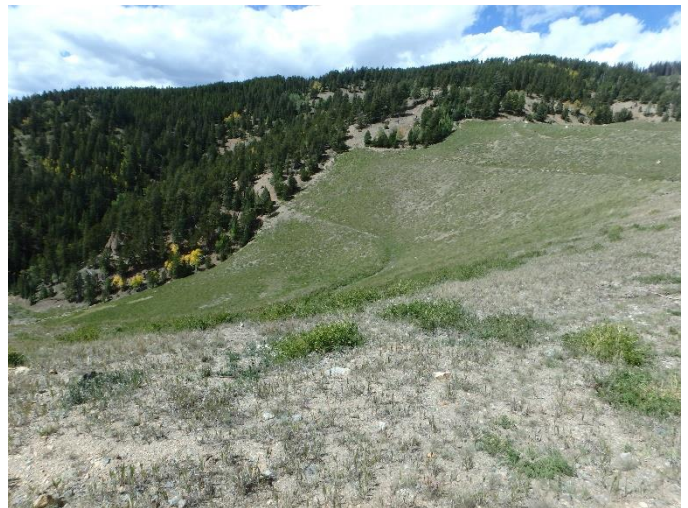
Indian Rock Dump: Slopes appear stable and vegetation is becoming well established. No significant erosional features were noted. Two injection wells have been installed at the base of the dump. No problems relating to the injection wells were noted.

Figure 14: Indian Rock Dump

Figure 15: Indian Rock Dump

Figure 16: Indian Rock Dump

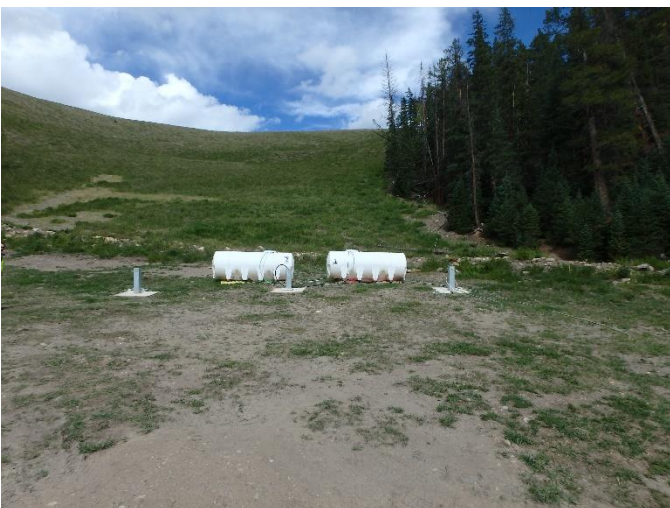
Figure 7: Injection wells at base of Indian Rock Dump

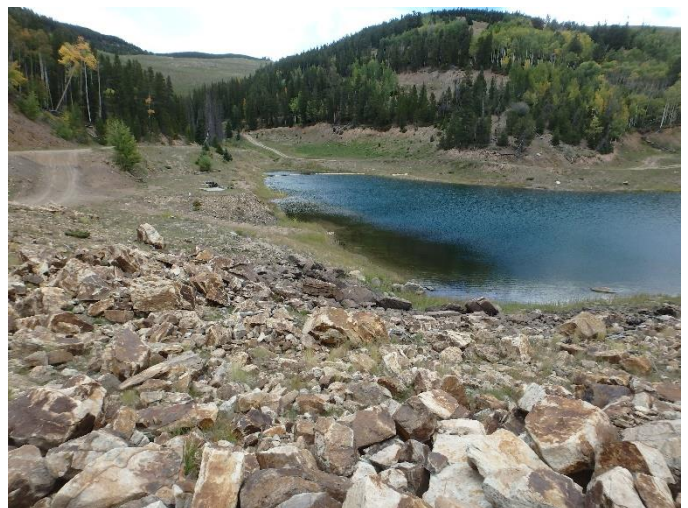
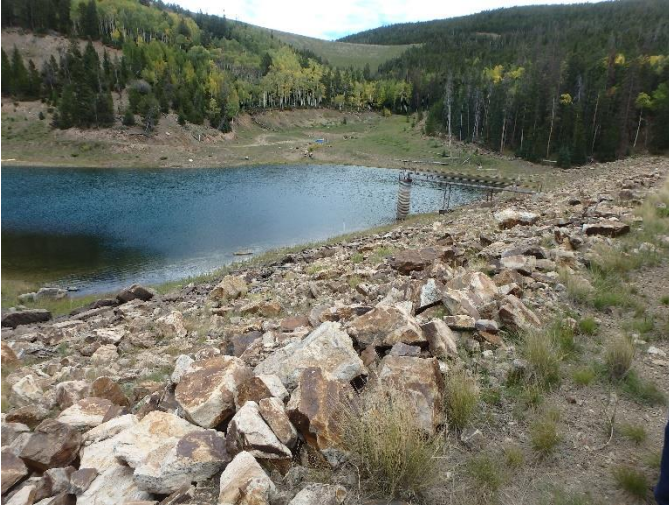
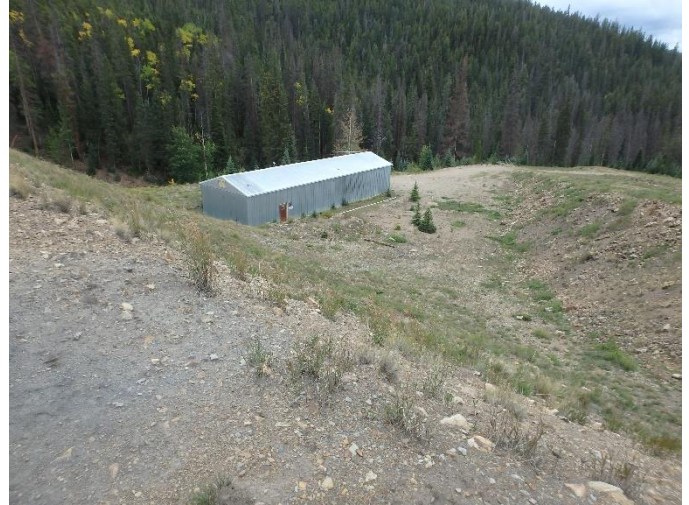
Sediment Pond: The sediment pond appears functional and the pond slopes appear stable. A surface filter boom placed at the upper end of the pond is maintained and still in place. No seepage or stability concerns were noted around the dam.

Figure 8: Sediment Pond

Figure 9: Sediment Pond

Figure 10: Sediment Pond
