MINERALS PROGRAM INSPECTION REPORT
PHONE: (303) 866-3567

MINE NAME: Cottonwood Pit	MINE/PROSPECTING ID#: M-1988-042	MINERAL: Sand and gravel	COUNTY: Weld
INSPECTION TYPE: Monitoring	INSPECTOR(S): Peter S. Hays	INSP. DATE: August 29, 2016	INSP. TIME: 10:00
OPERATOR: Martin Marietta Materials, Inc.	OPERATOR REPRESENTATIVE:	TYPE OF OPERATION: 112c - Construction Regular Operation	
REASON FOR INSPECTION: Normal I&E Program	BOND CALCULATION TYPE: IT.Bondcalculationtype.CD.Desc	BOND AMOUNT: \$421,700.00	
DATE OF COMPLAINT: NA	POST INSP. CONTACTS: None	JOINT INSP. AGENCY: None	
WEATHER: Clear	INSPECTOR'S SIGNATURE:

OBSERVATIONS

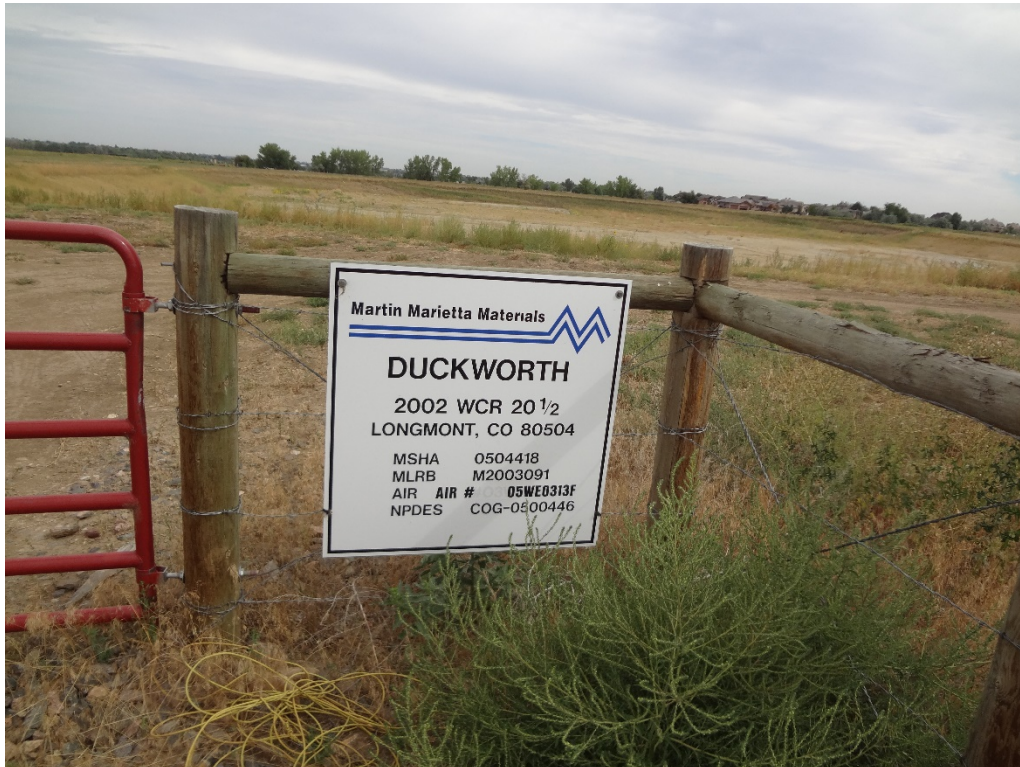
The mine sign and boundary markers were observed as required by Rule 3.1.12.

Duckworth Pit mine sign

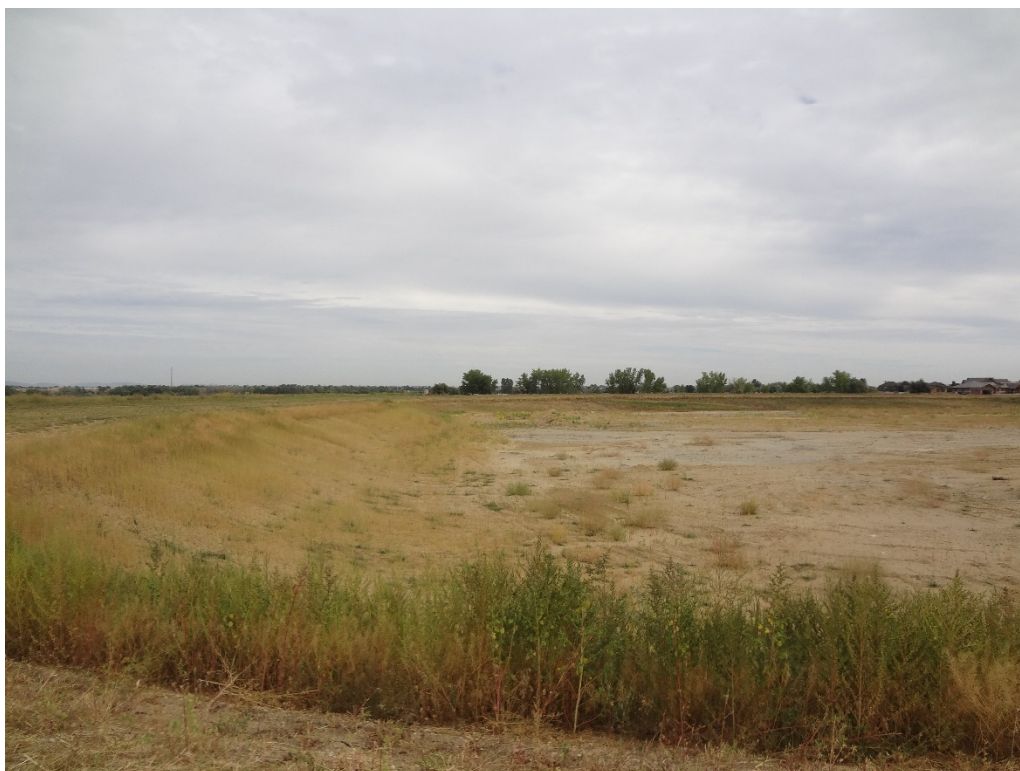
View of Phase 2 reservoir looking north from SW corner

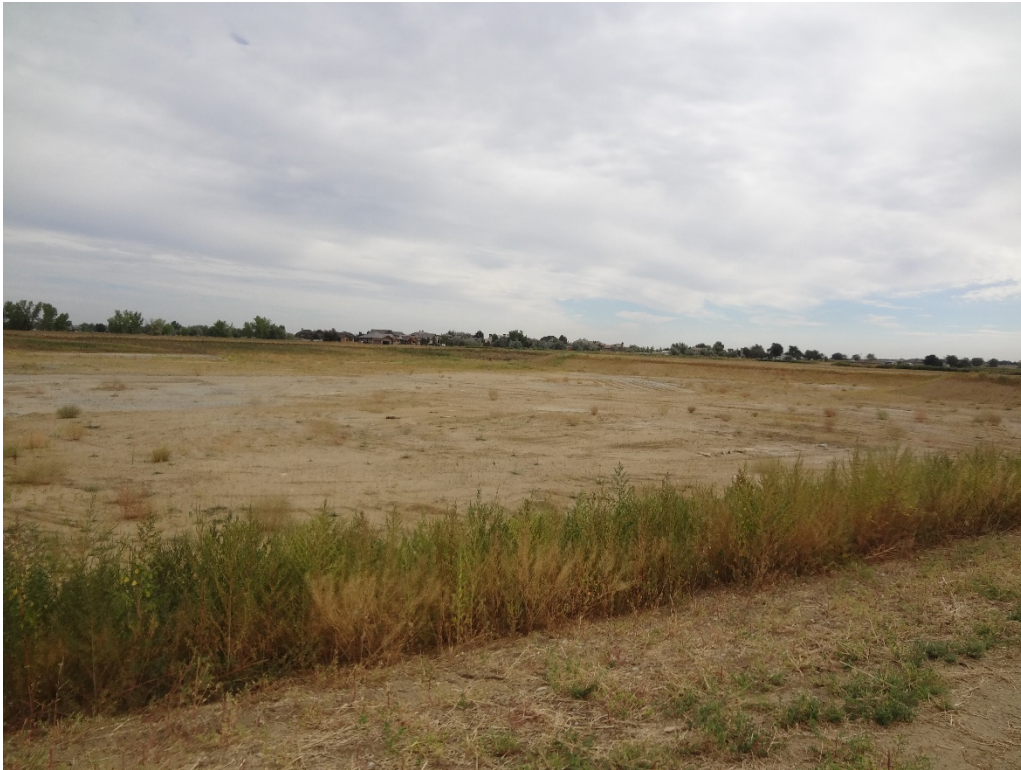
View of Phase 2 reservoir looking NE from SW corner

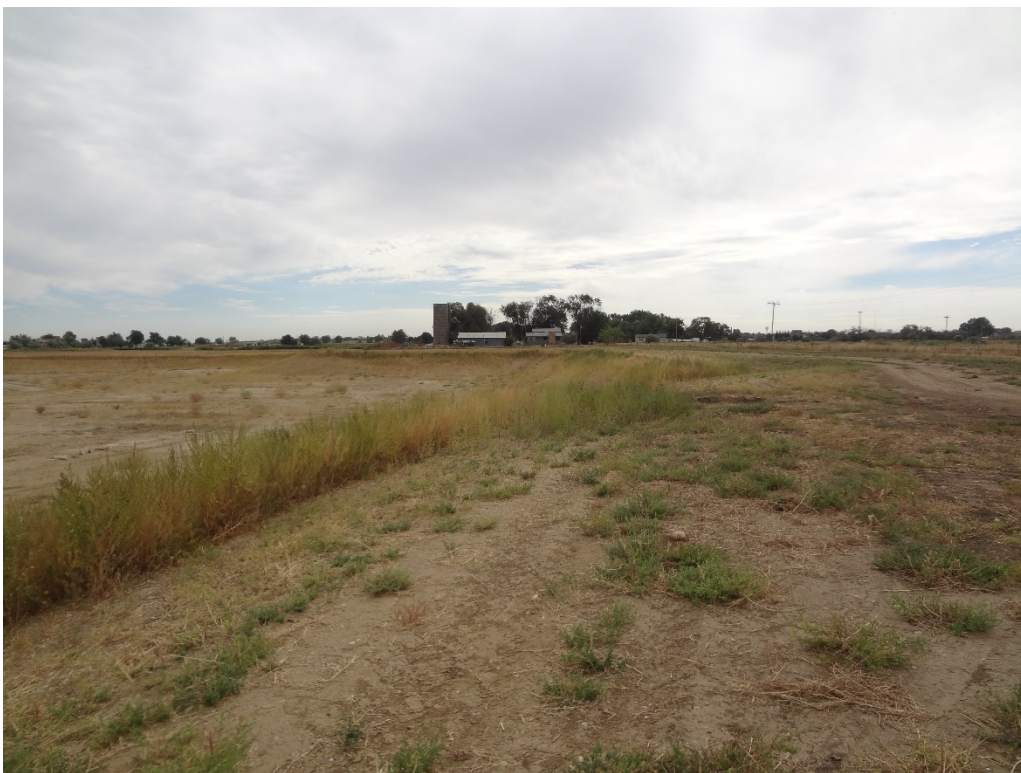
View of Phase 2 reservoir looking east from SW corner

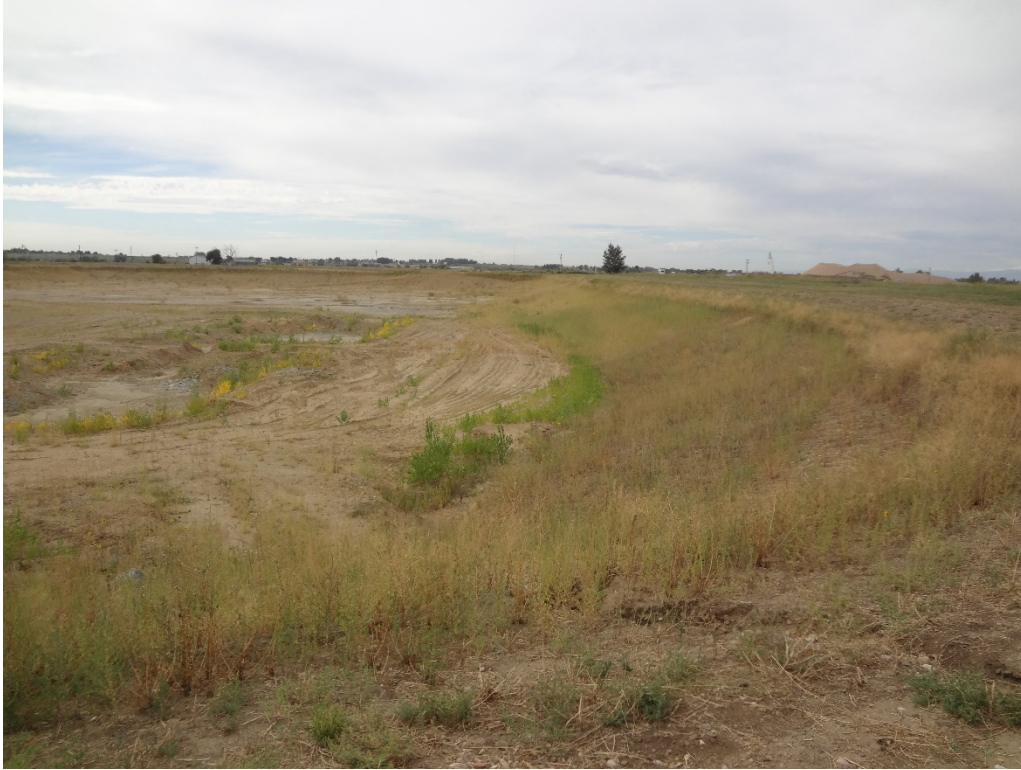
View of Phase 2 reservoir looking south from NW corner

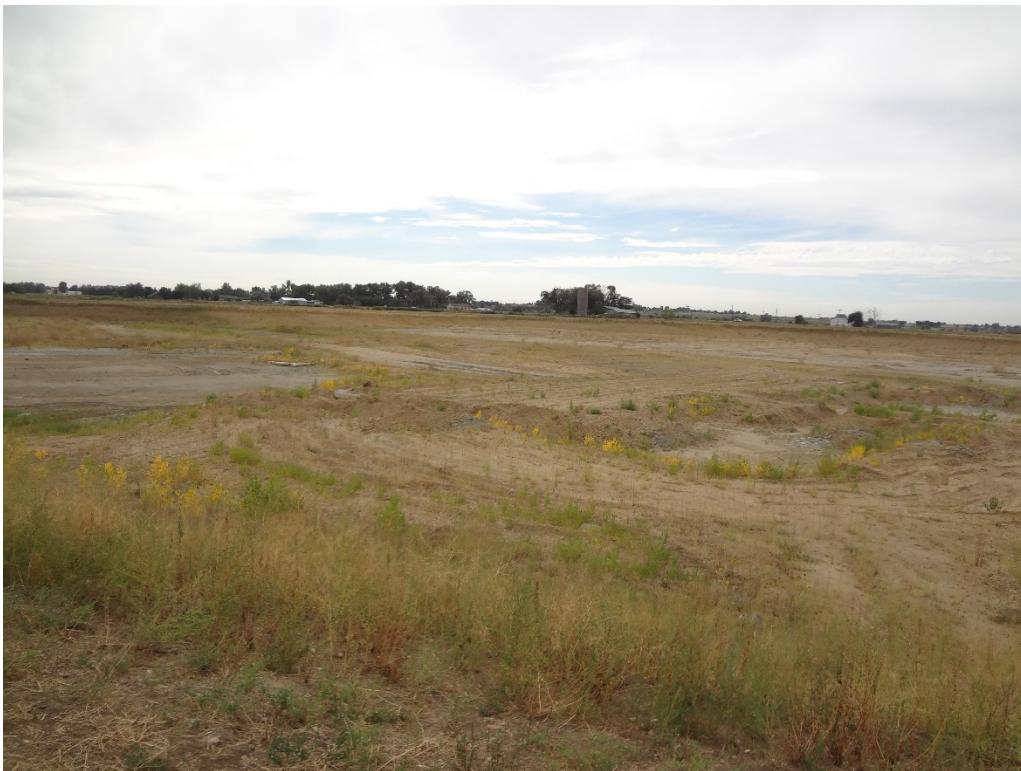
View of Phase 2 reservoir looking SE from NW corner

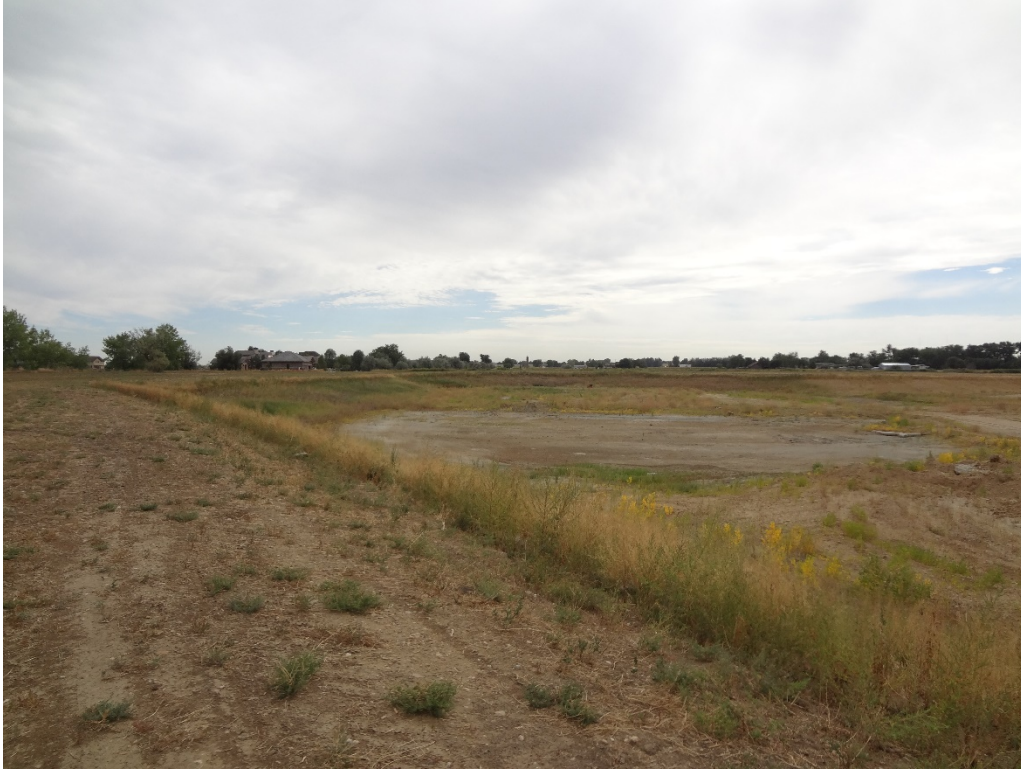
View of Phase 2 reservoir looking east from NW corner

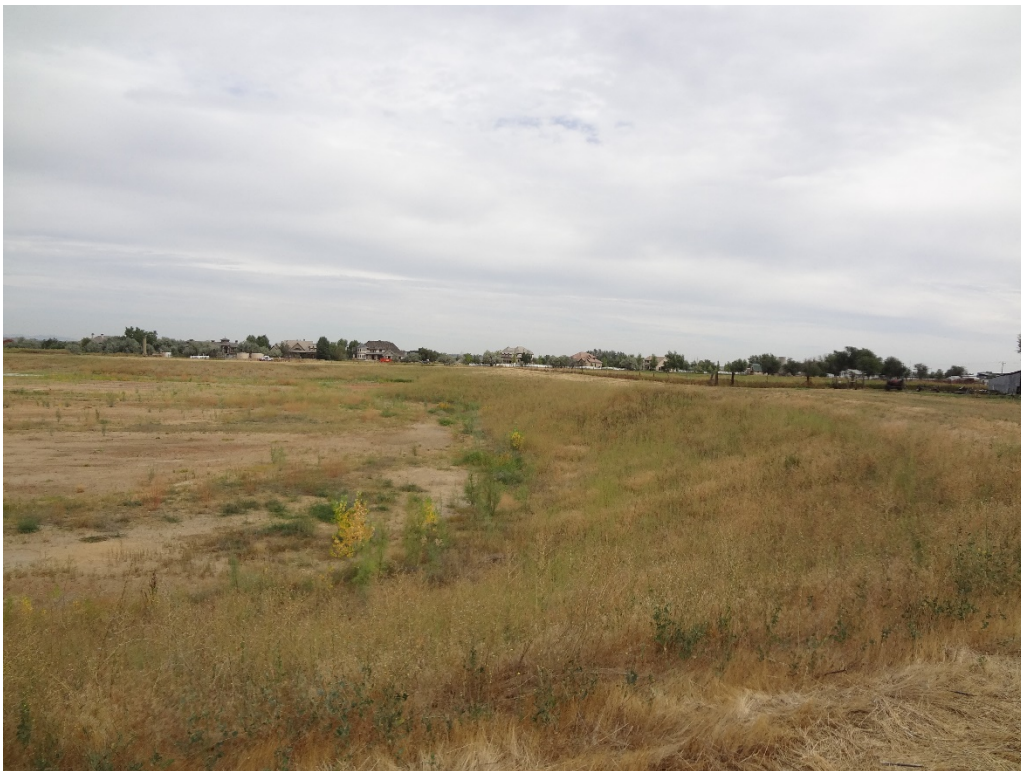
View of Phase 1 reservoir looking north from SE corner

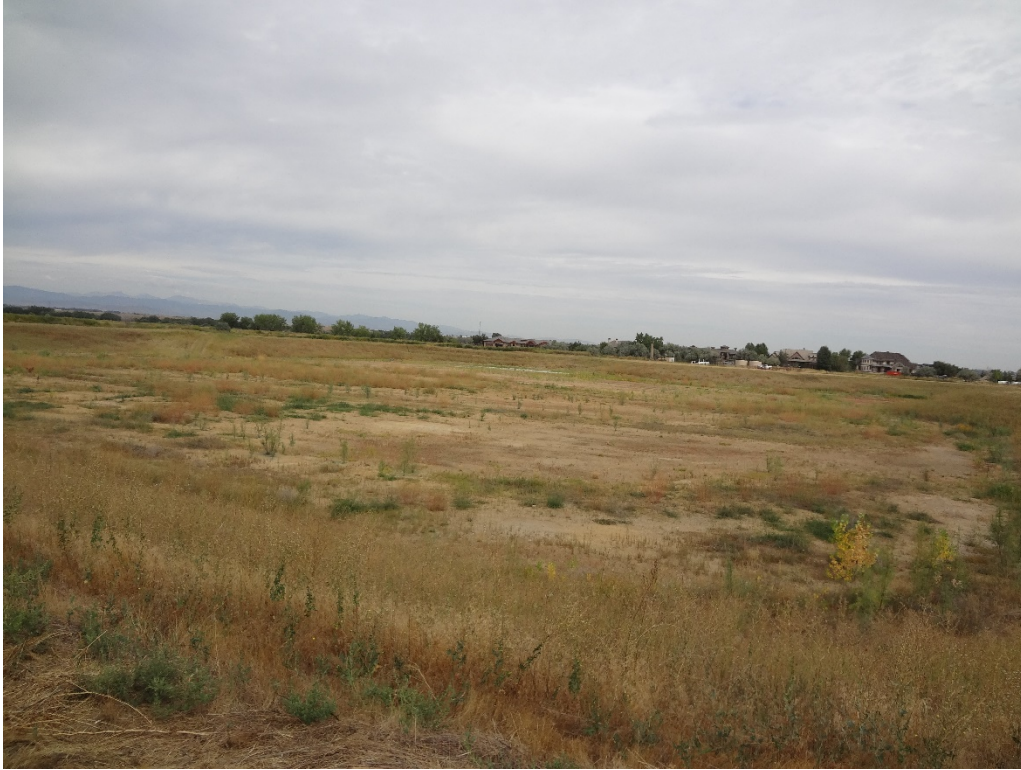
View of Phase 1 reservoir looking NW from SE corner

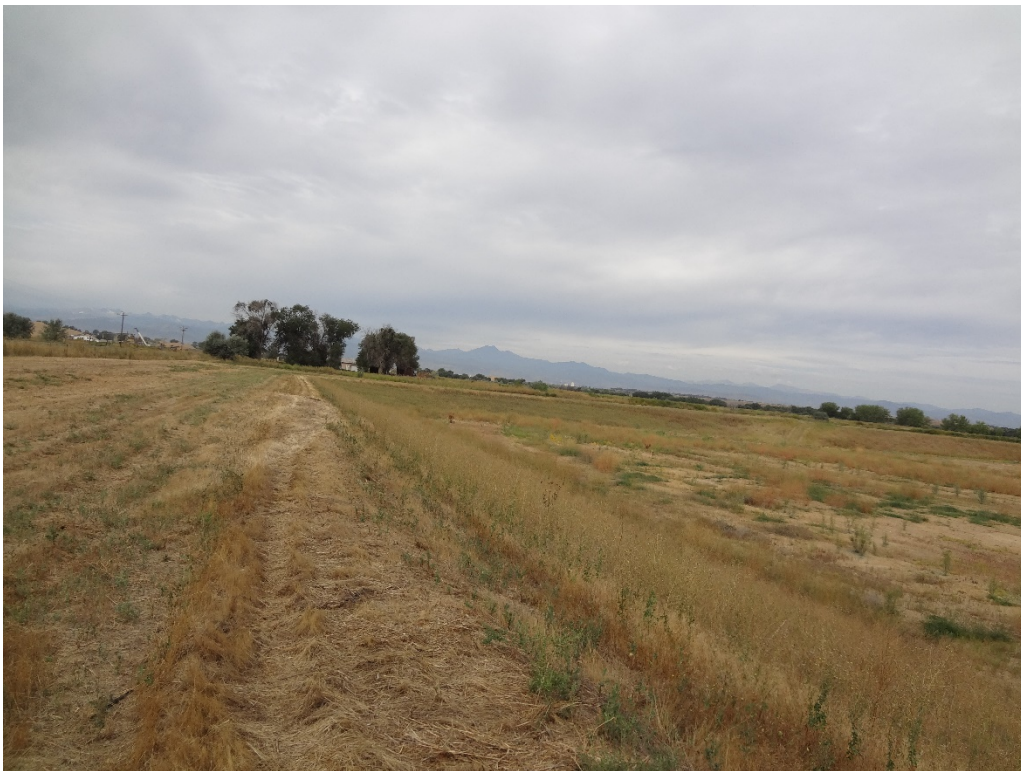
View of Phase 1 reservoir looking west from SE corner
